**Failure Analysis of Pre-Northridge Connections -  
Lessons Learned**

**John M Barsom**

**Barsom Consulting Ltd.**

*January 16-17, 2014 - University of California, Los Angeles*

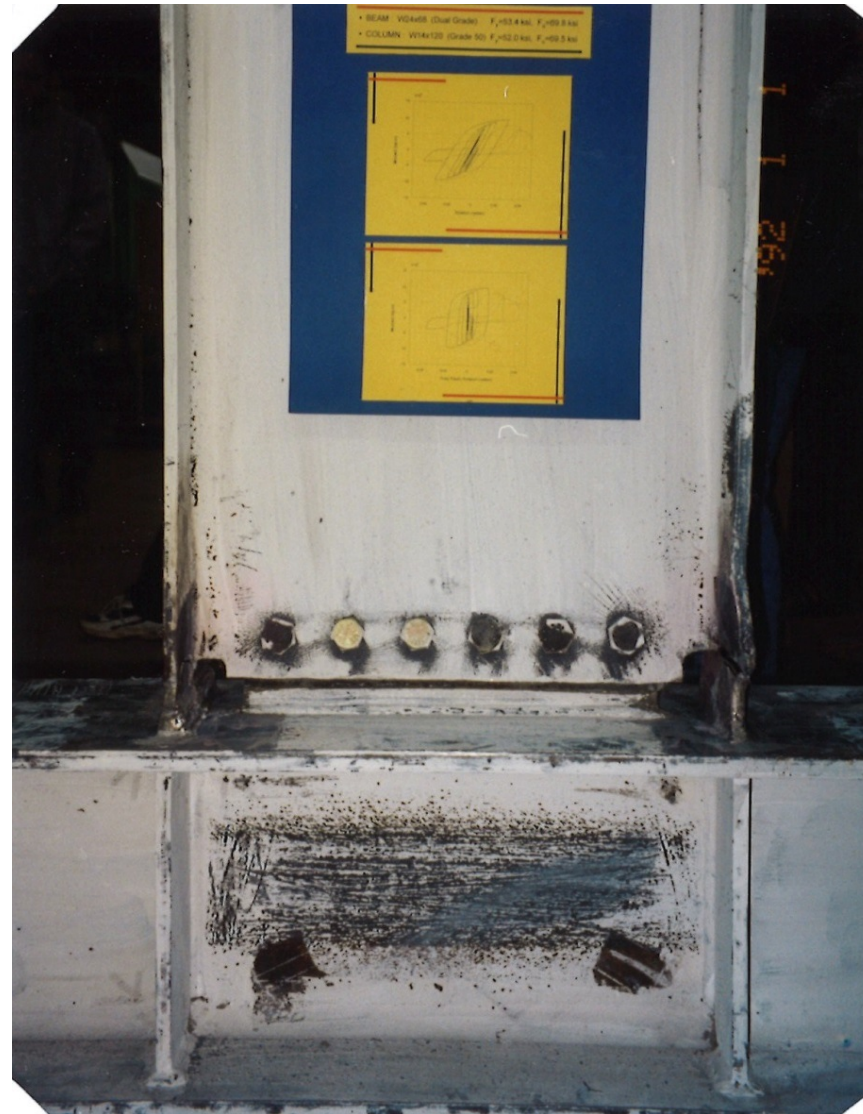
**Figure 1. General view of specimen SP3.2. Top flange on left.**

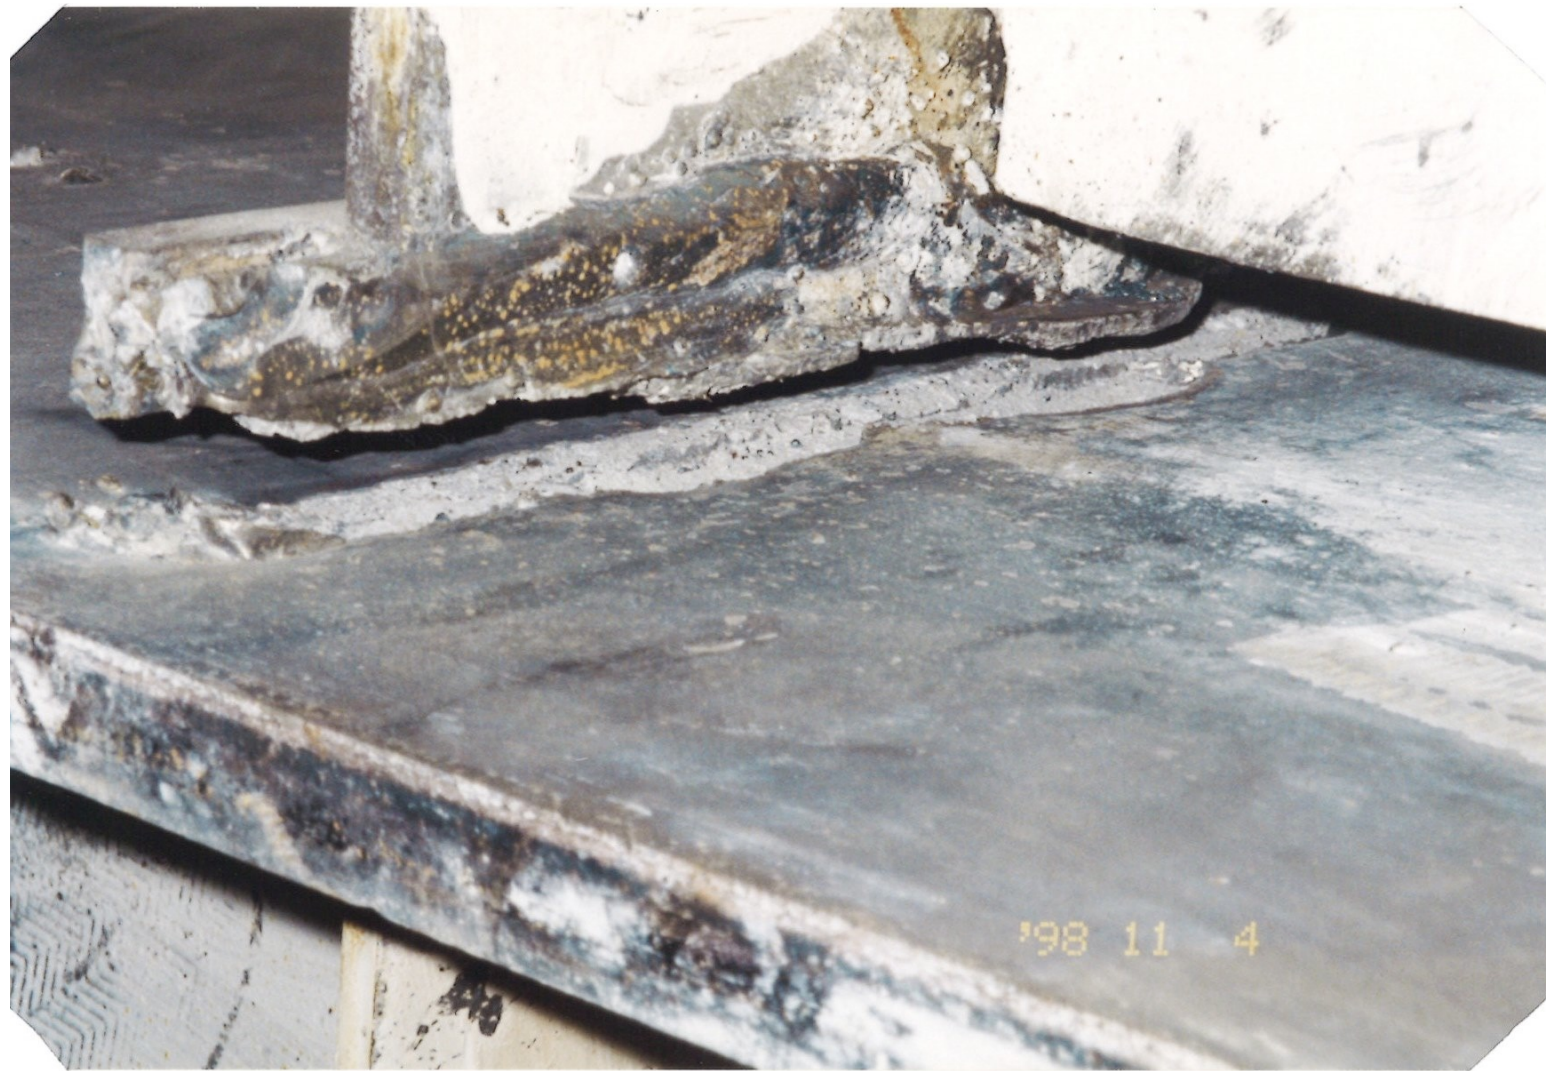
**Figure 5. Divot type fracture of connection SP1.1.**

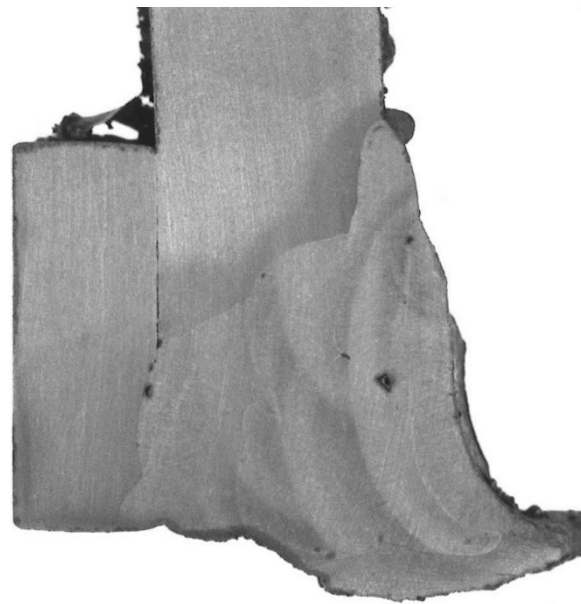
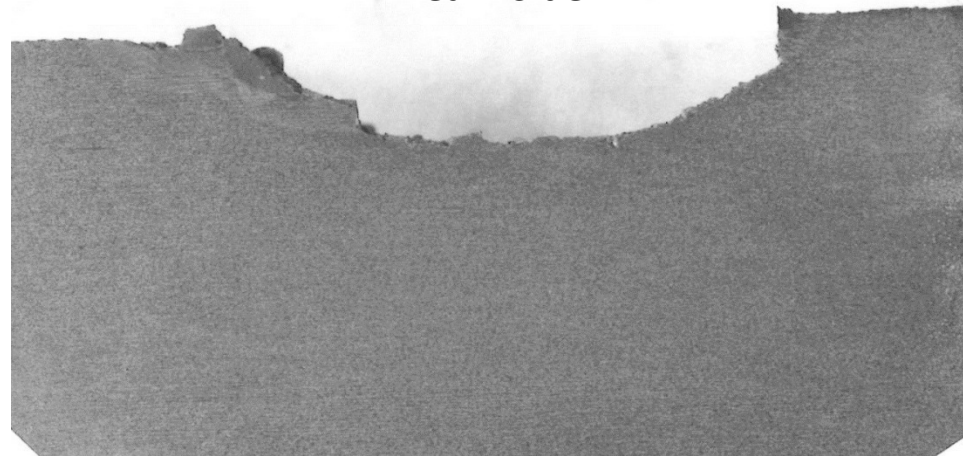
**Figure 7. Cross sections of divot-type fractures at mid-width of the beam flange.**

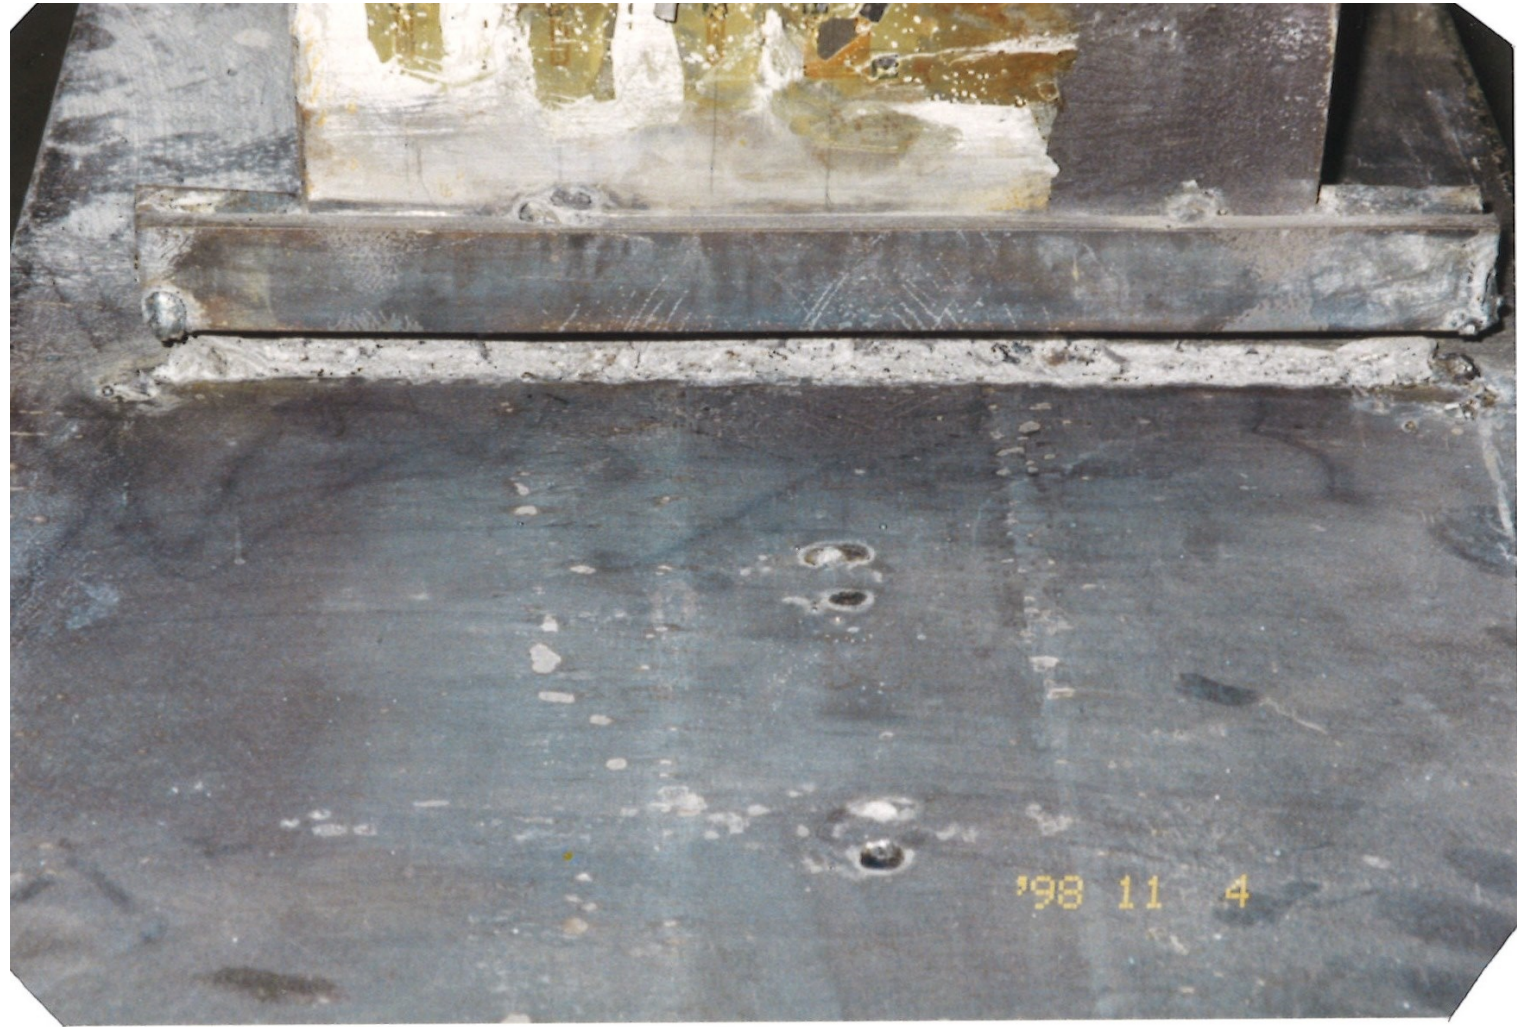
**Figure 4. Bottom flange fracture of connection SP1.1 along the length of the backing plate.**

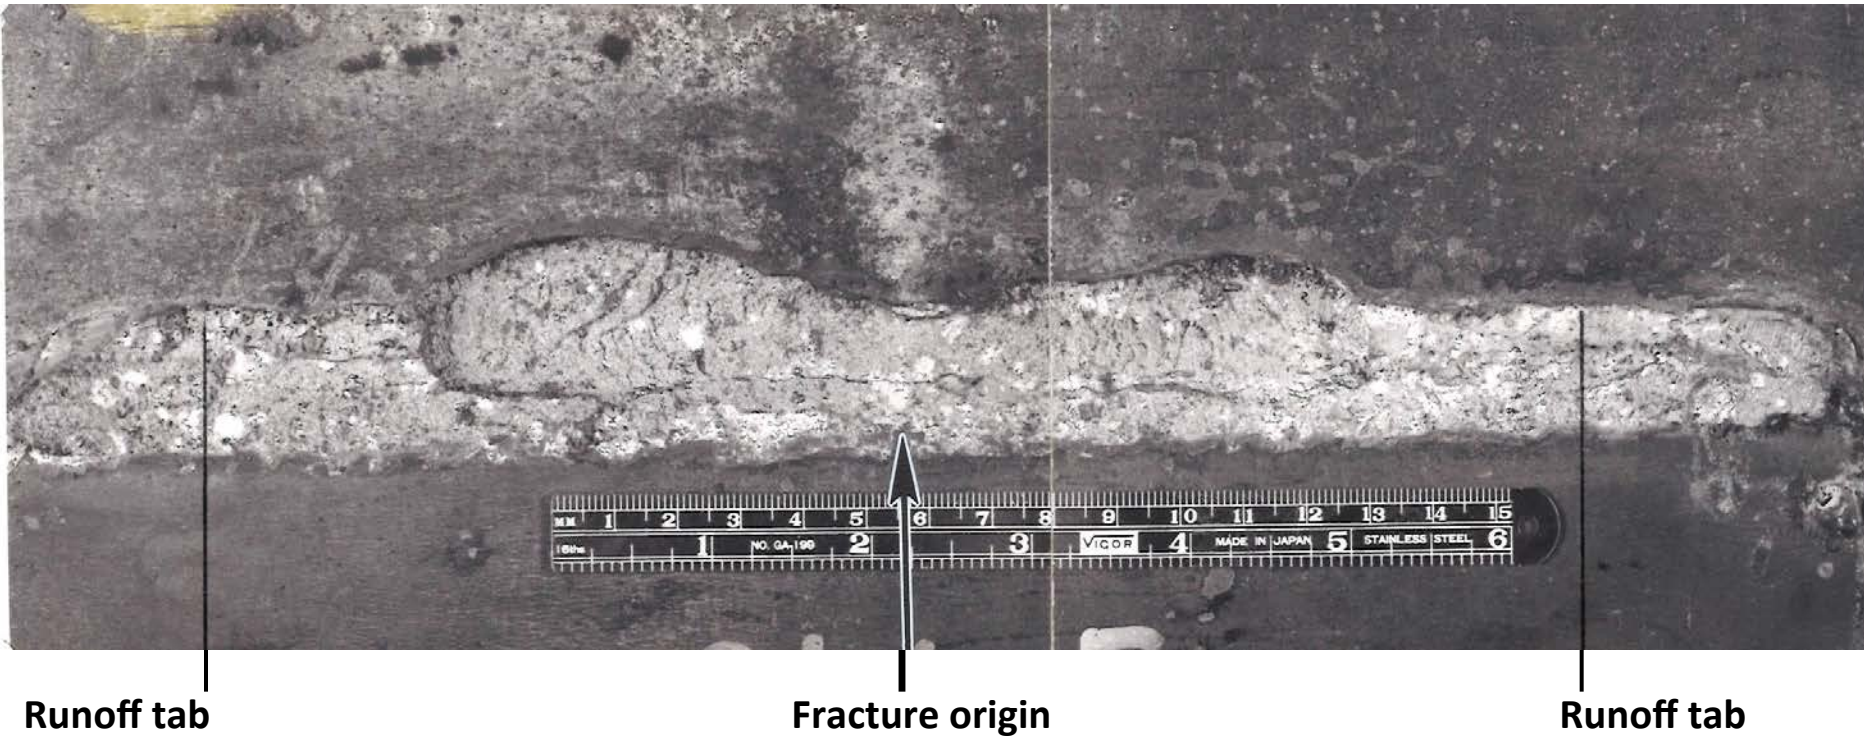
**Figure 6. Surface of bottom beam-flange divot-type fracture.**

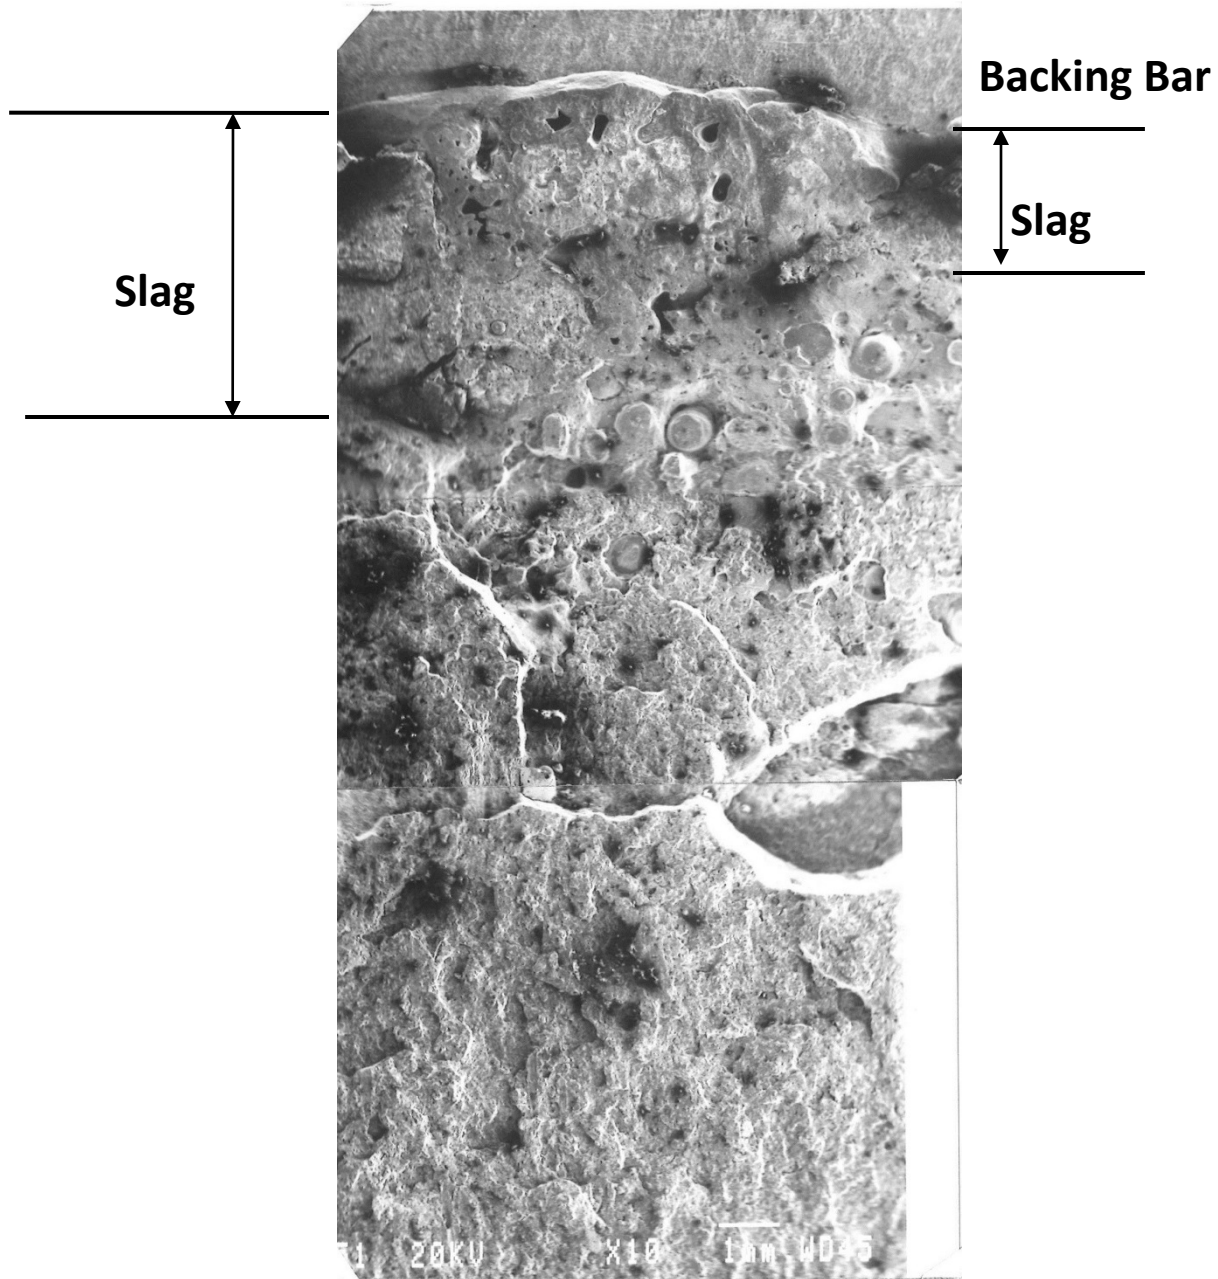
**Figure 9. Scanning electron micrograph of the fracture origin on the beam side.**

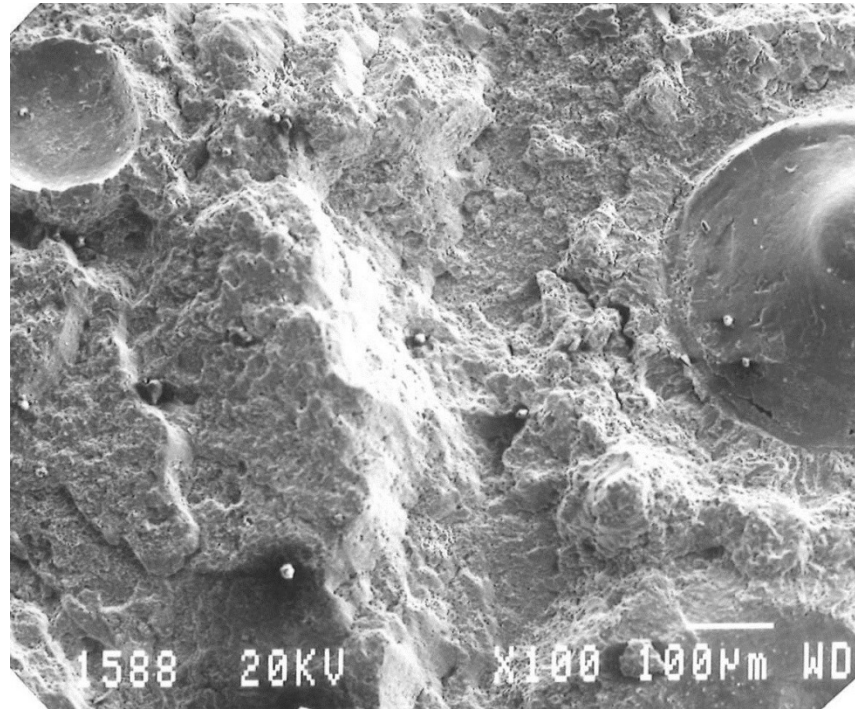
**Figure 11.1. Ductile fracture of an area in the weld metal at the fracture origin.**

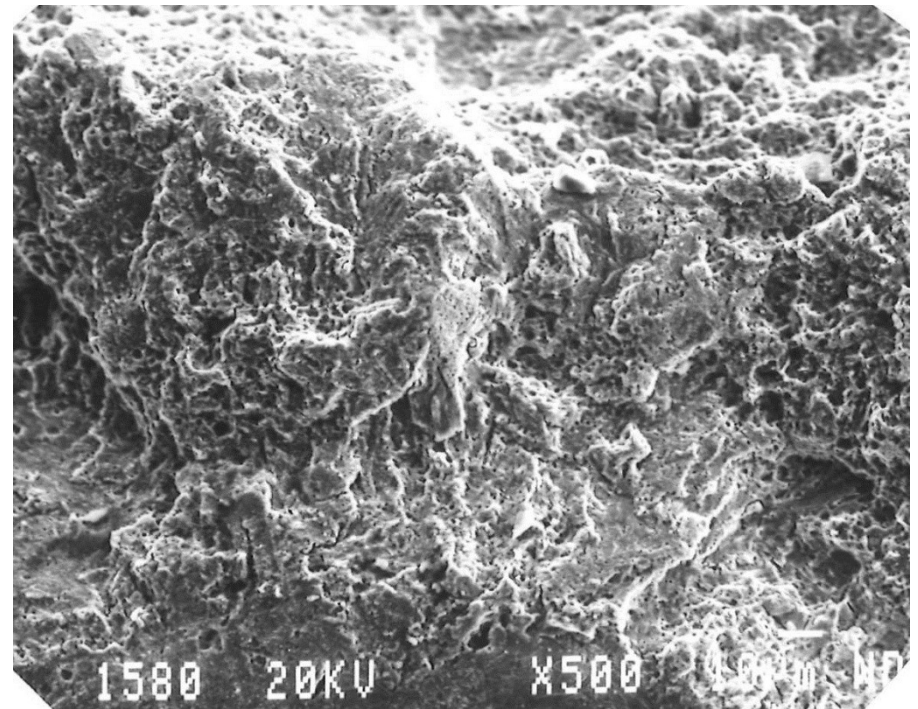
**Figure 11.2. Higher magnification of ductile fracture area in the weld metal at the fracture origin.**

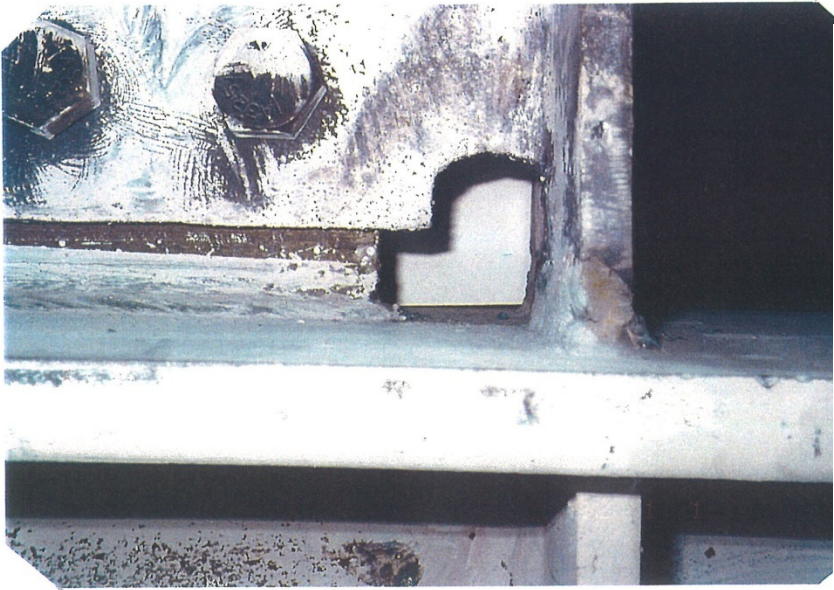
**A. Specimen 3.1 (Bottom)**

**Figure 17. Examples of severe web-to-flange intersections at weld access hole.**

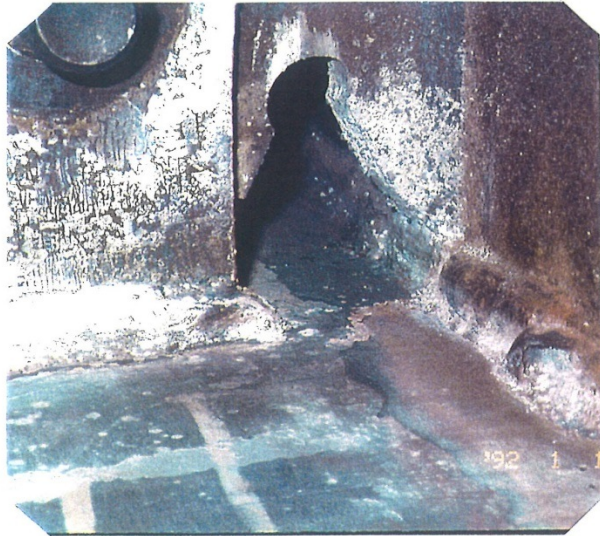
**Specimen 4.1**

**A. Web-to-flange intersection at the weld access hole coincident with weld toe.**

**Figure 18. Examples of stress and strain regions caused by the coincidence of the web-to-flange intersection at the weld access hole and the weld toe.**

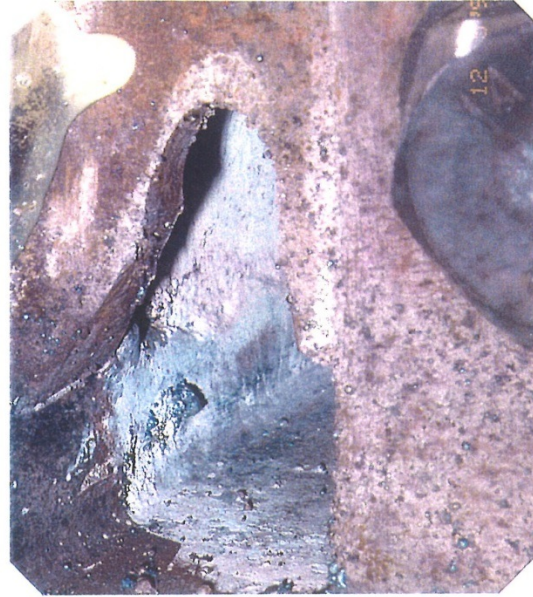
**Specimen 5.2 (Bottom)**

**B. Close up of weld access hole and inside weld geometry.**

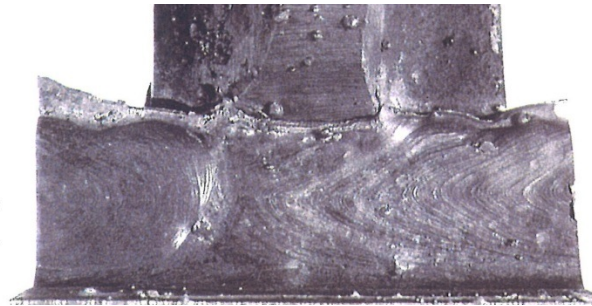
**Specimen 5.1 (Bottom)**

**C. Close up of fatigue crack at web-to-flange intersection of the weld access hole coincident with the weld toe.**

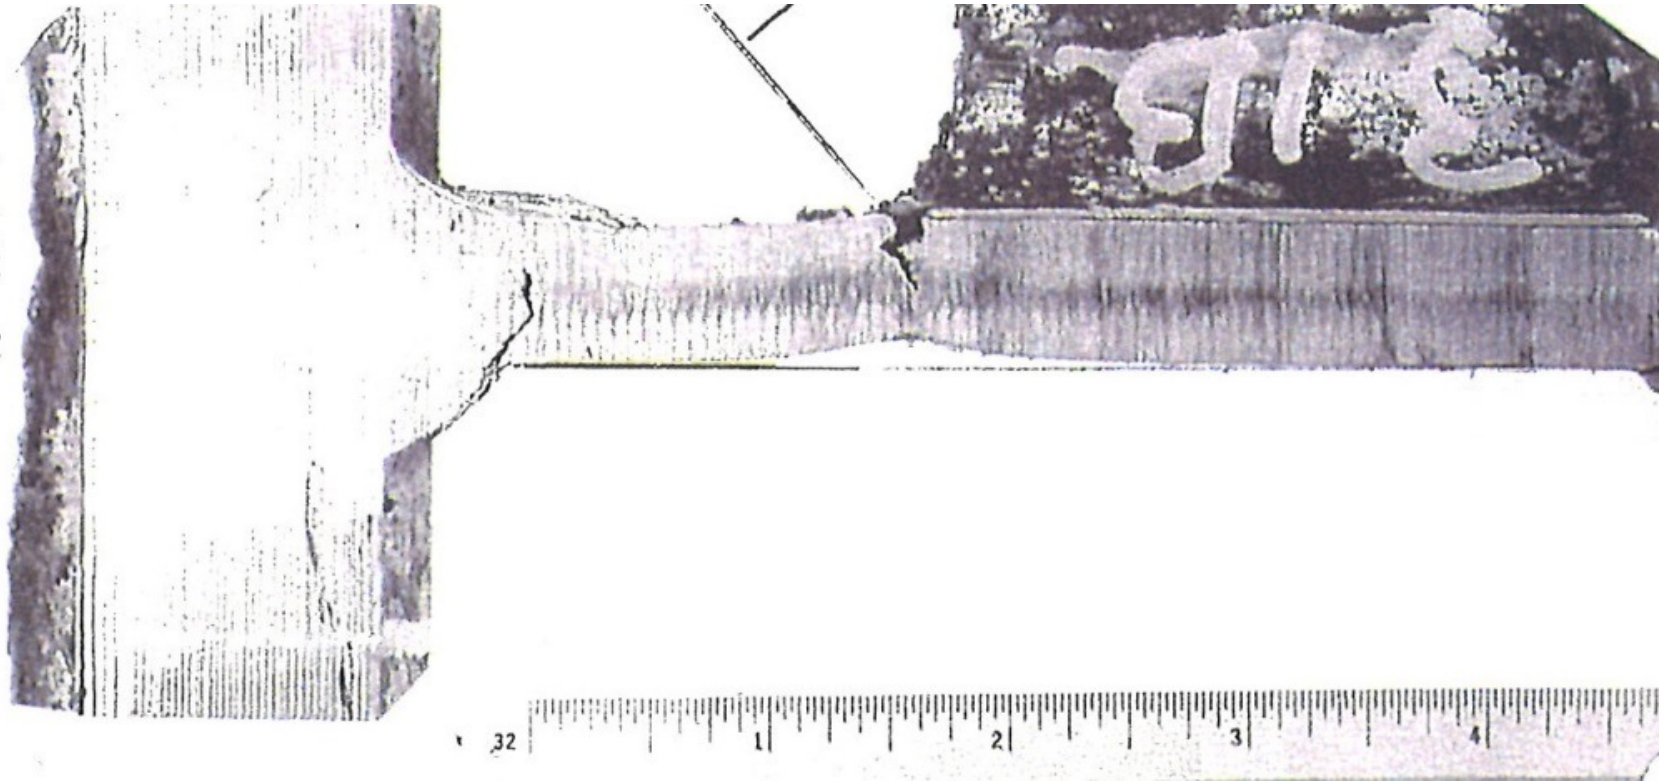
**Figure 20. Fatigue cracks initiated at web-to-flange intersection at the weld access hole and at the weld toe in the bottom surface of the bottom flange.**

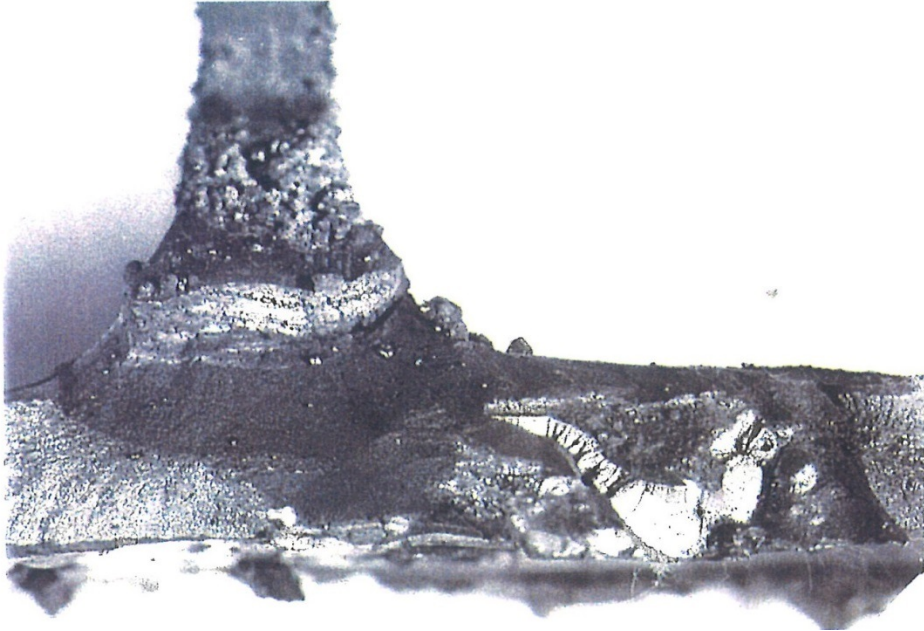
**Specimen 4.2 (Bottom)**

**A. Fracture surface showed the fracture was caused by two fatigue cracks. One within the weld metal from a lack-of-fusion and slag inclusions, the other from the web-to-flange intersections at the weld access hole.**

**Figure 22. Fatigue crack initiated at lack-of-fusion imperfections.**

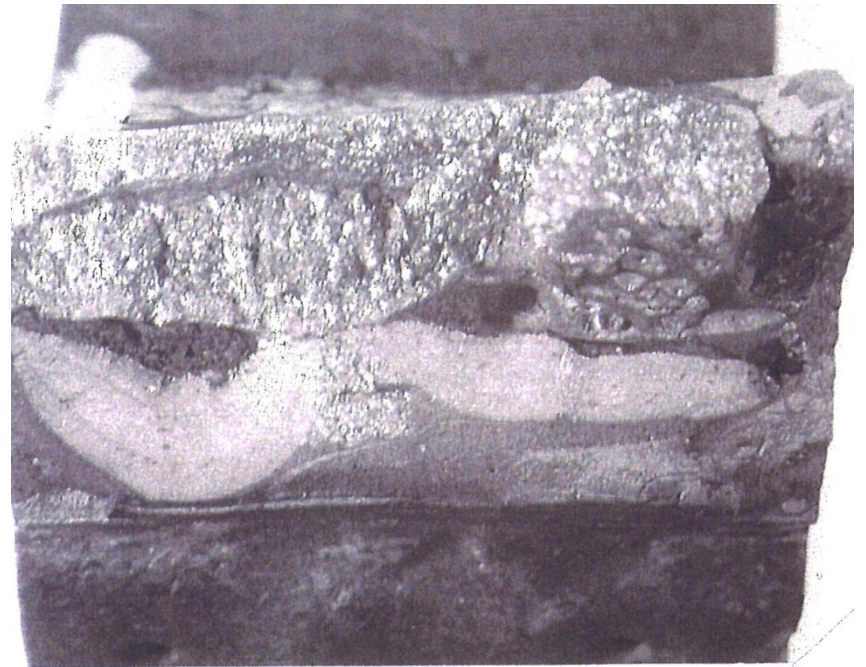
**Specimen 3.1 (Bottom)**

**B. Multiple cracks initiated within the weld from lack-of-fusion and slag inclusions.**

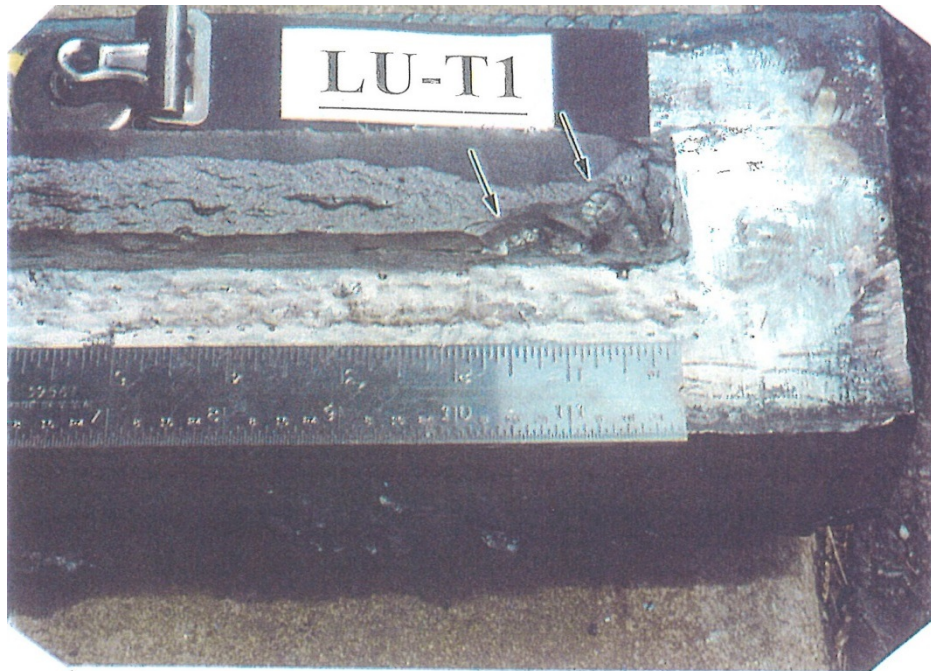
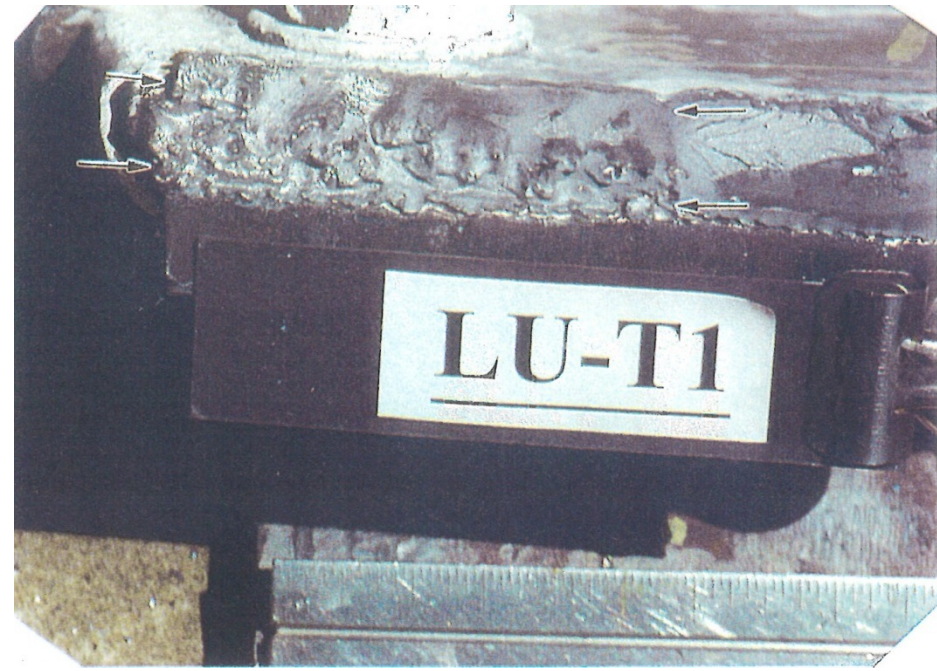
**Figure 31.1. Examples of weld imperfections in Lehigh University connection LU-T1.**

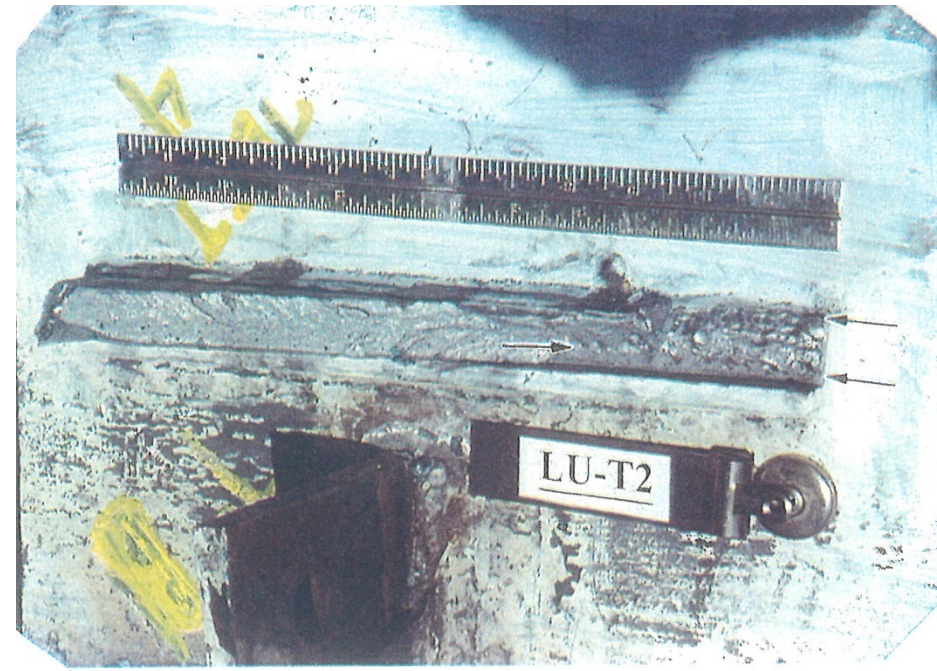
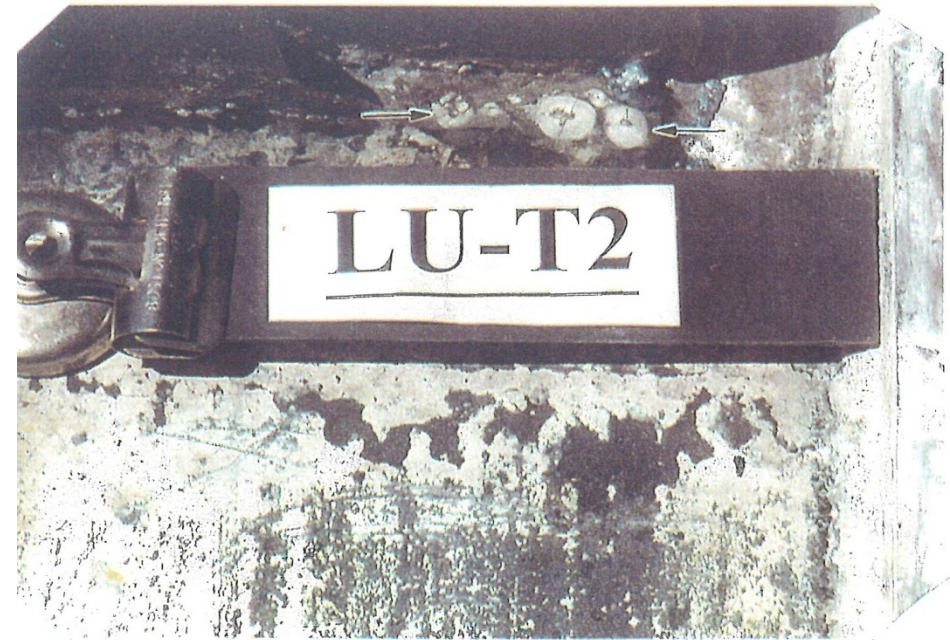
**Figure 32. Examples of weld imperfections in Lehigh University connection LU-T2.**

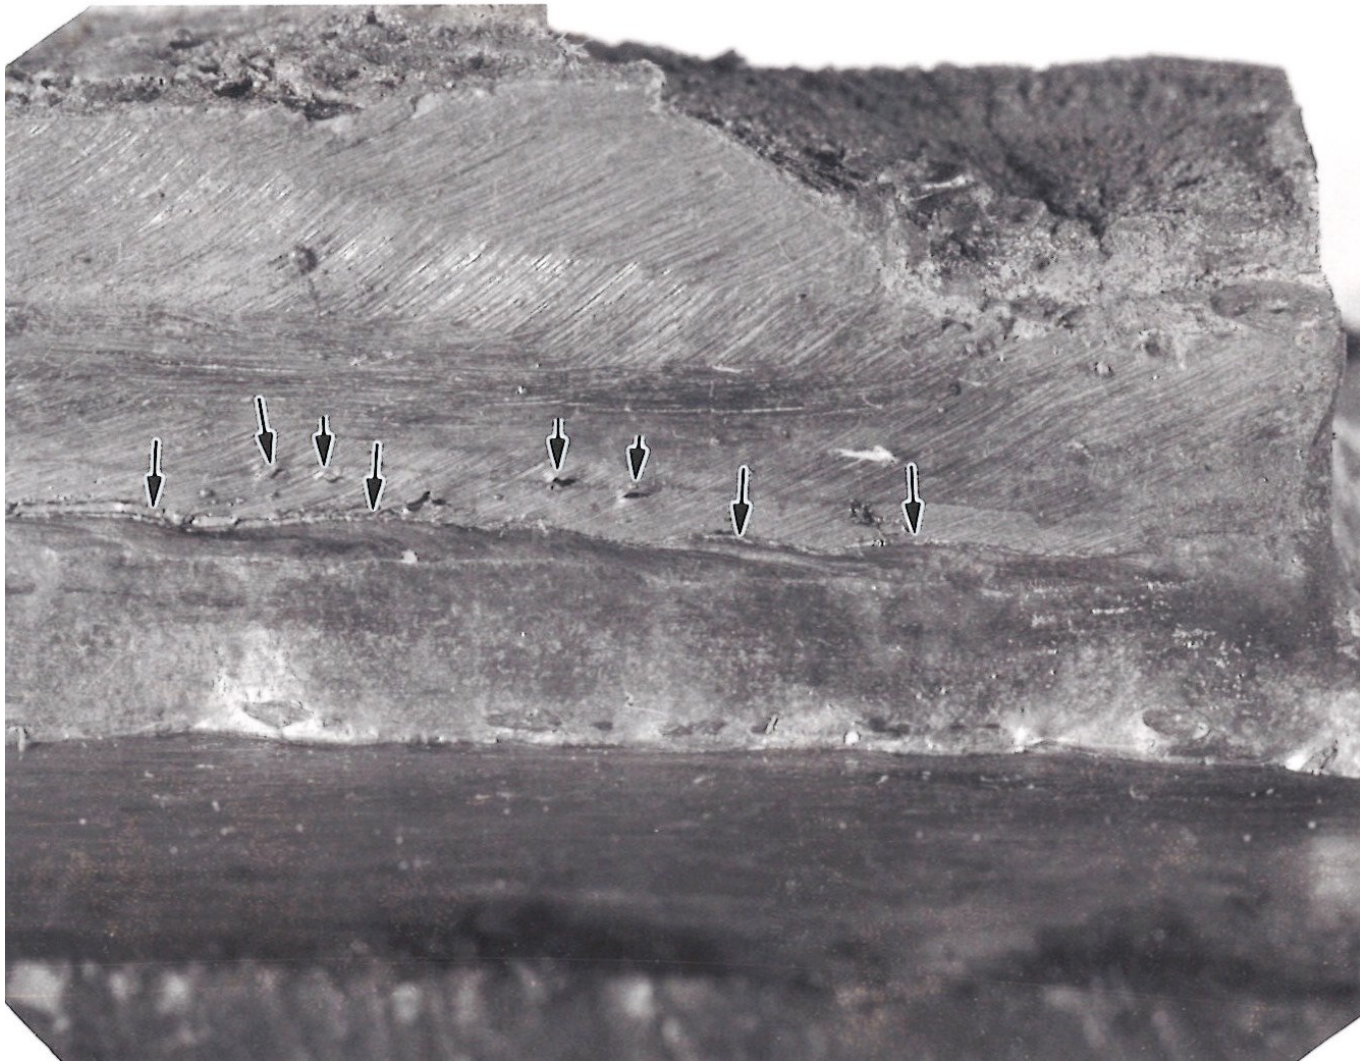
**Figure 36. Multiple fatigue cracks along the fillet weld toe and the fusion line of the groove weld.**

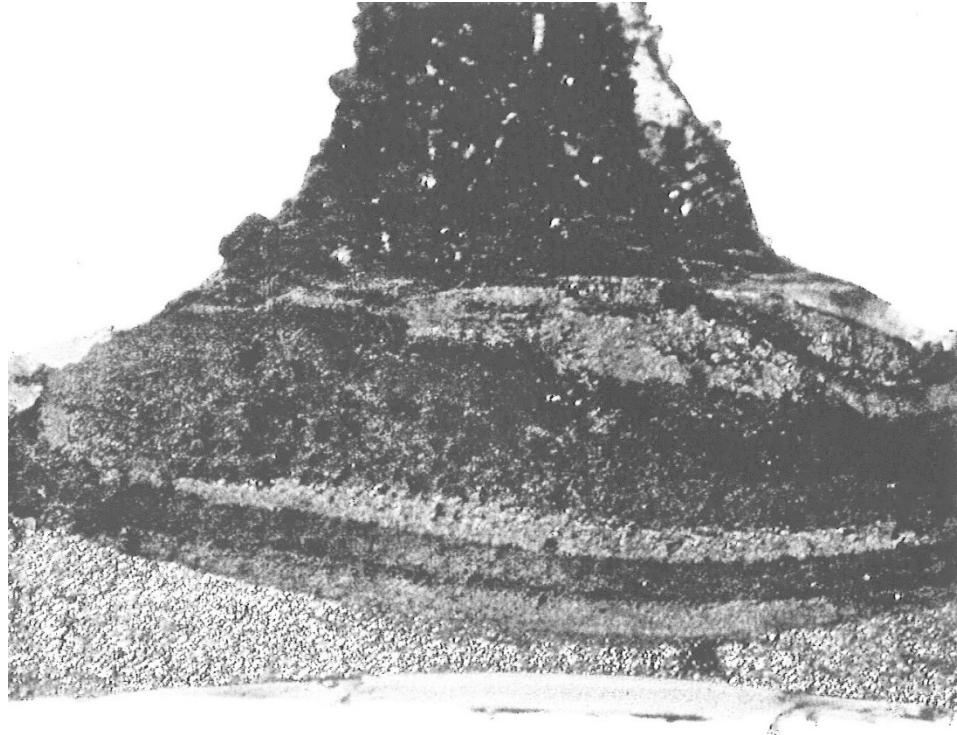
**A. Rapid fatigue crack propagation in specimen SP-3.1.**

**Figure 37. Rapid fatigue crack propagation through the thickness of beam flanges.**

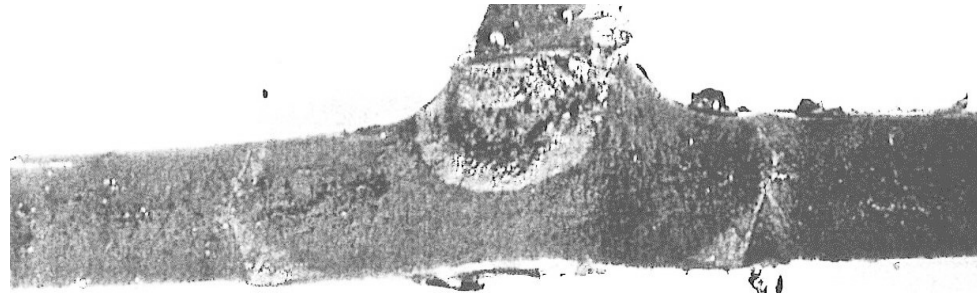
**B. Rapid fatigue crack propagation in specimen SP3-2.**
