# The 1994 Northridge Earthquake: Impacts, Outcomes, and Next Steps

## Revisiting W1 Indications

Duane K. Miller, Sc.D, P.E.

**How W1s mislead many in  
the aftermath of Northridge...  
...and continue to do so today.**

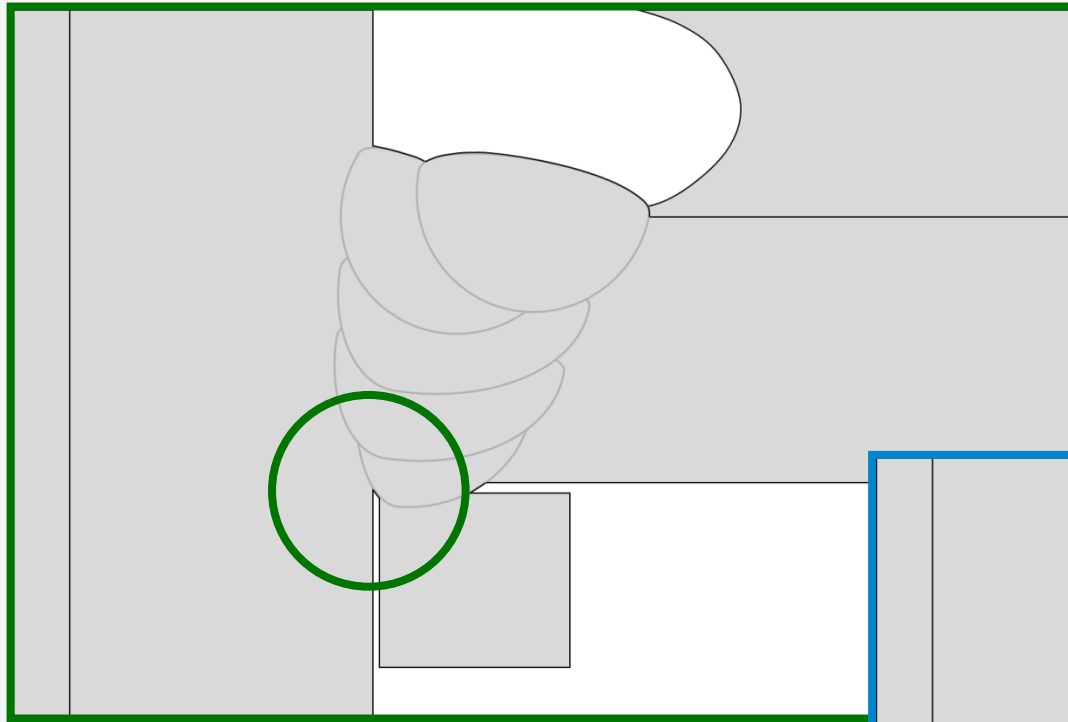
**Acceptable**

**Difficult** to distinguish with UT between an acceptable weld with backing left in place and a weld with a root crack

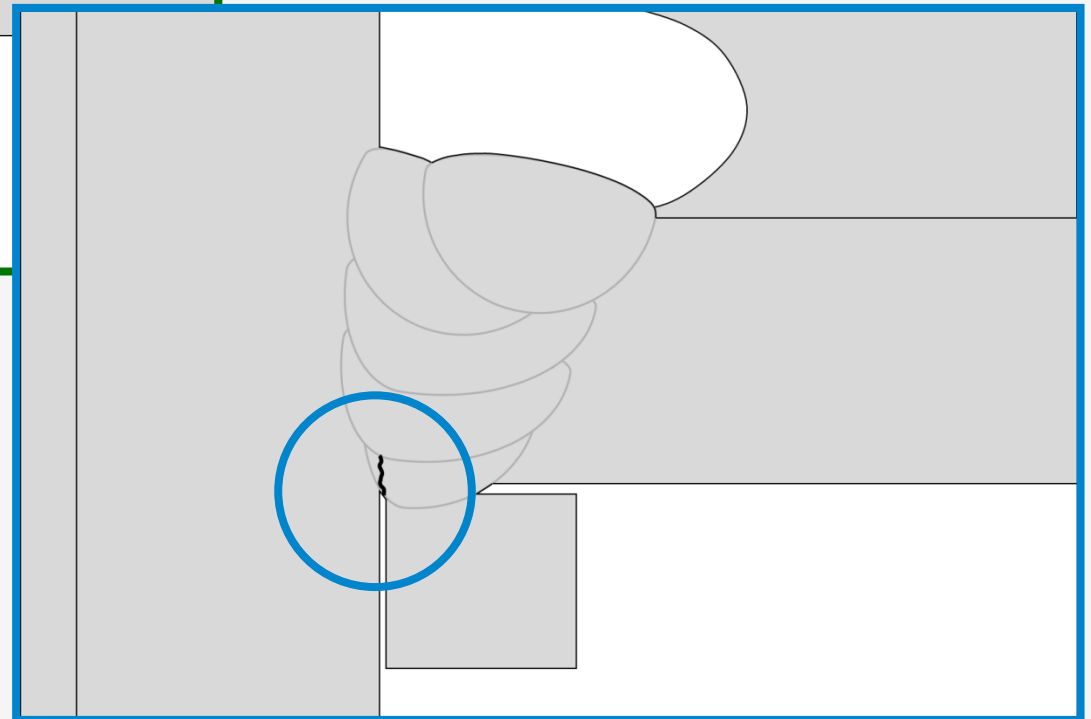
**Crack in root**

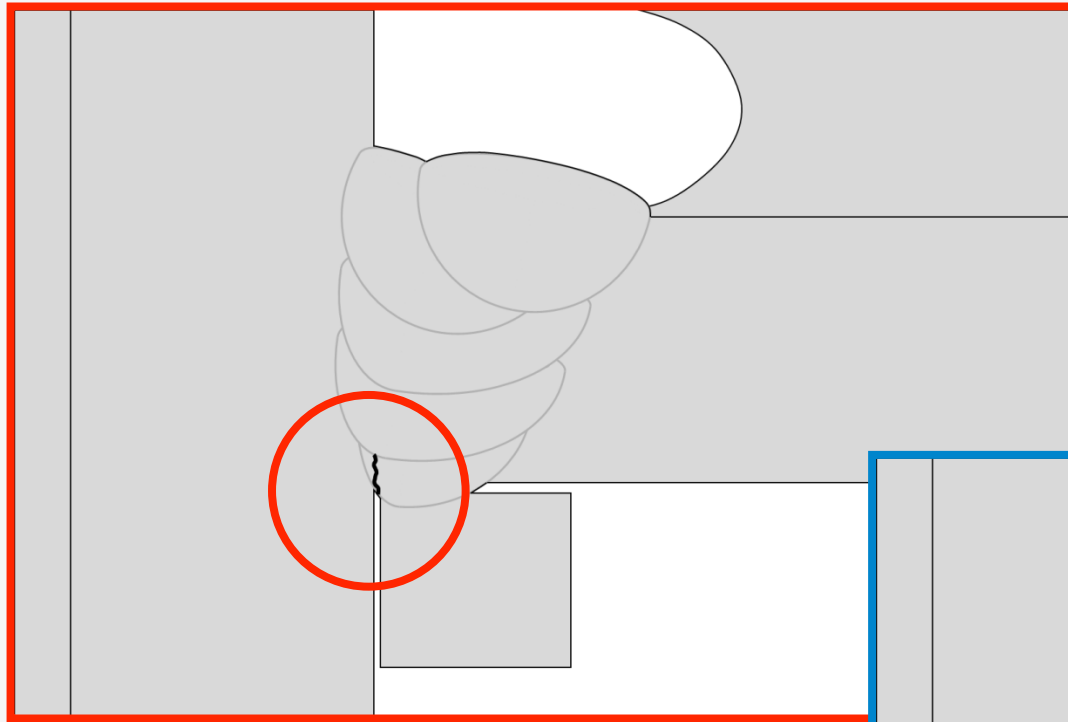
**Pre-existing crack**

**Impossible** to distinguish with UT whether a crack is pre-existing, or due to earthquake

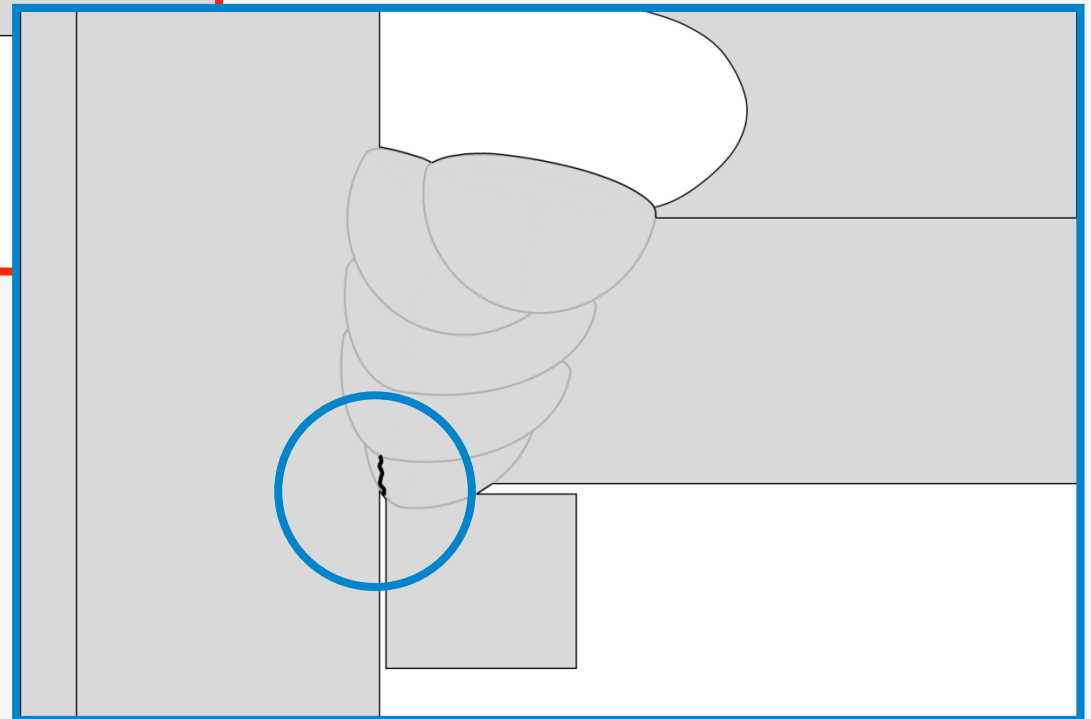
**Earthquake crack**

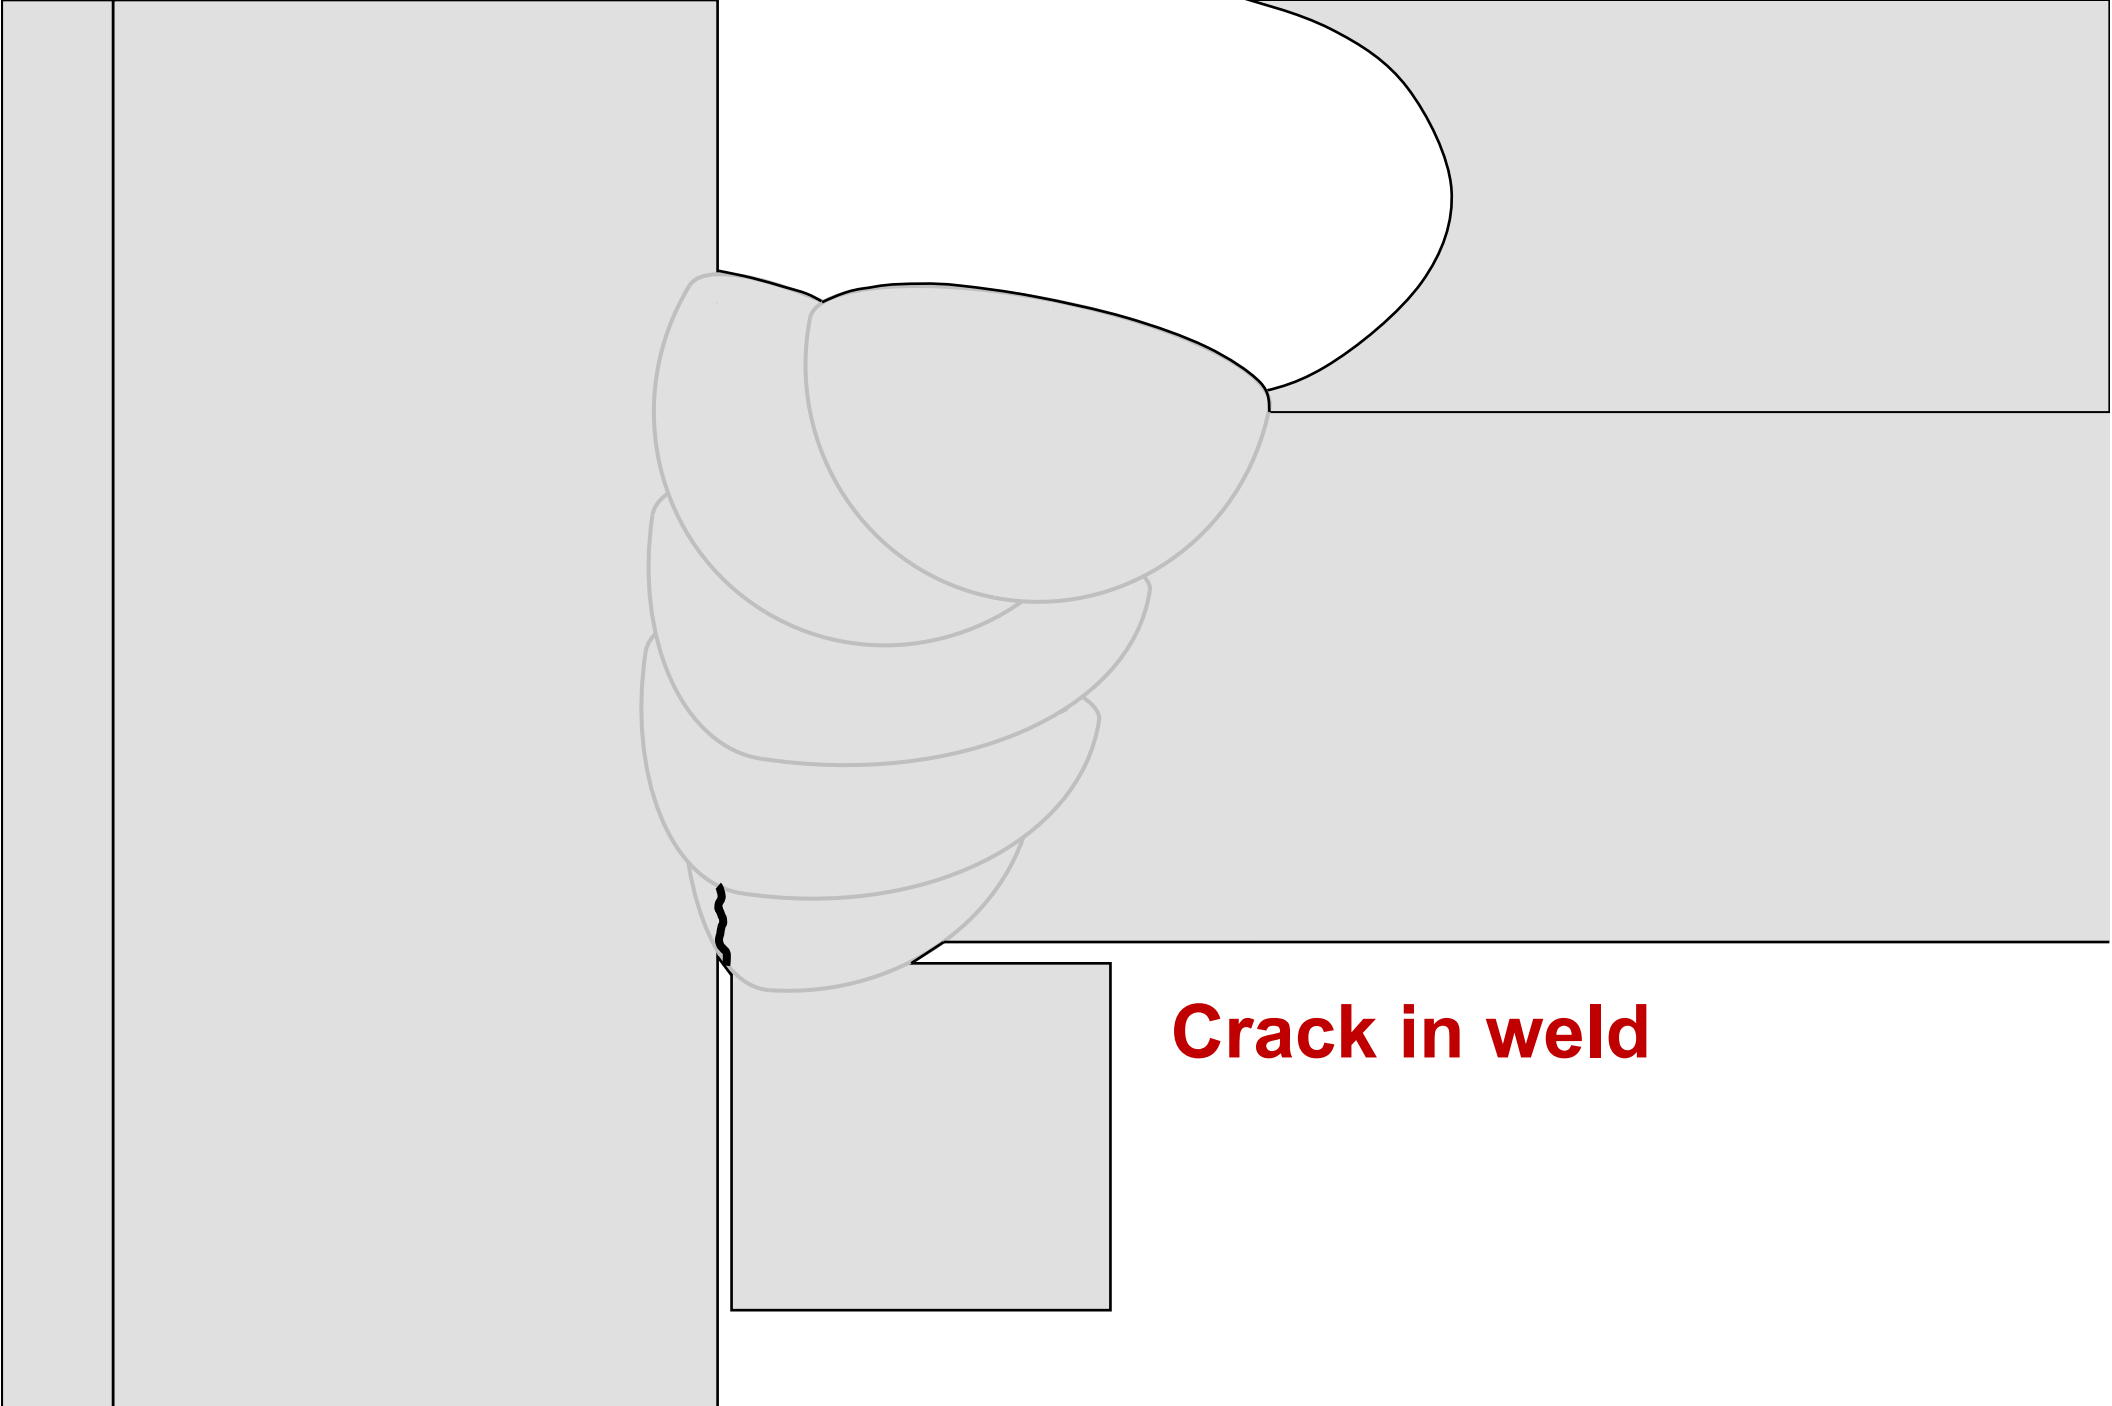
**Crack in weld**

**All could be identified as W1 in inspection reports**

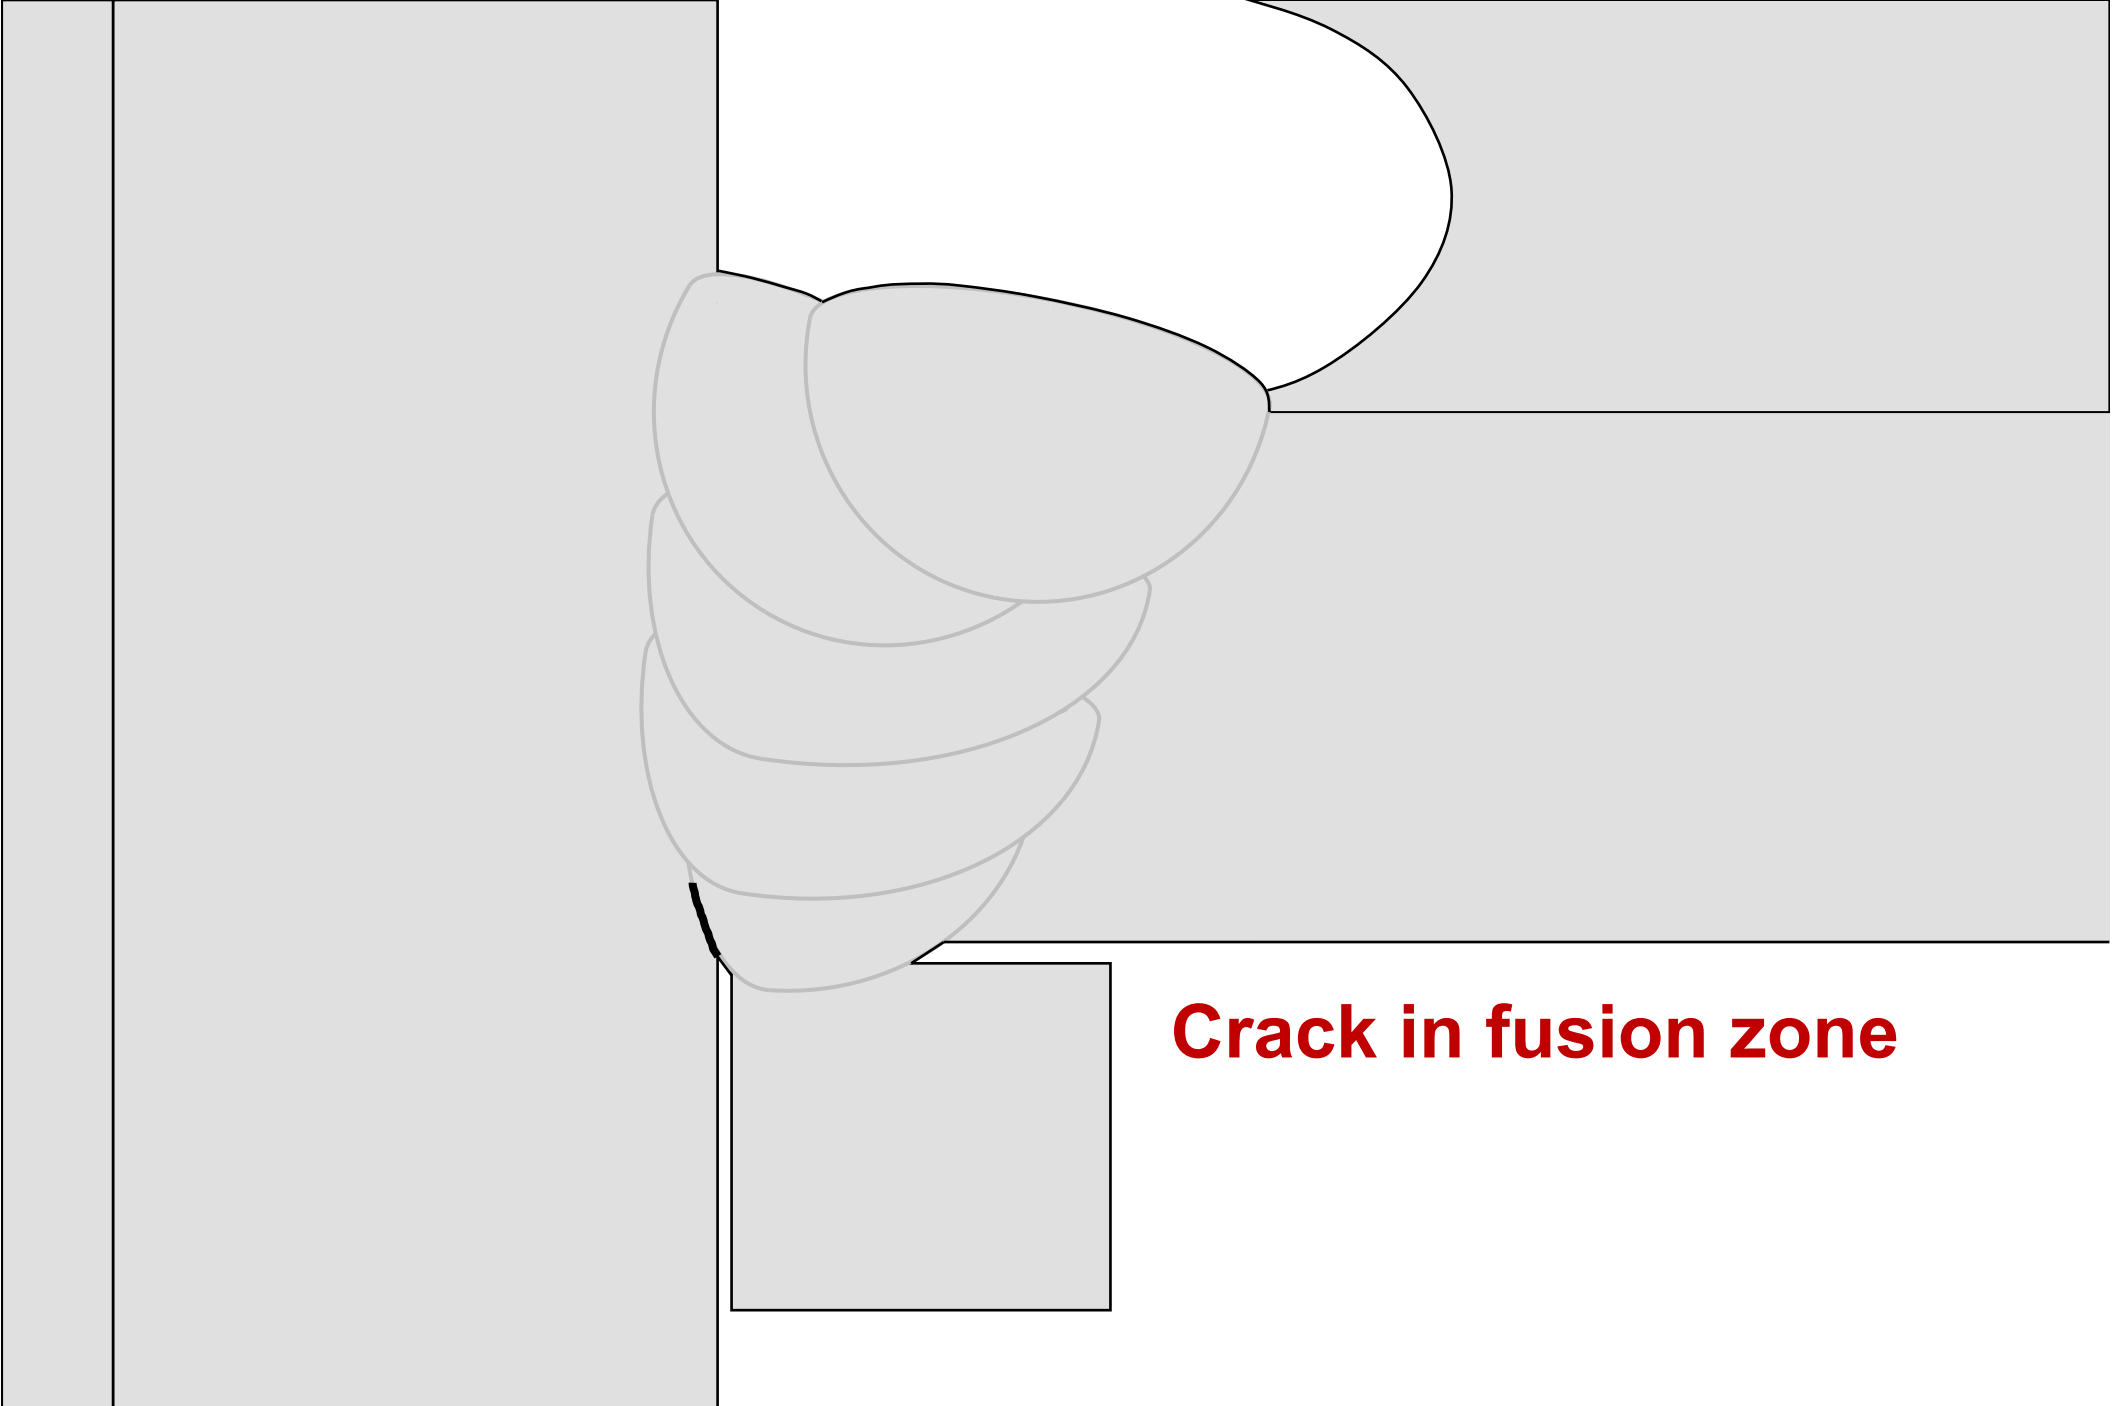
**Crack in fusion zone**

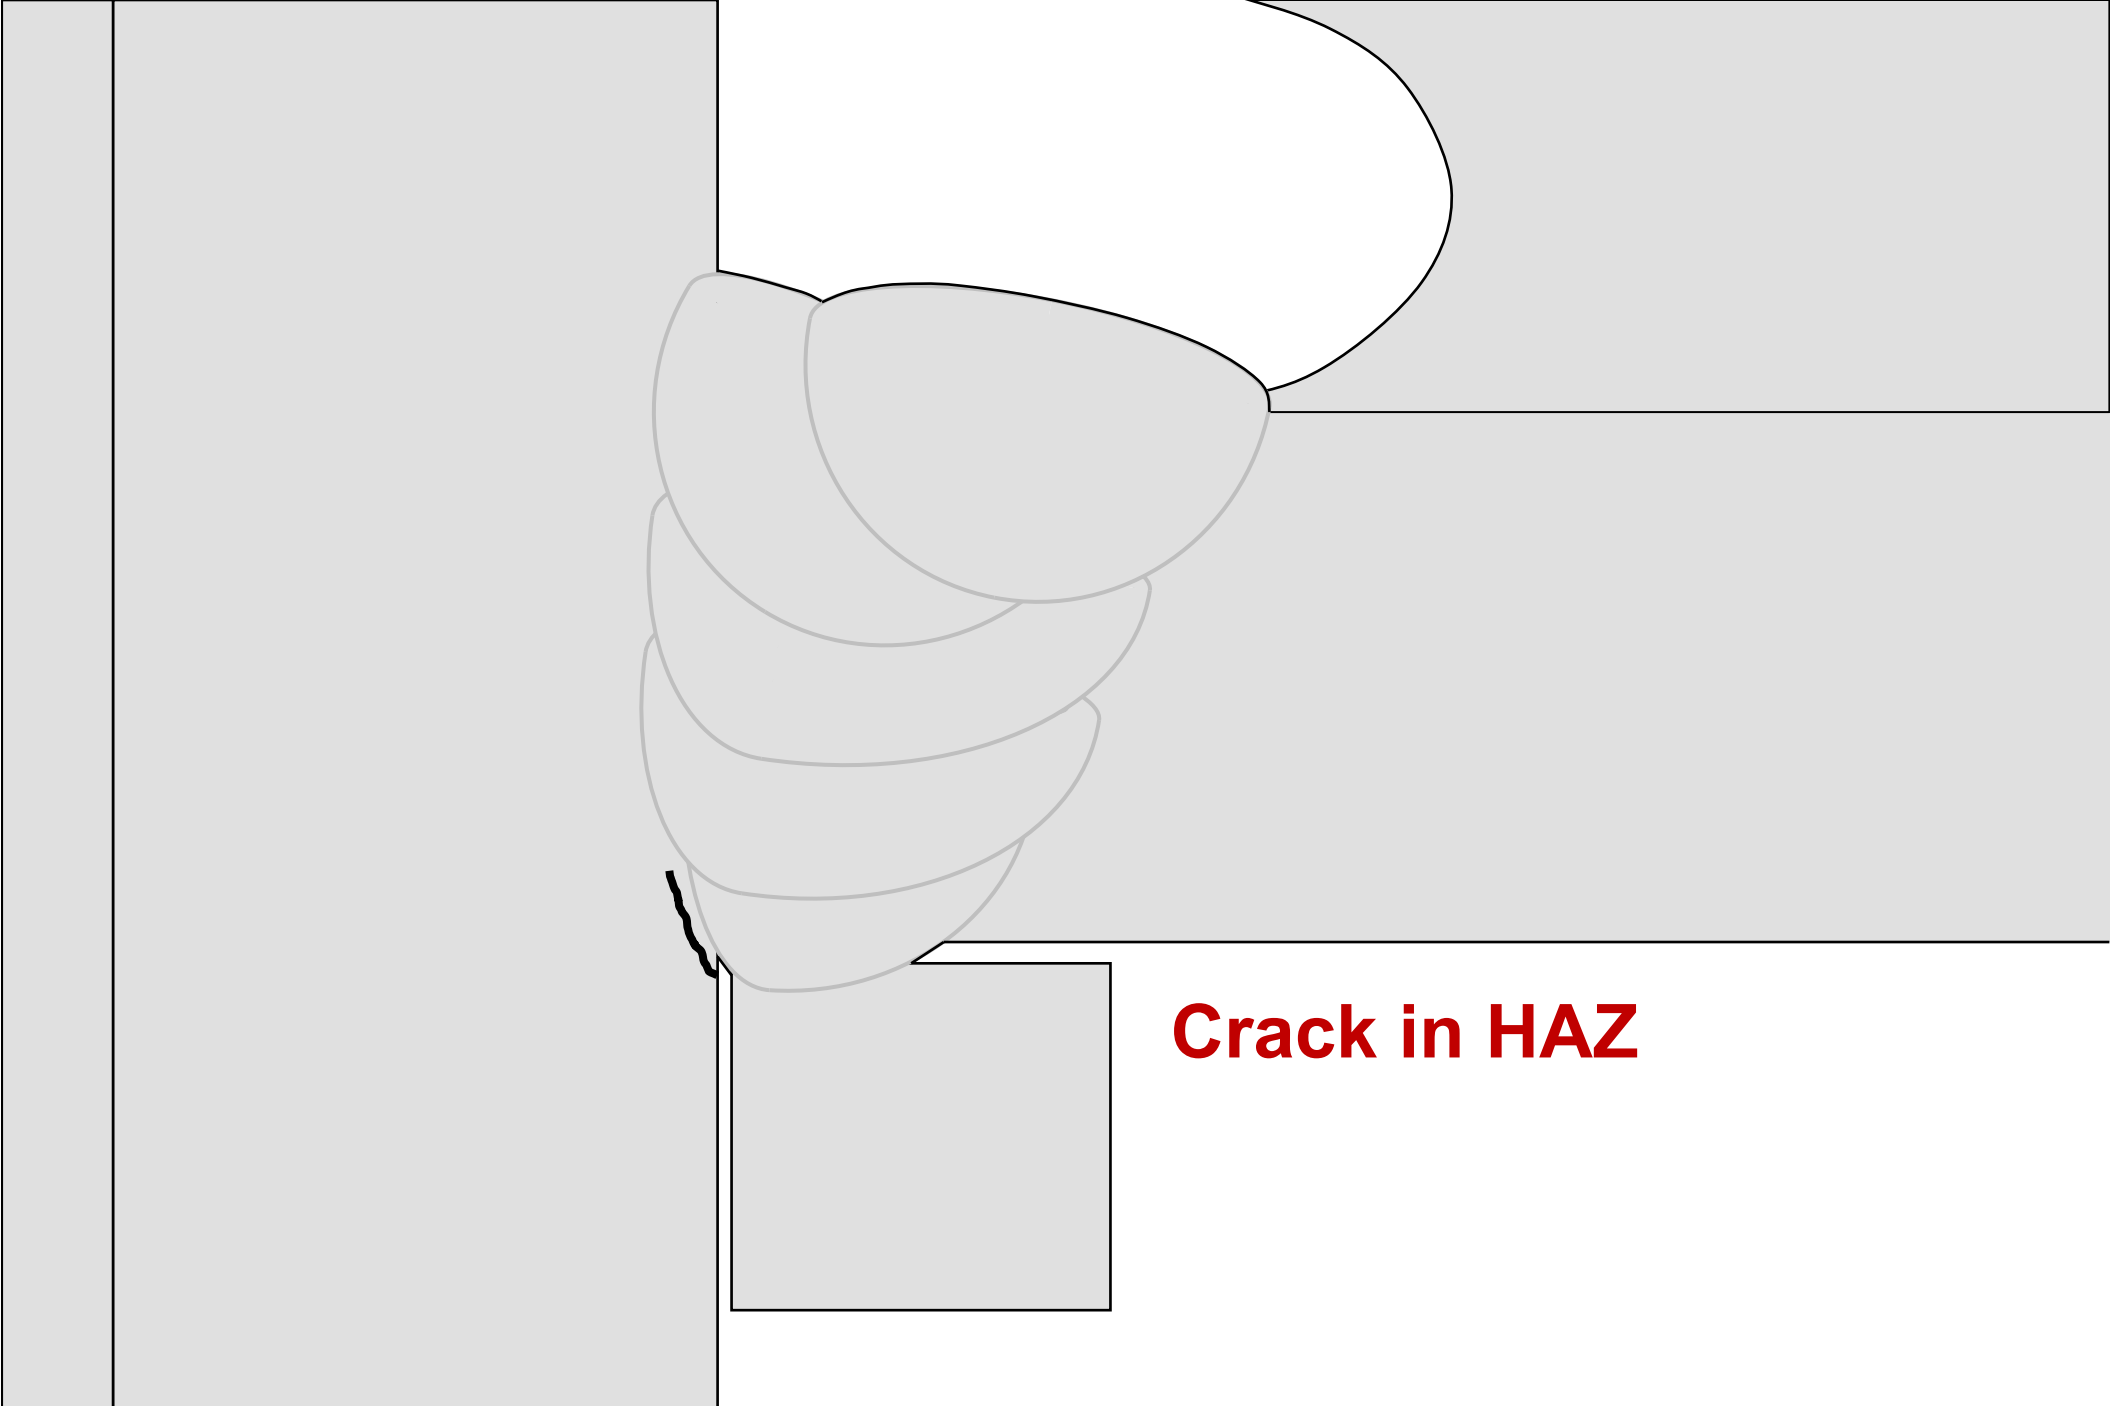
**Crack in HAZ**

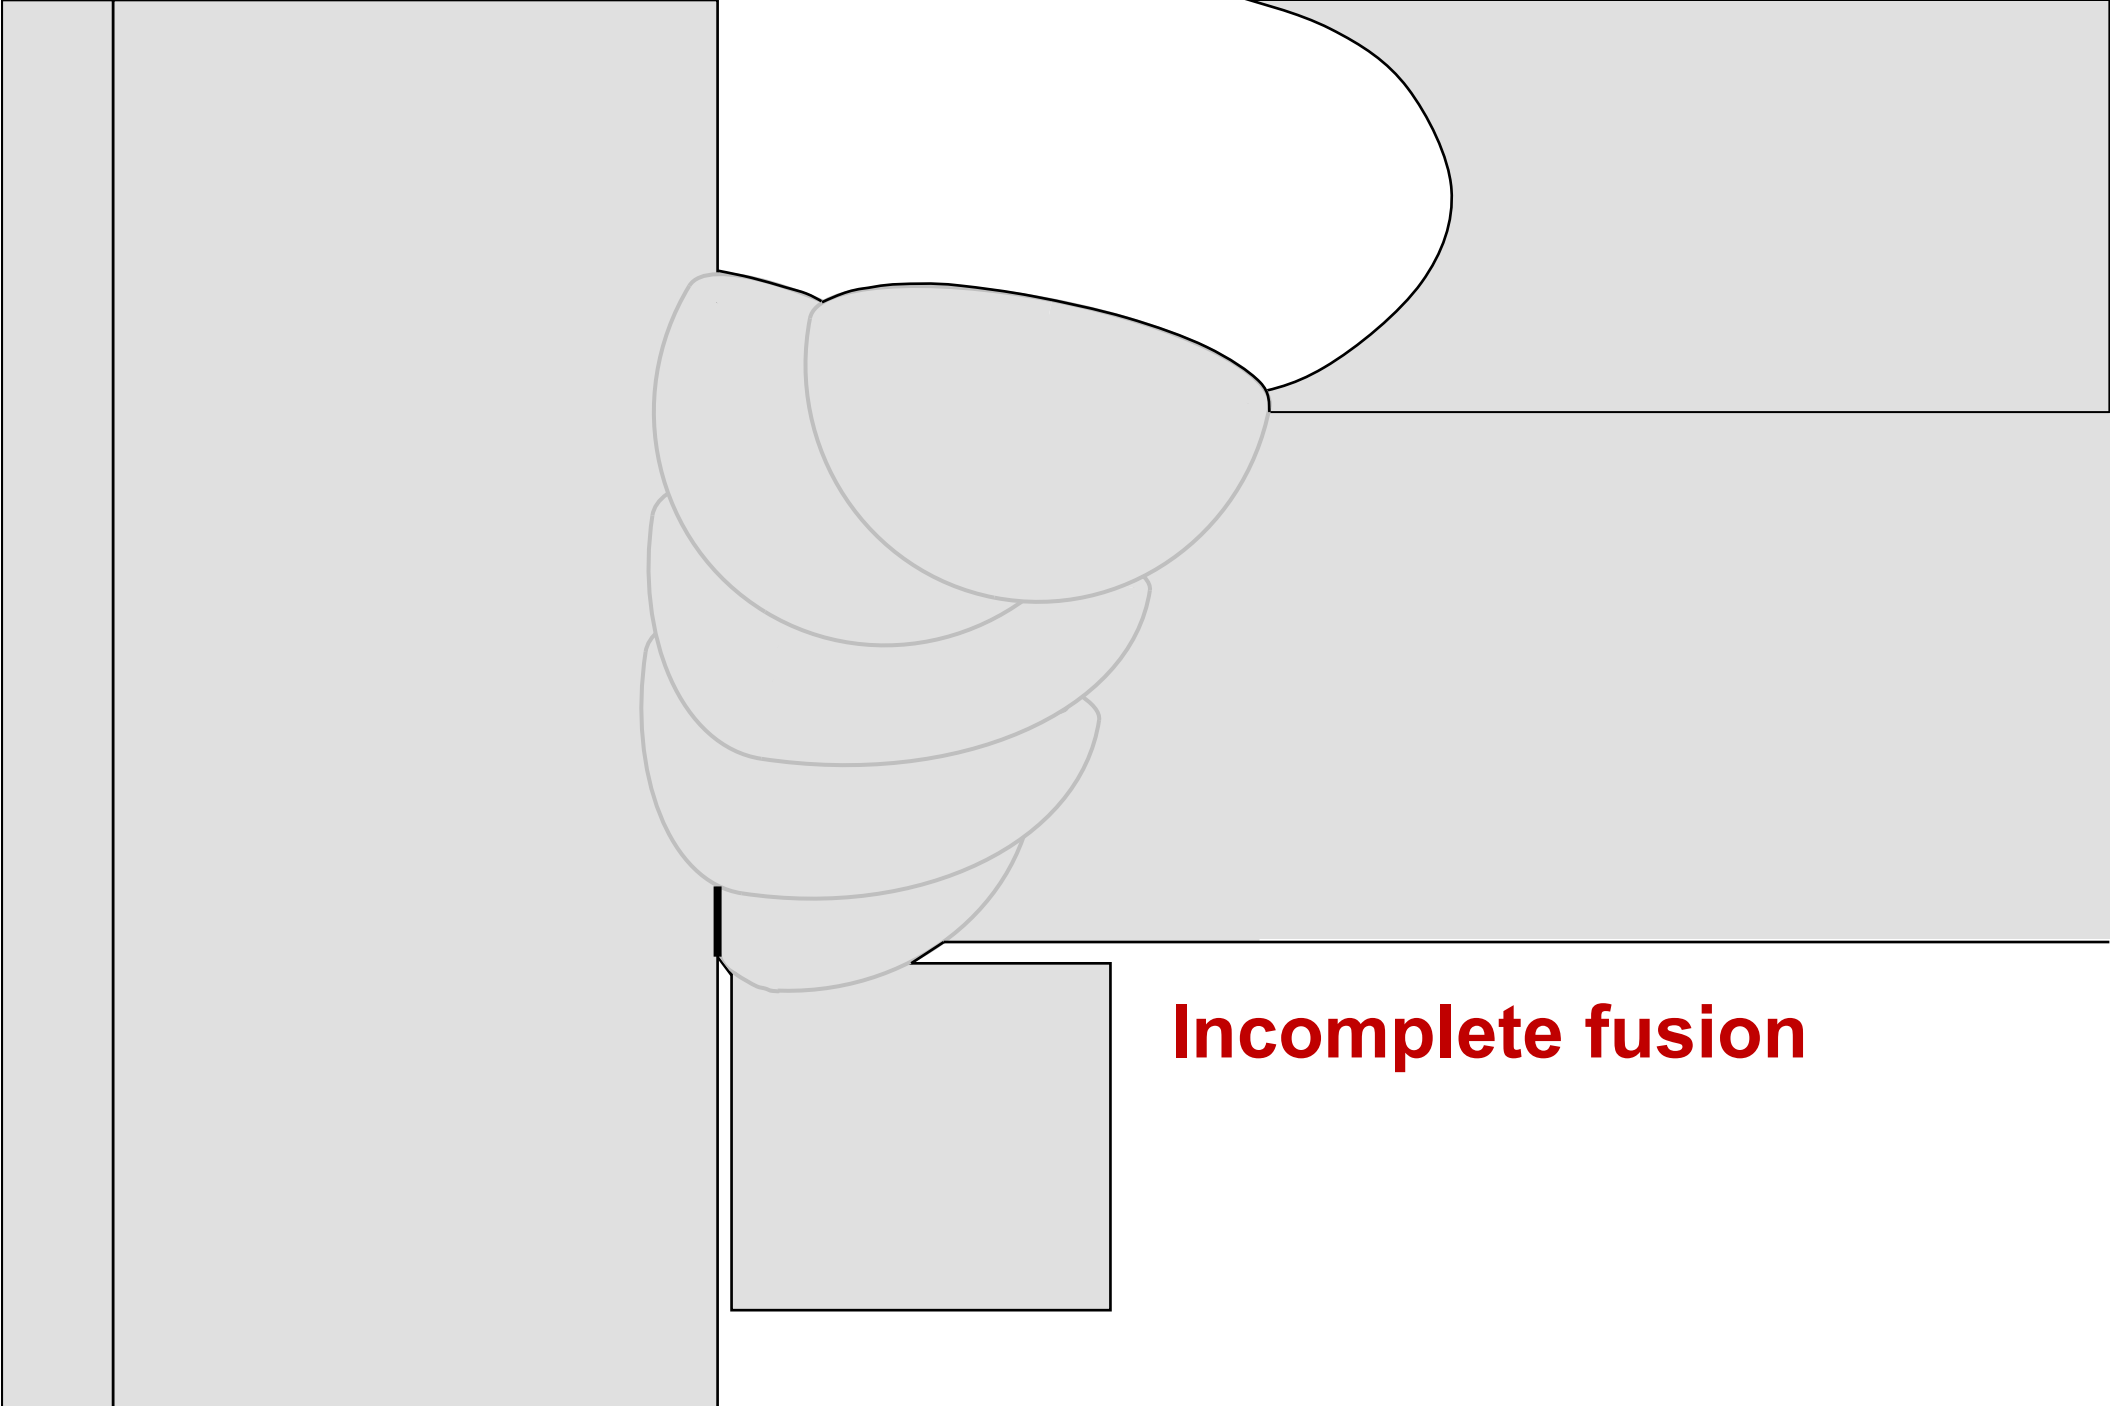
**Incomplete fusion**

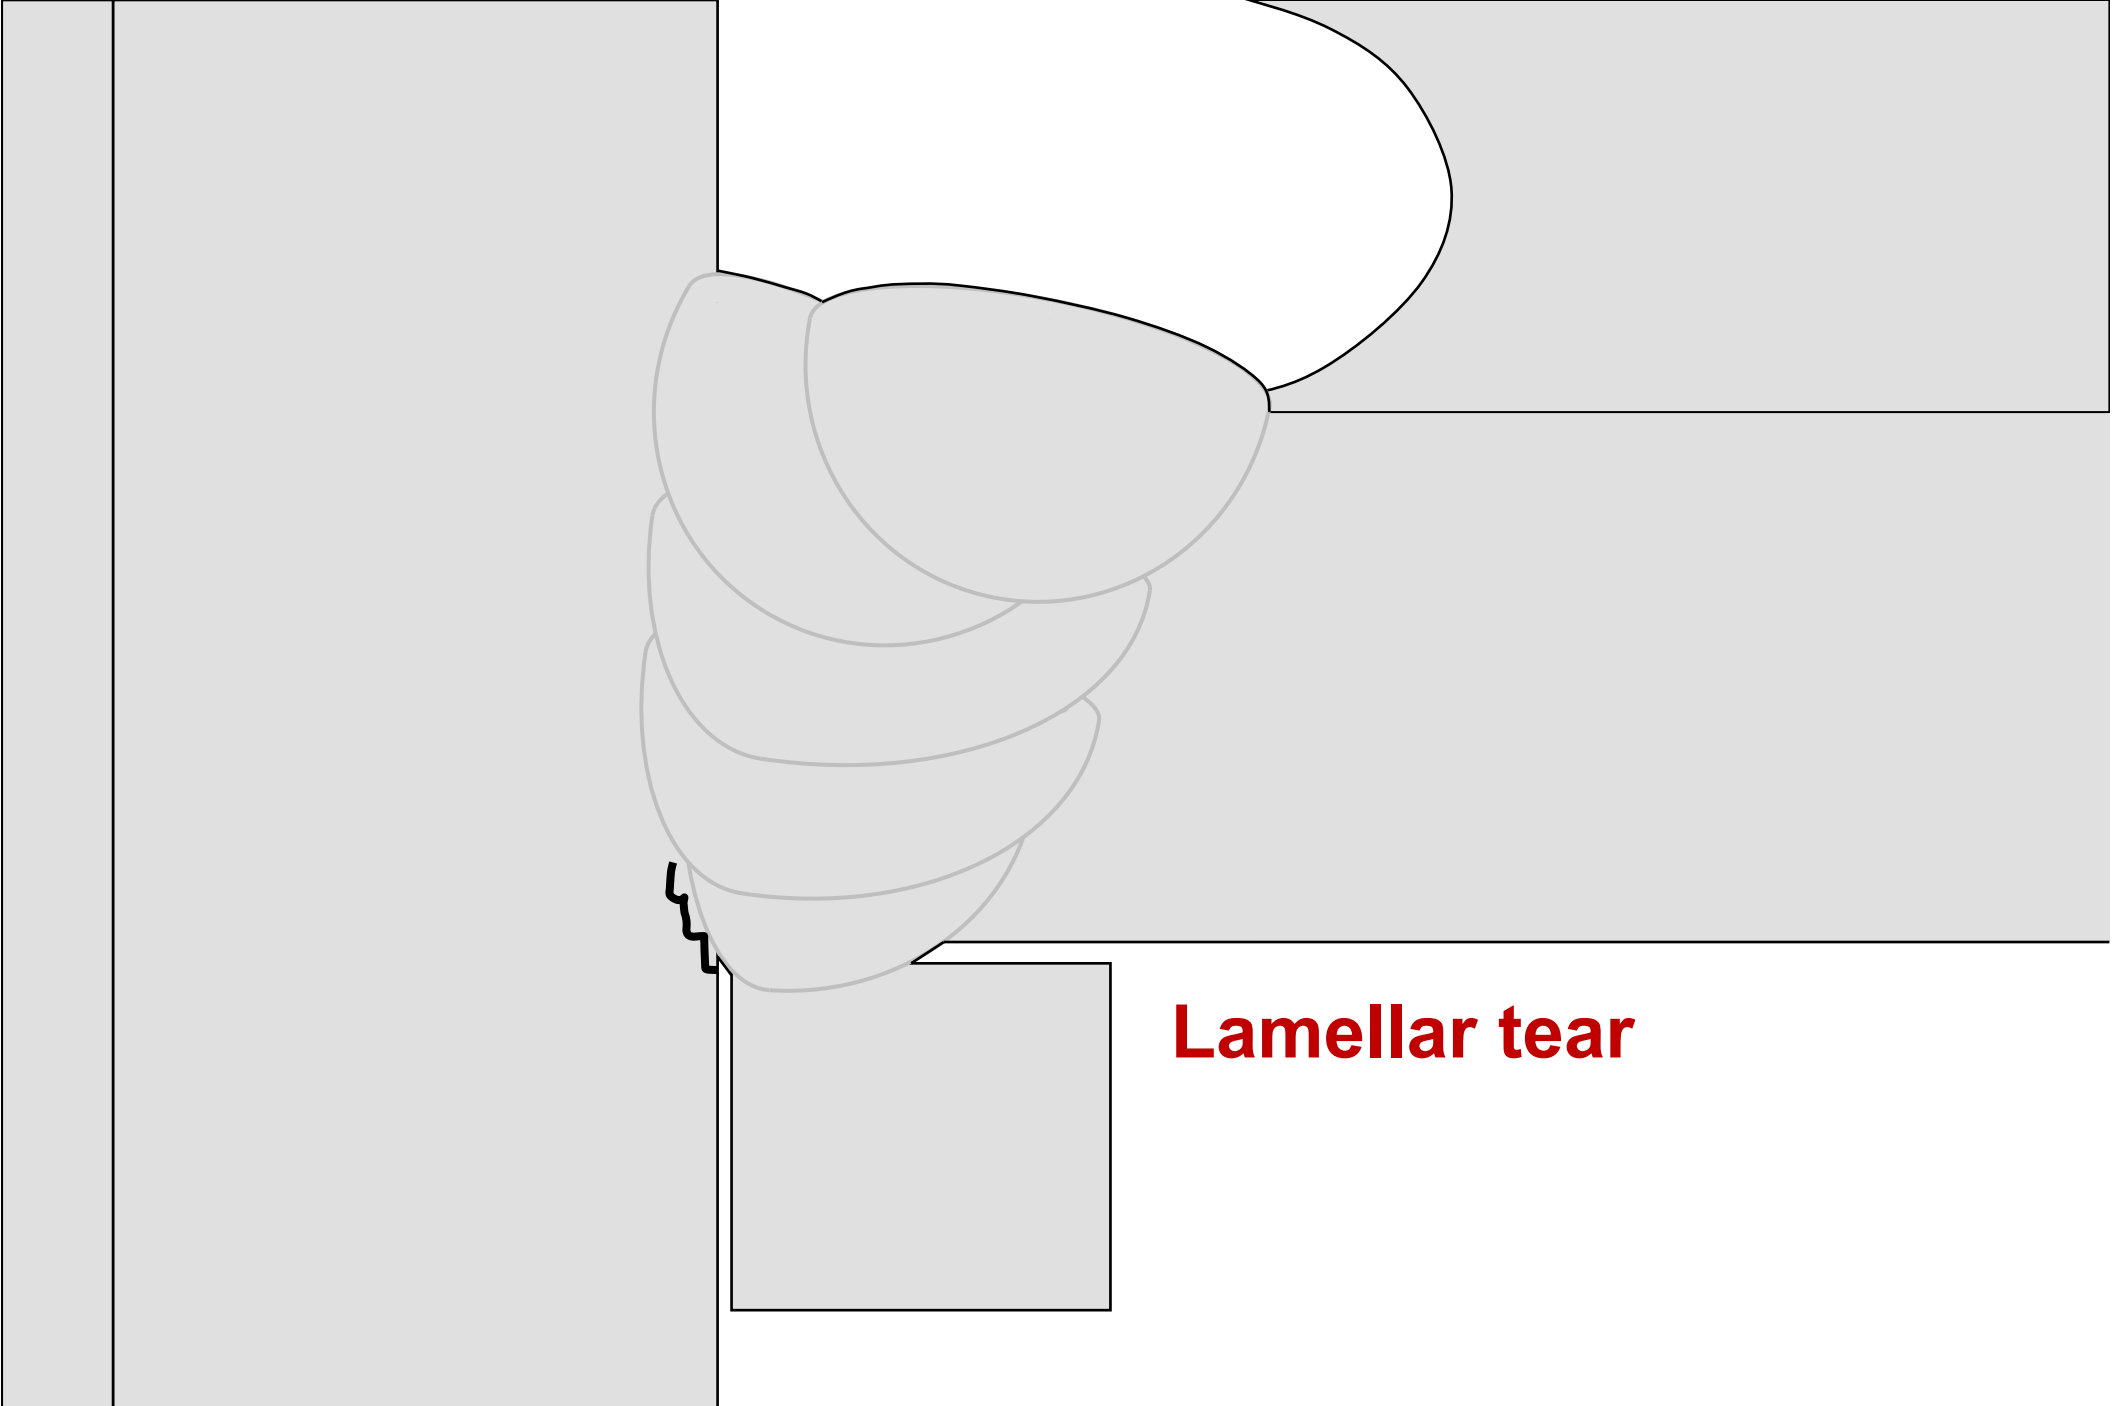
**Lamellar tear**

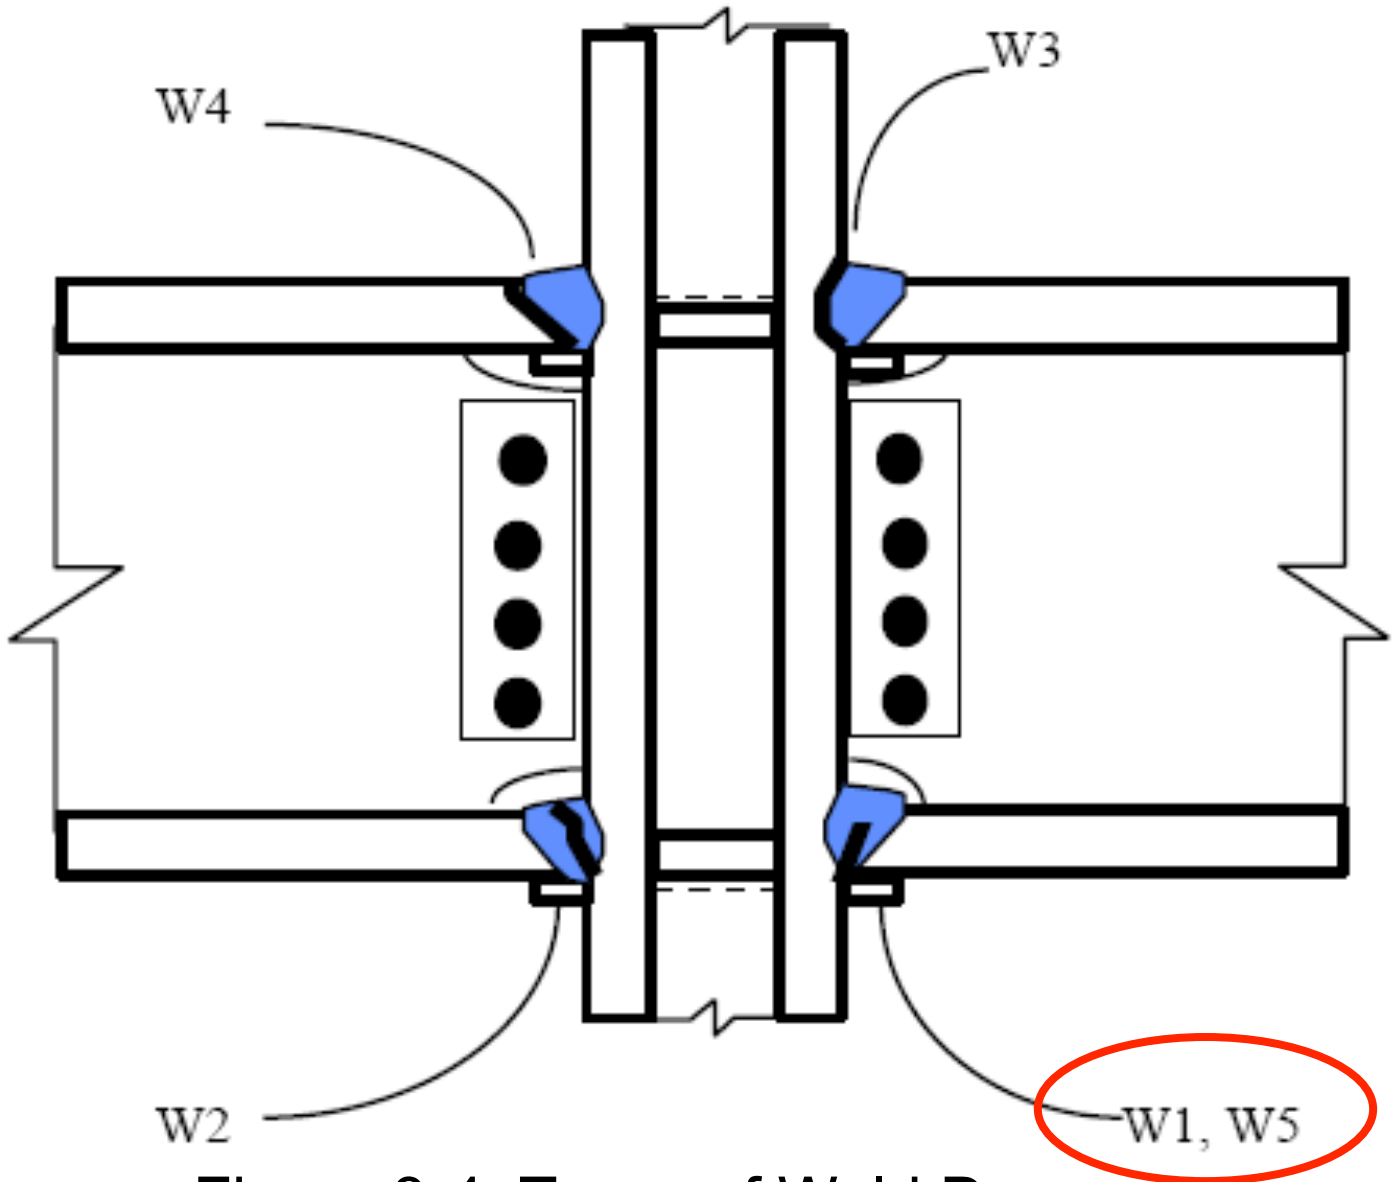
Figure 3-4 Types of Weld Damage

Type W1 is the single most commonly reported non-conforming condition, representing more than 80 per cent of the total damage reported.

Some engineers believe that type W1a indications are not earthquake damage at all, but rather, previously undetected defects from the original construction process. A W1b indication is one that exceeds these limits but is not clearly characterized by one of the other types. It is more likely that W1b indications are the result of the earthquake than the construction process.

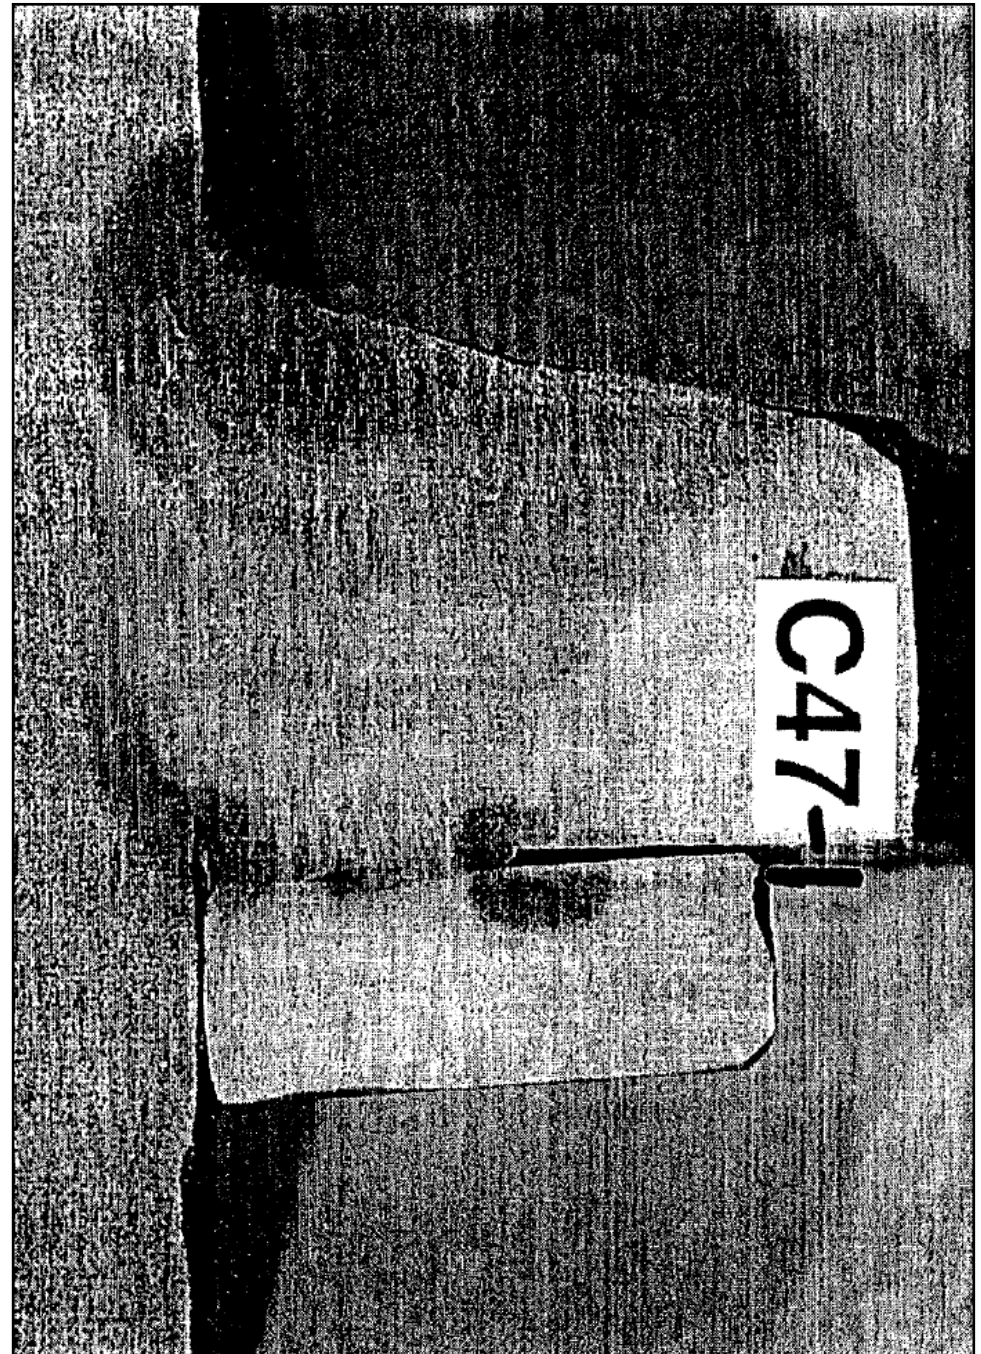
Figure 1. Polished and Etched  
Weld Sample with W1

1. W1's are a result of poor welding and inspection practices during construction, not a result of earthquake ground motions.

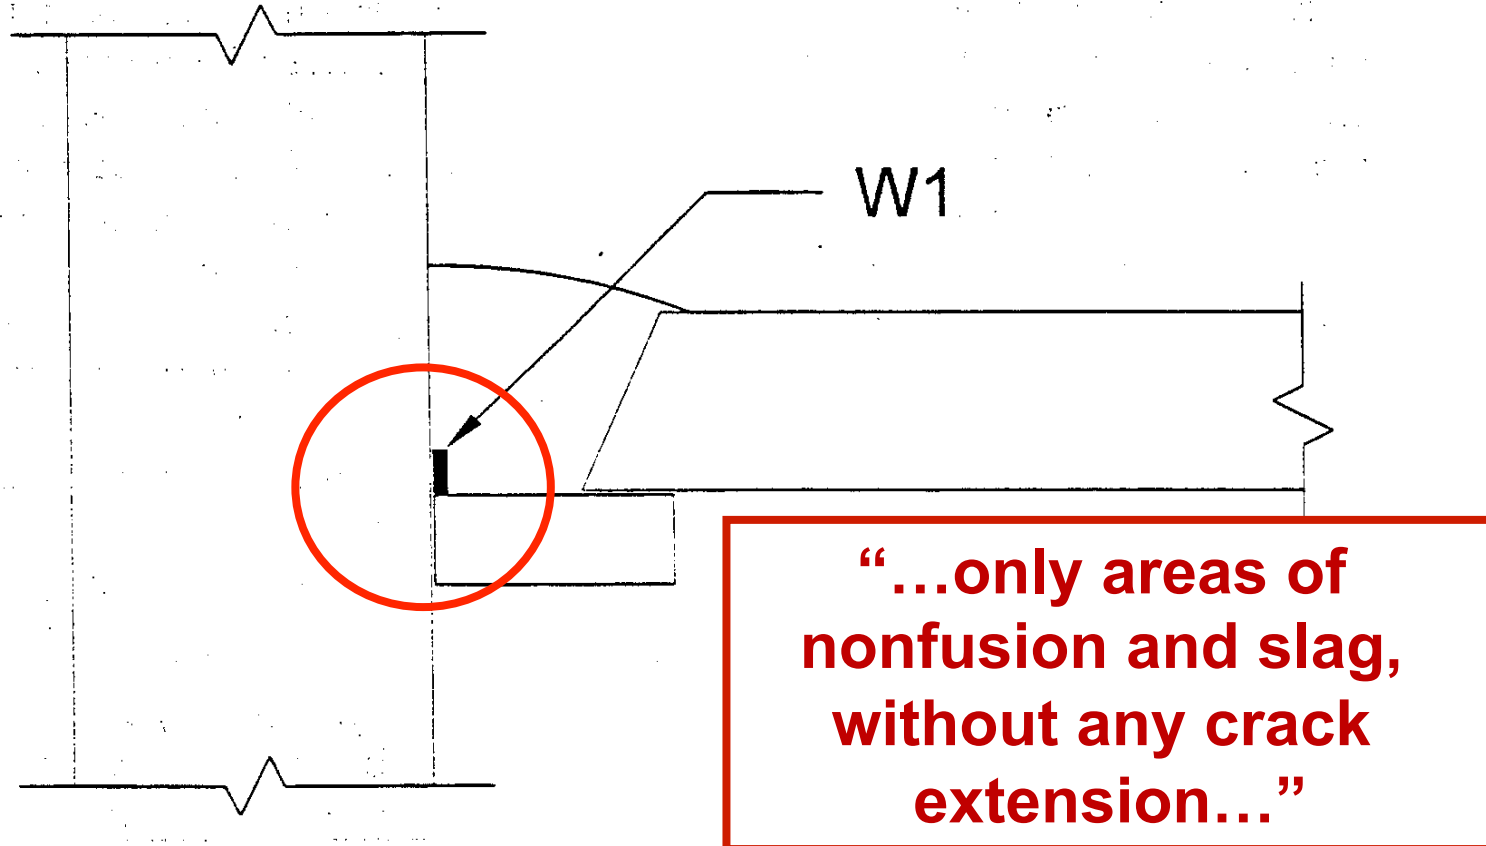
Figure 2. Location most often defined for W1's by ultrasonics

2. Ultrasonic inspection as normally employed by testing laboratory personnel **is not a reliable inspection technique** for identifying defects in the roots of welded full penetration “T” joints with backing.
