# The 1994 Northridge Earthquake: Impacts, Outcomes, and Next Steps

## Revisiting W1 Indications

Duane K. Miller, Sc.D, P.E.

**How W1s mislead many in  
the aftermath of Northridge...  
...and continue to do so today.**

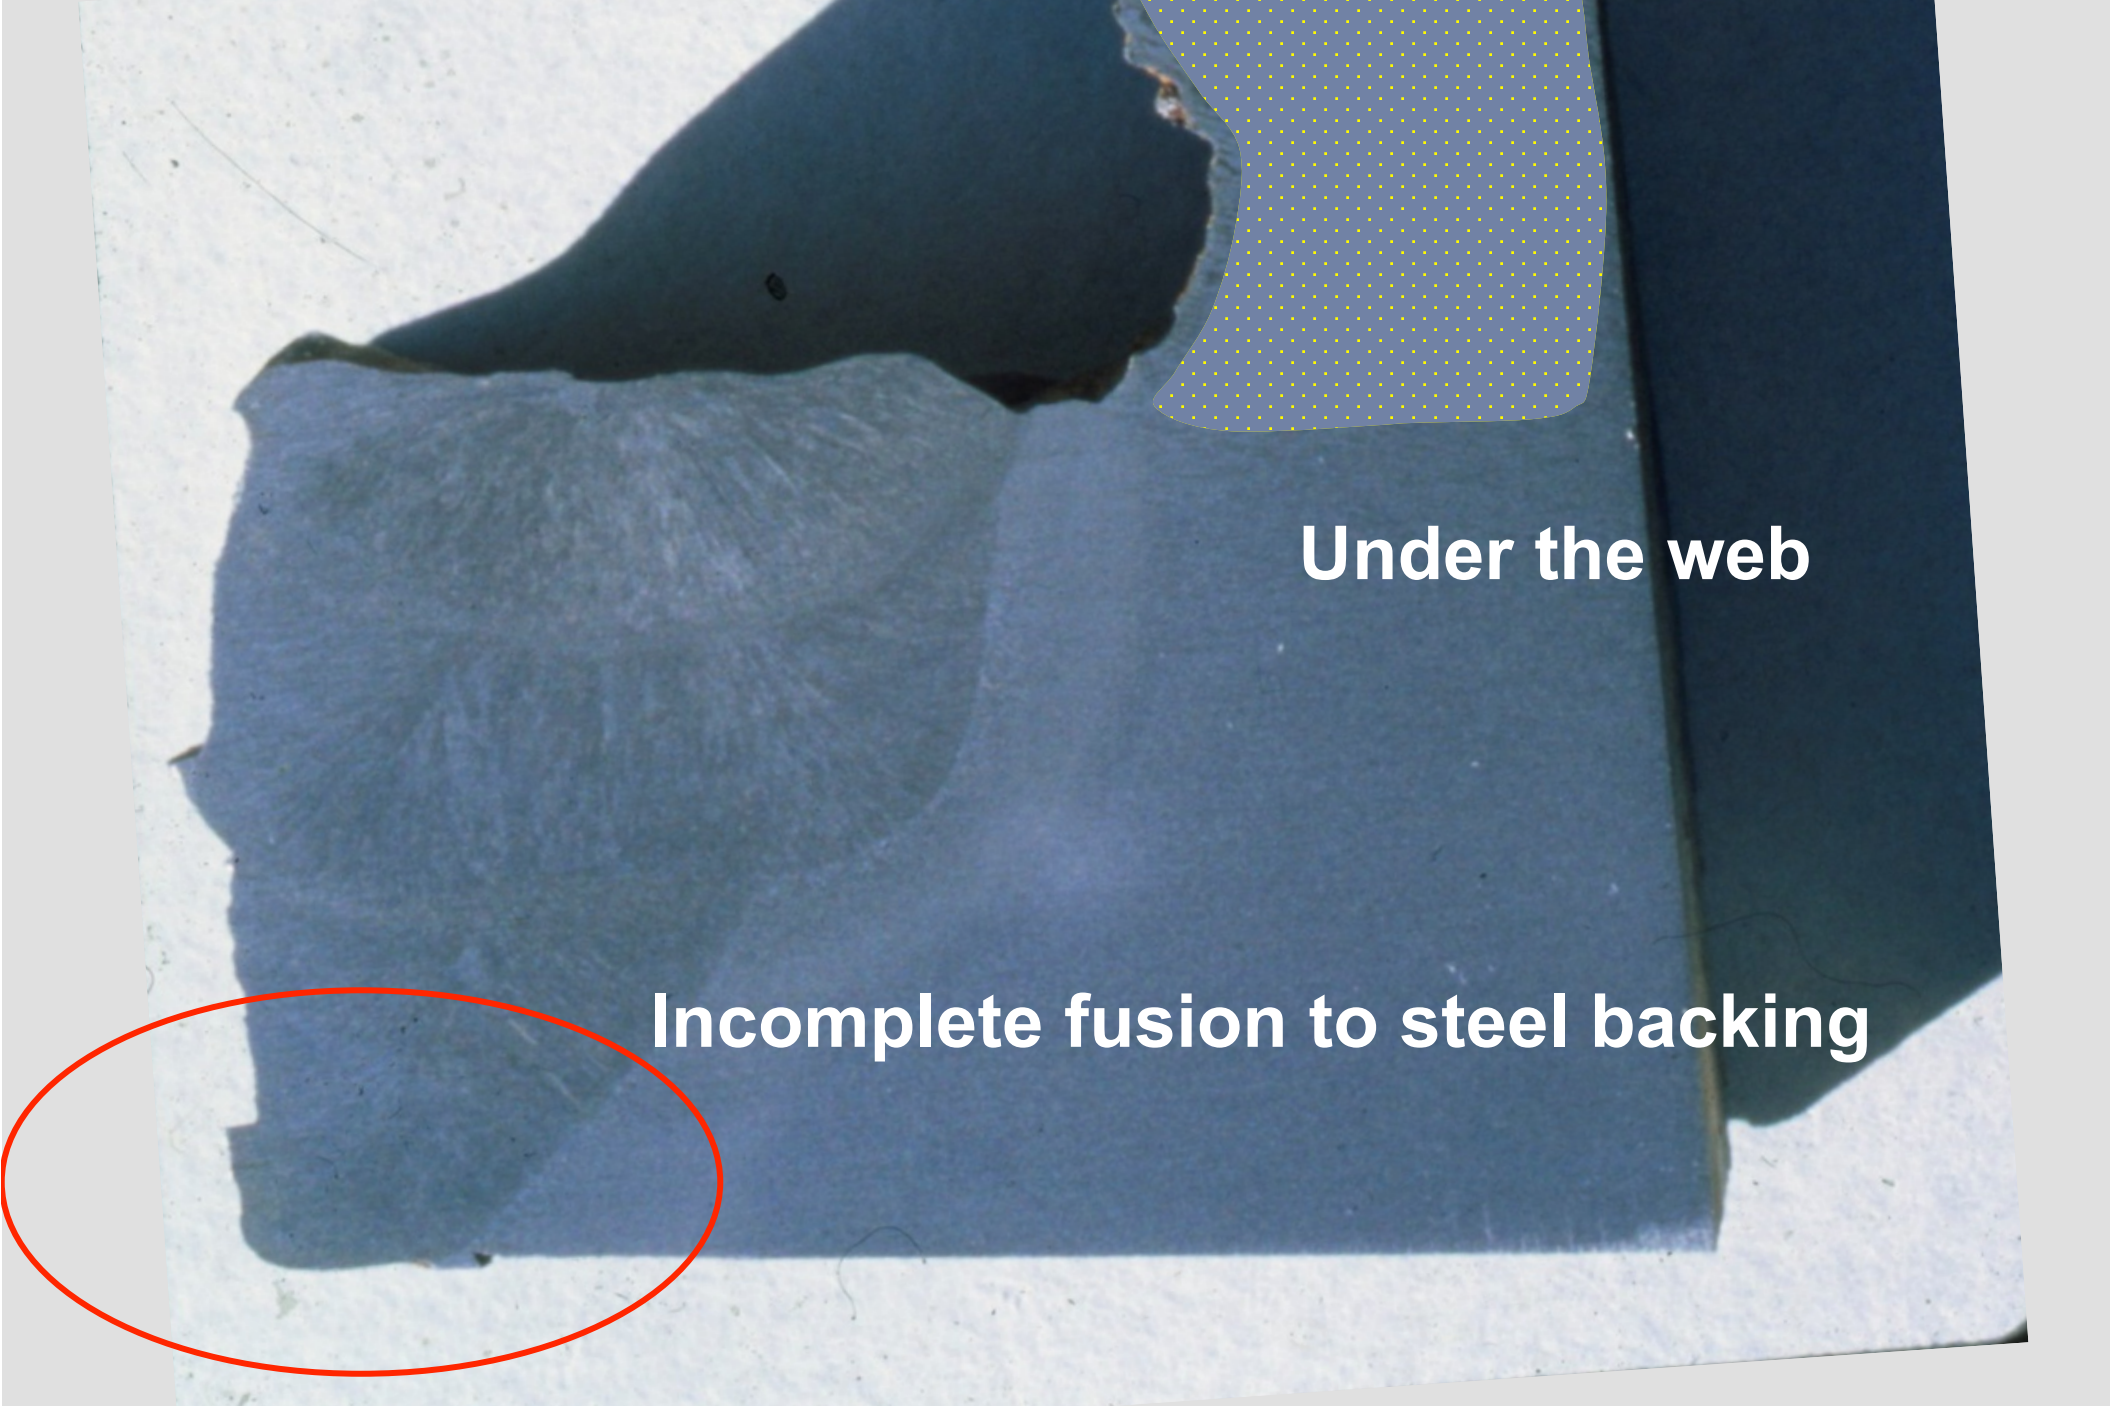
**Under the web**

**Incomplete fusion to steel backing**

**1/4"**  
**[6 mm]**

The thickness of the weld layers in groove welds, except root and surface layers, shall not exceed  $1/4$  in (6 mm).

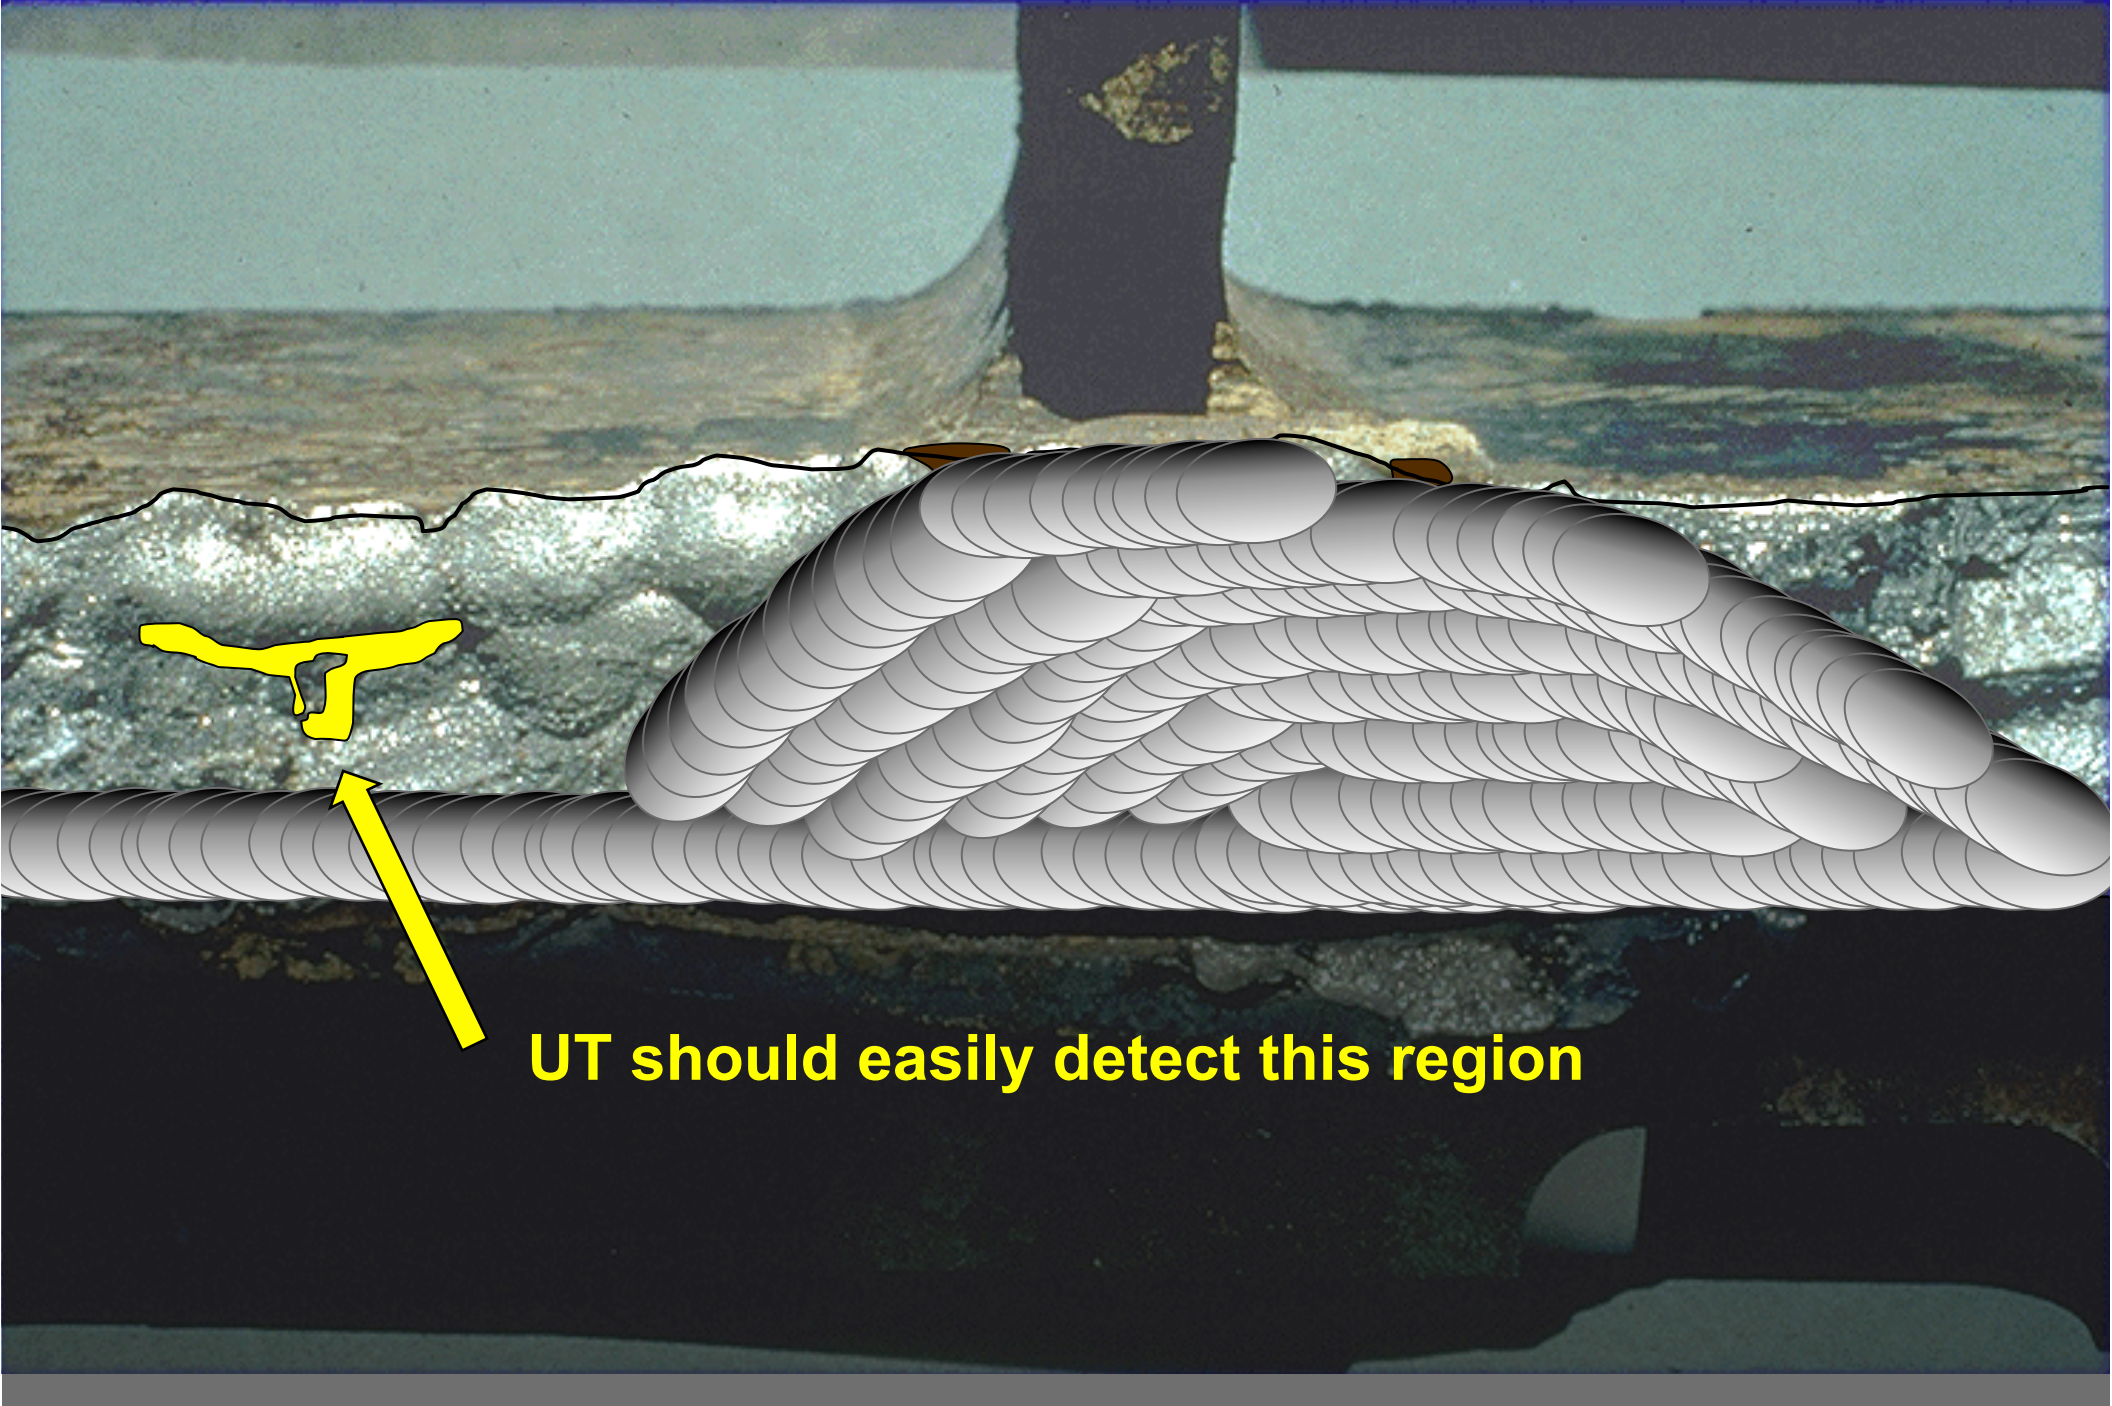
**UT should easily detect this region**
