The Northridge Experience and CUREE-Caltech Woodframe Project

Kelly Cobeen, Wiss Janney Elstner & Associates

Woodframe Project Goal

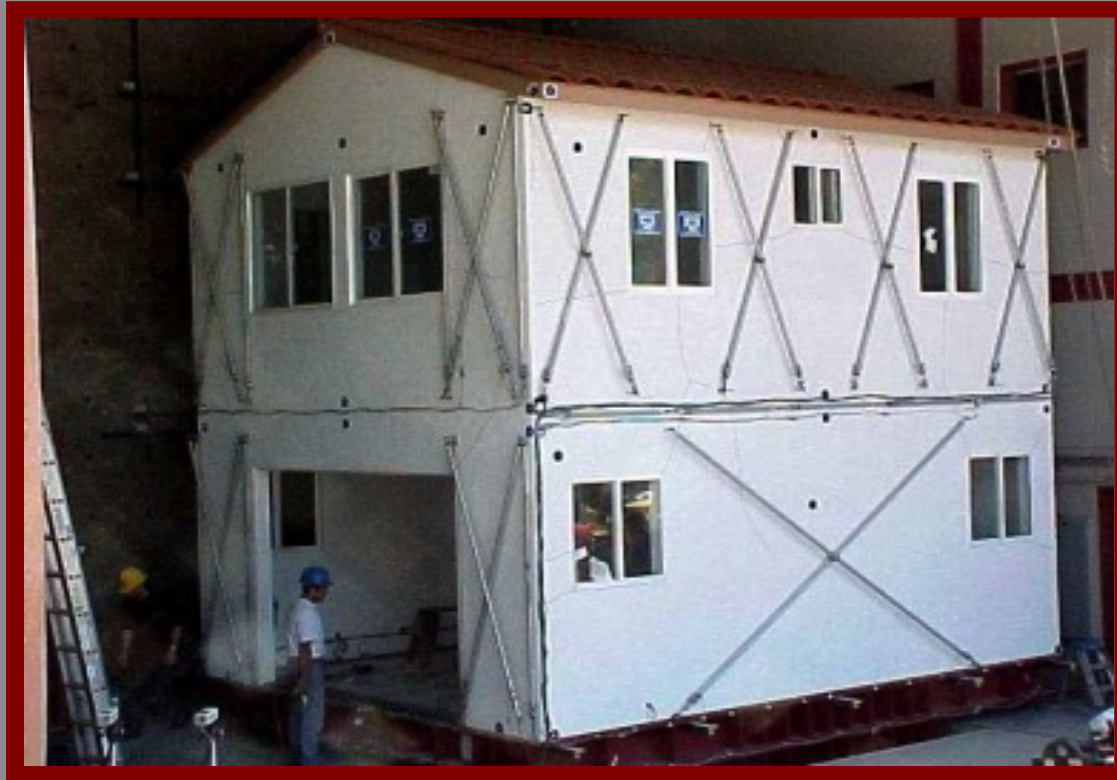
W-06: Shake Table Tests of a Two-Story Woodframe House

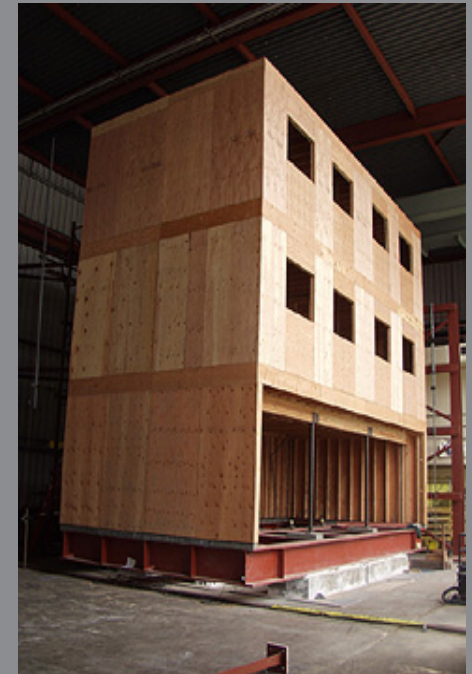
W-19: Seismic Evaluation of an Asymmetric Three-Story Woodframe Building

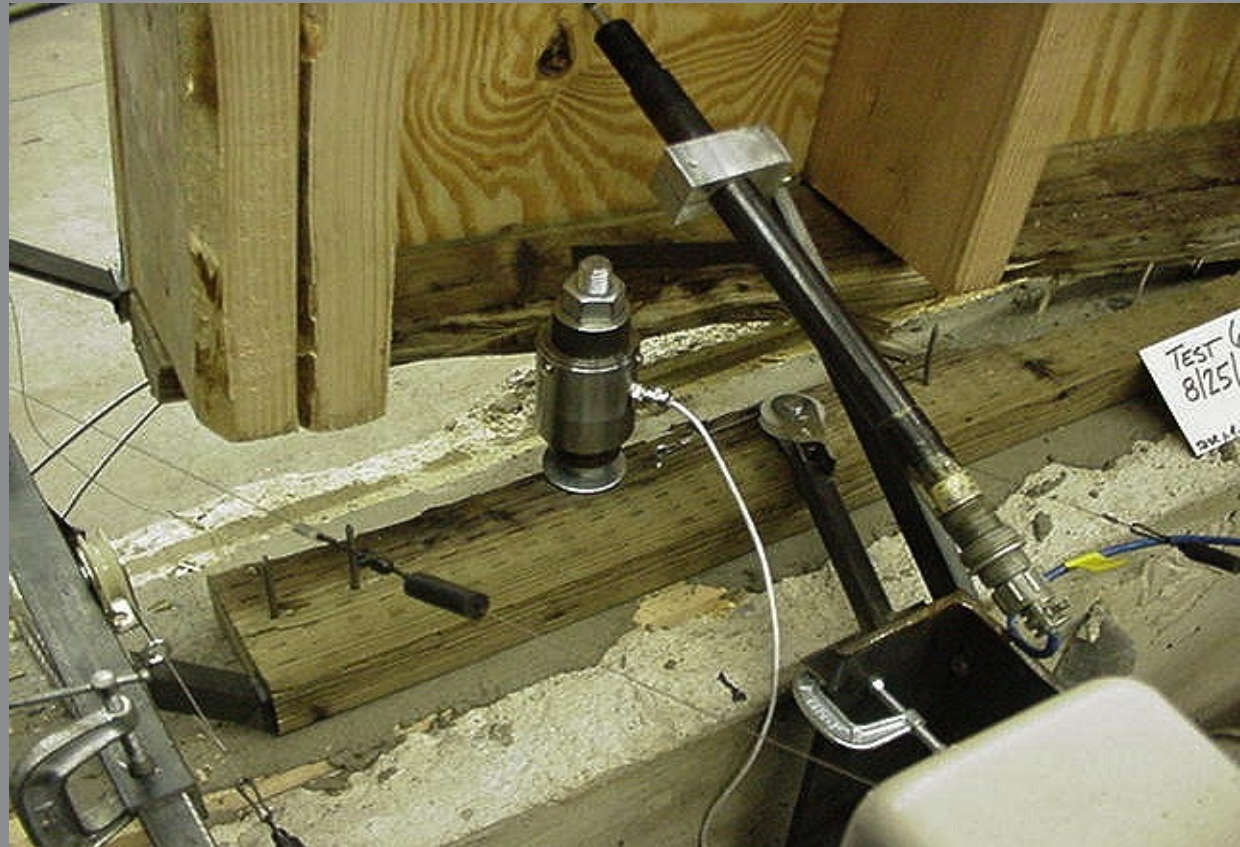
W-14: Anchorage of Woodframe Buildings: Laboratory Testing Report

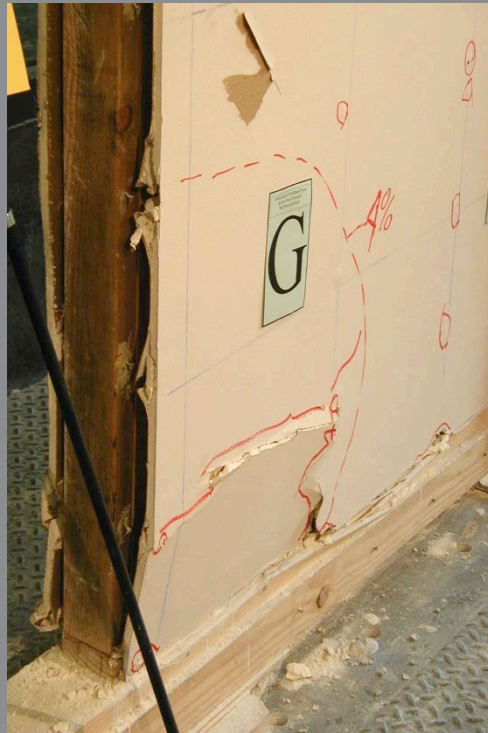
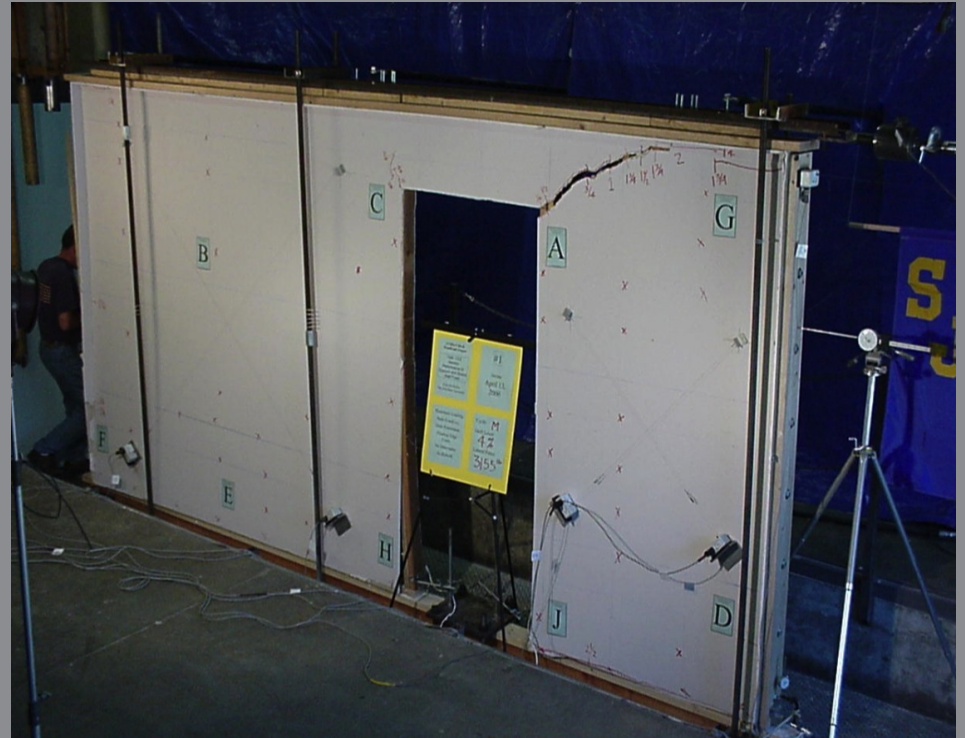
W-15: Seismic Performance of Gypsum Walls: Experimental Test Program

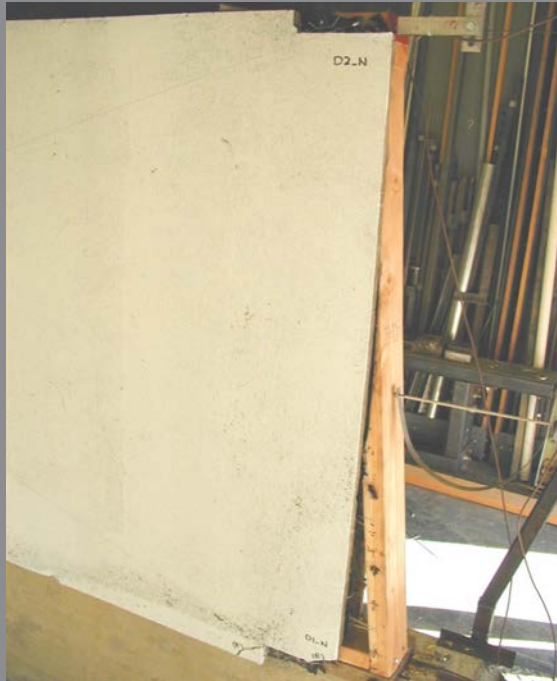
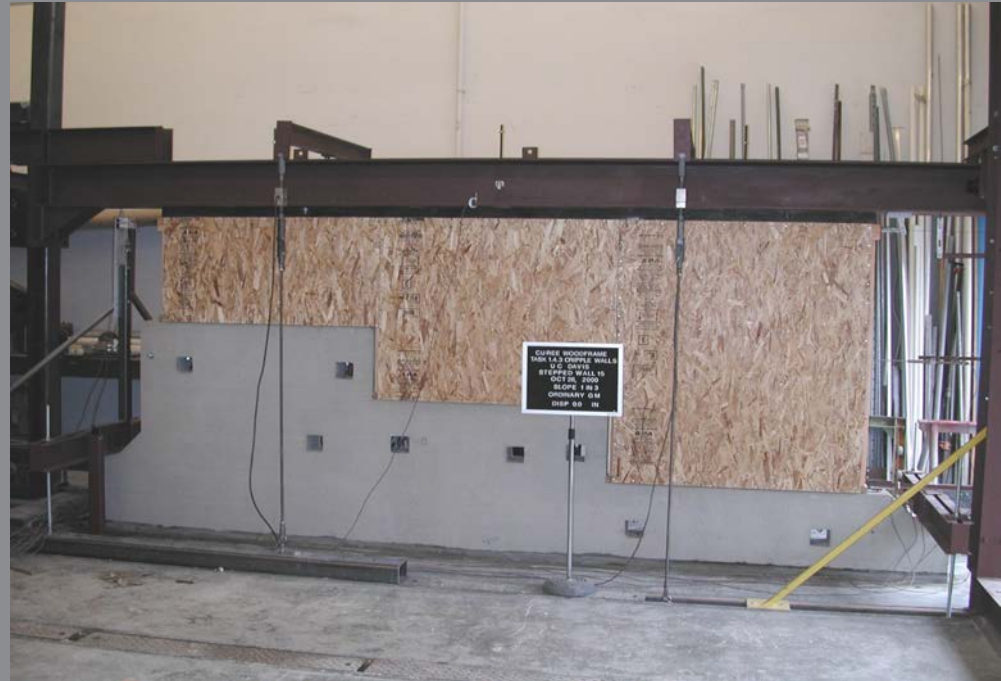
W-17: Seismic Behavior of Level and Stepped Cripple Walls

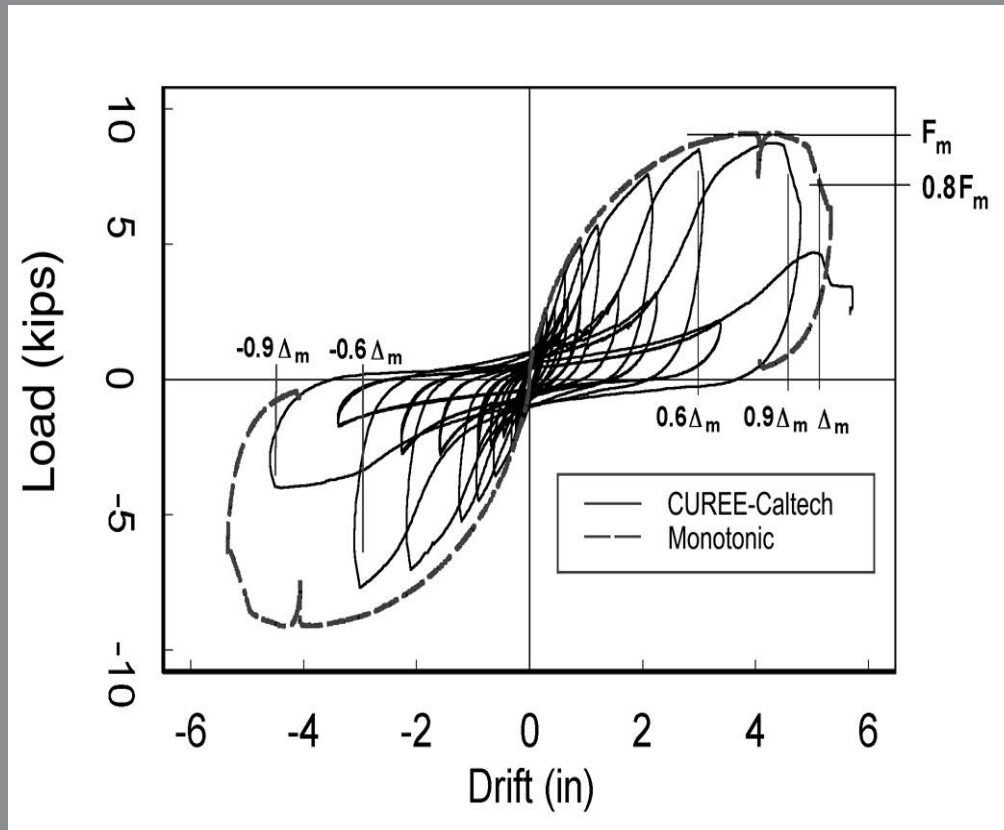
W-02: Development of a Testing Protocol for Woodframe Structures

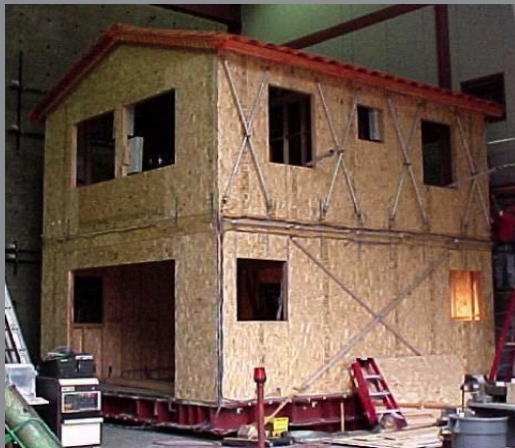
Task 1.1.1 - Phase 9 Test Structure
