Column Base and Splice Details

Amit Kanvinde, University of California, Davis

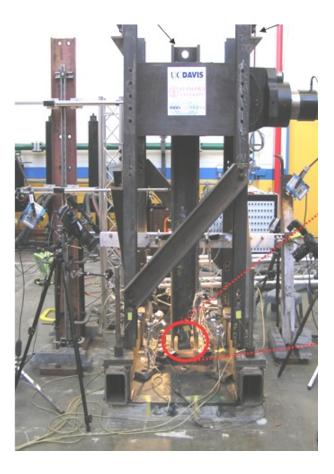
NEES03 Phase 2

Specimen CJP4 (NW) under Far-Field time history

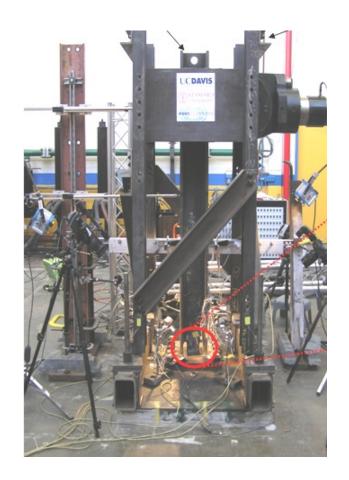
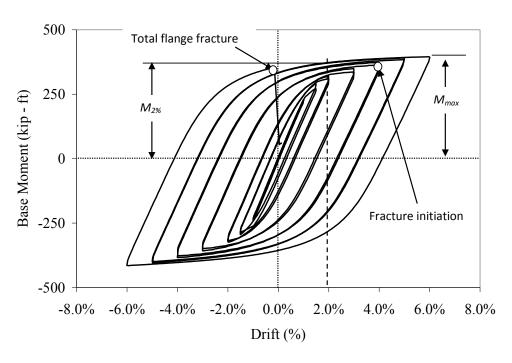
NEESR Tests on Bases

- Excellent ductility
- PJP performance better than CJP
- Fracture models advanced

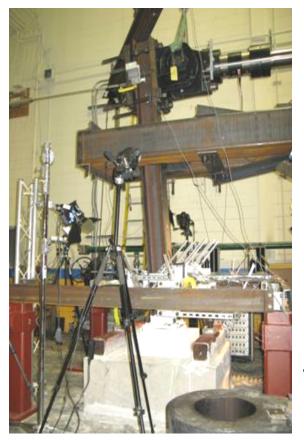
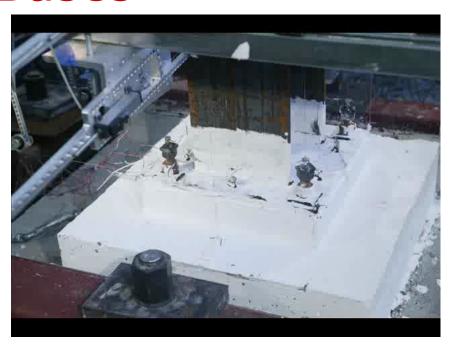
AISC Tests on Bases

- Design Guide One is fine/ conservative
- Excellent ductility
- Models for strength refined/ stiffness models developed

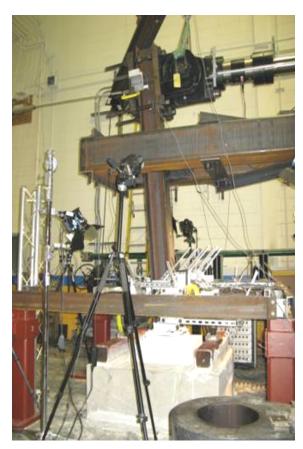
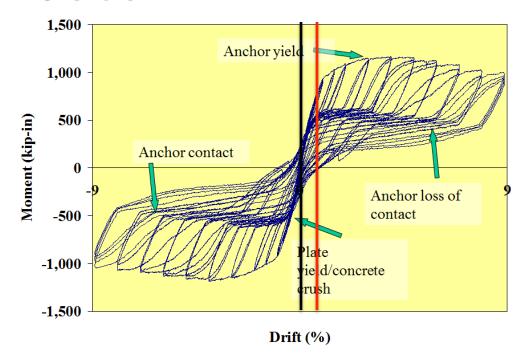
AISC Tests on Bases

Main surprise

Stiffness much lower than anticipated even when designed as fixed

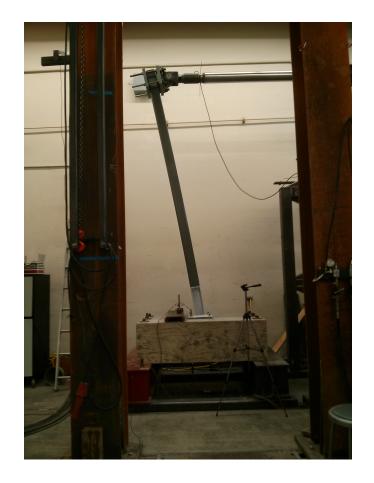
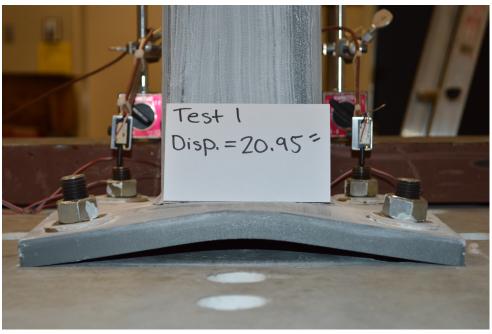
HSS Column bases

- Excellent ductility
- New method for eight-rod configuration
- Stiffness still lower than desired

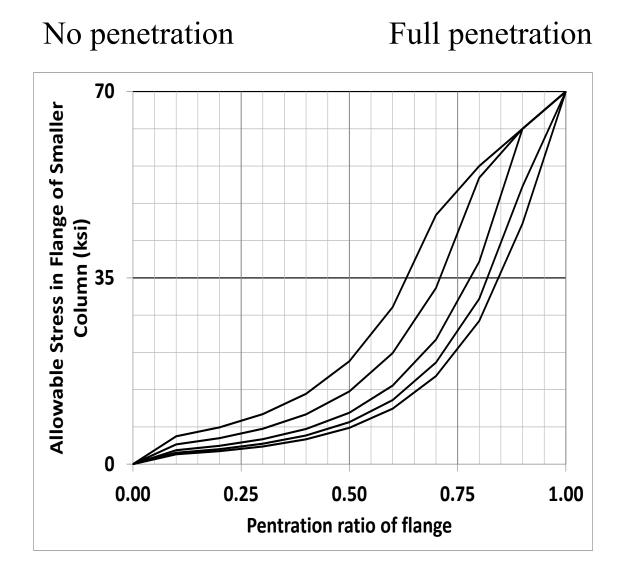
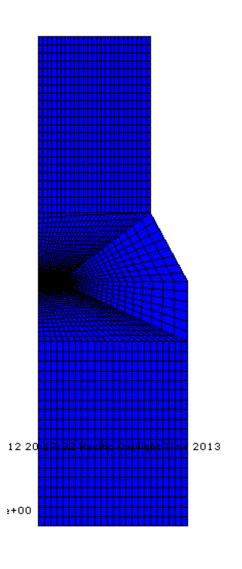
Follow up fracture mechanics analysis raises issues for pre Northridge Splices

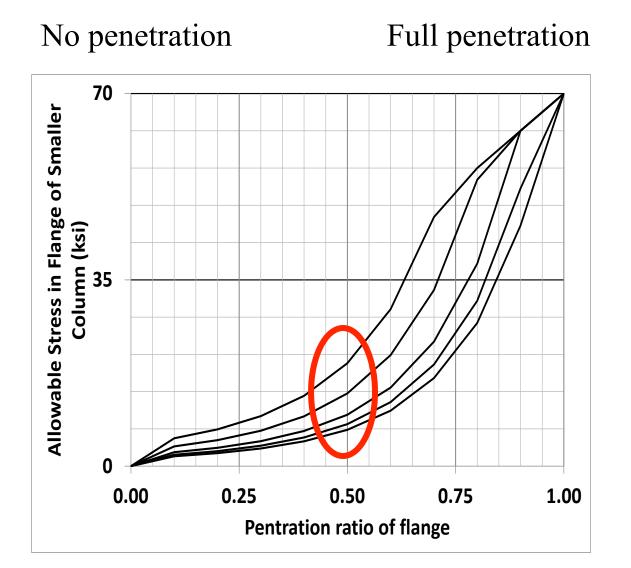
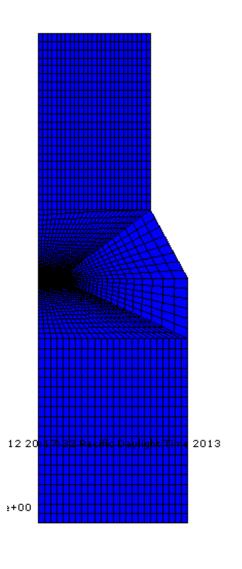
Follow up fracture mechanics analysis raises issues for pre Northridge Splices
