California Dam Safety

David A. Gutierrez, Chief Division of Safety of Dams

January 16-17, 2014 - University of California, Los Angeles

California Division of Safety of Dams (DSOD)

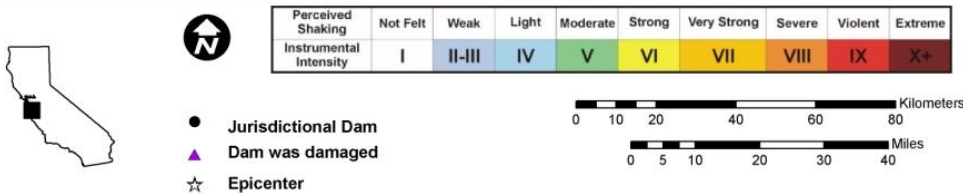
Instrumental Intensity Map for 1989 M6.9 Loma Prieta Earthquake (Modeled)

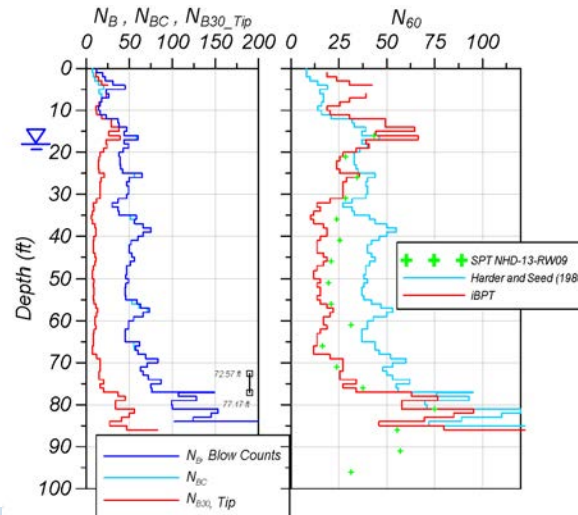
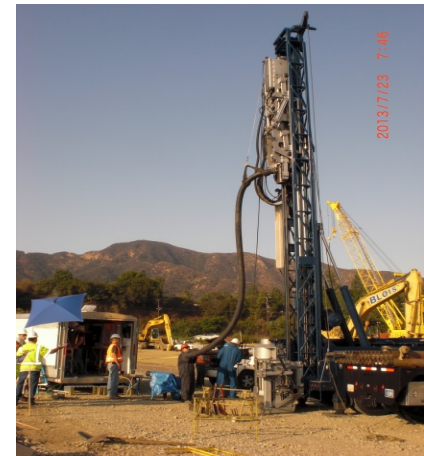
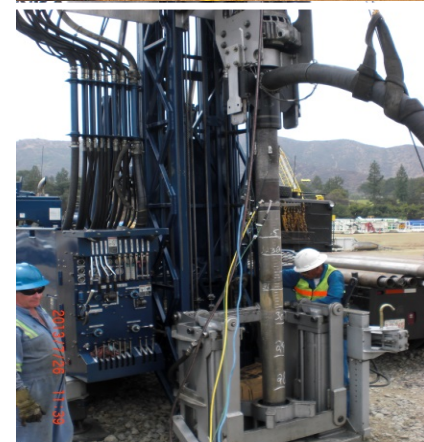
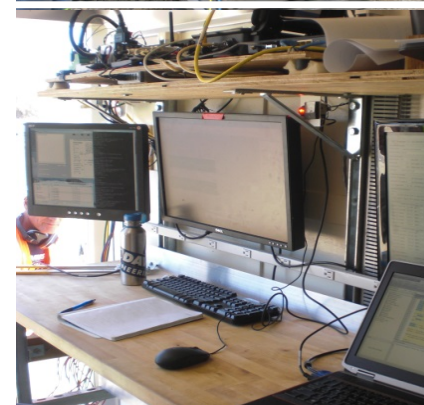
Instrumented Becker Penetration Test (iBPT) for Characterization of Sites w/ Gravelly Soils

- Equipment provides continuous direct measurement of penetration resistance at driving tip (energy and blows per foot).
- Site specific calibration of iBPT N_{b30_tip} to SPT N_{60} values
- Provides improved accuracy and spatial resolution of gravelly soils relative to conventional methods

Example iBPT results from field project with LADWP (Craig Davis).
