Lifelines & Utilities – Southern California Edison

“Keeping the Lights On”

Impacts – SCE Power System

Impacts – Pardee Sub. Damages

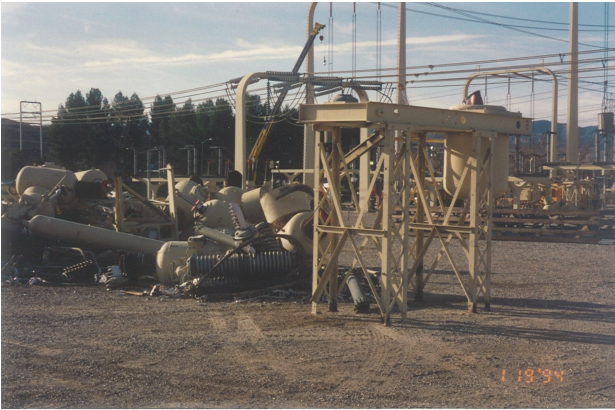
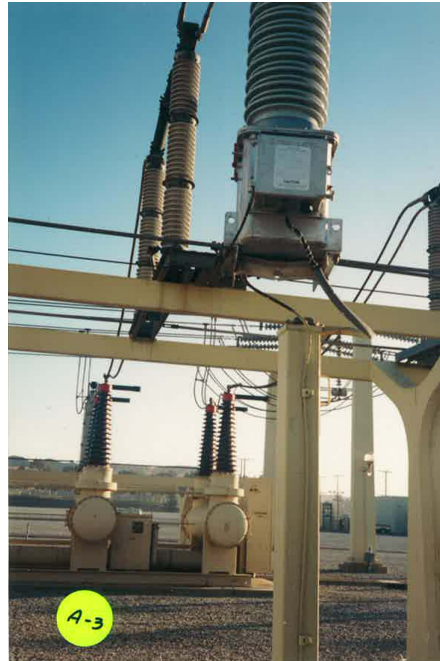
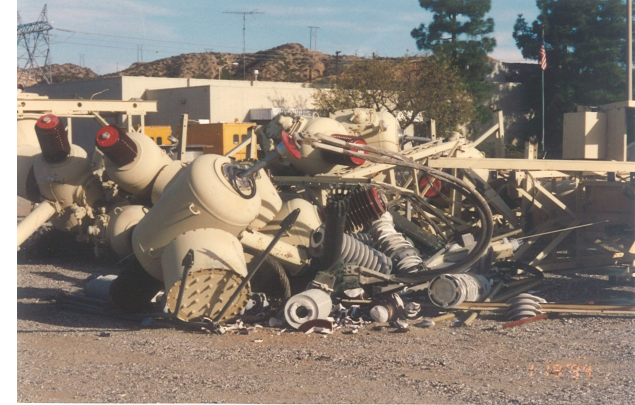
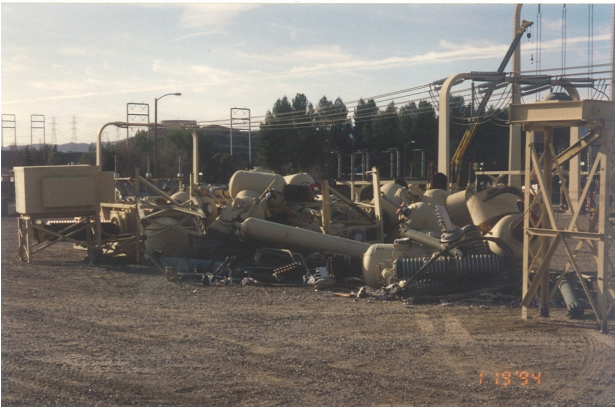
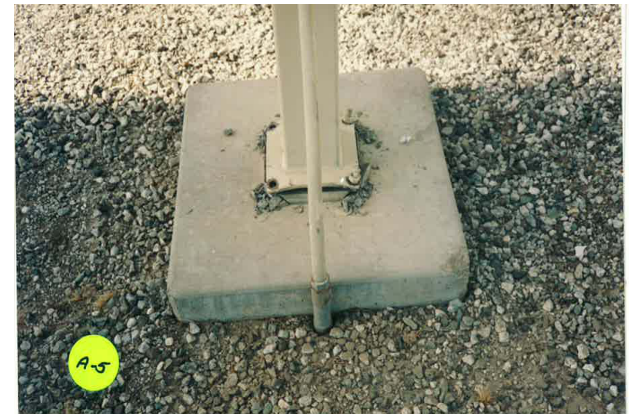
Images of Pardee Sub. Damages

- Damaged equipment (Circuit Breakers, Disconnect Switches, Insulators, CCVT, bushings, etc.)
- Damaged steel support structures
- Damaged transmission towers outside of substation
- Damaged foundations for Transmission and Substation equipment/structures
- Presence of cracks in the control building walls and basement

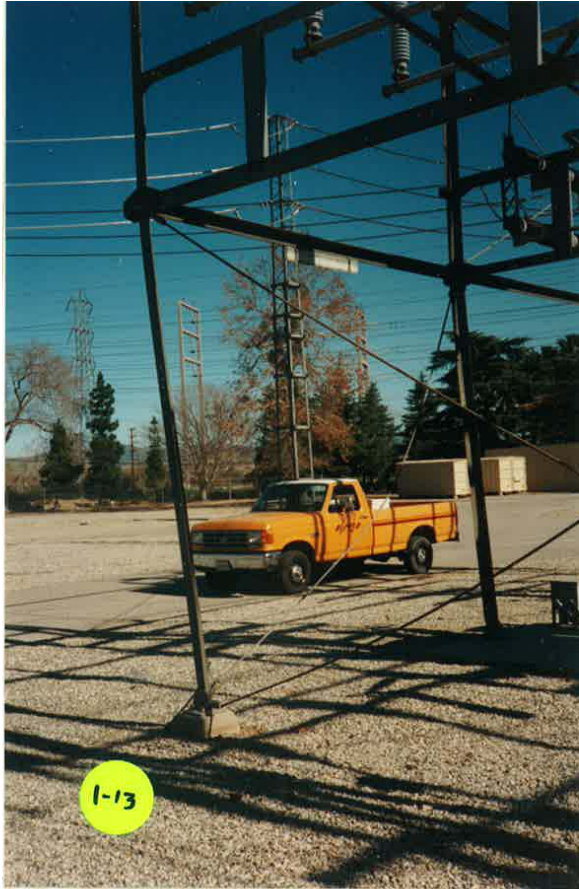
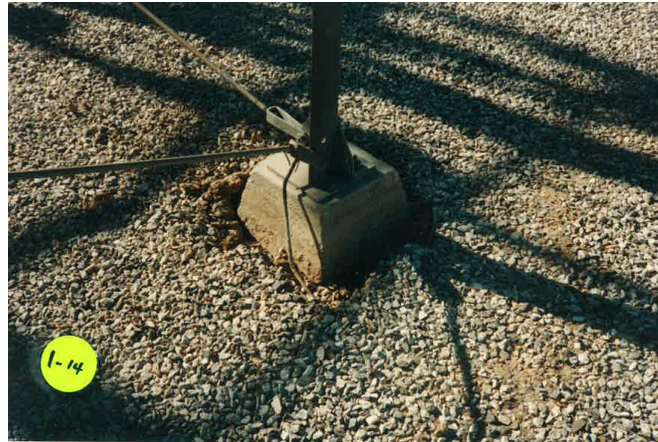
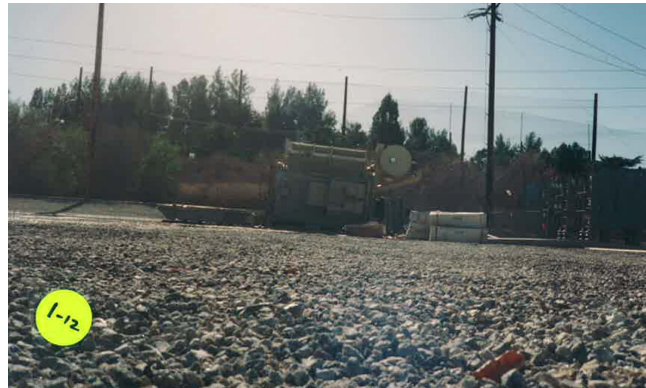
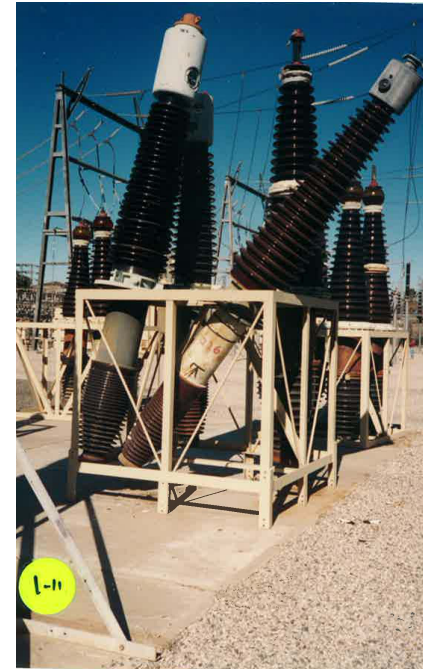
Images of Saugus Sub. Damages

- SCE customers lost power on the Ventura Plane
- Approx. 600,000 – Ventura
- Approx. 225,000 – Santa Clarita Valley
- Ventura Plane outages due to combination of regional power isolation caused by damages at Pardee Substations
- Santa Clarita outages due to damages at Saugus Substation

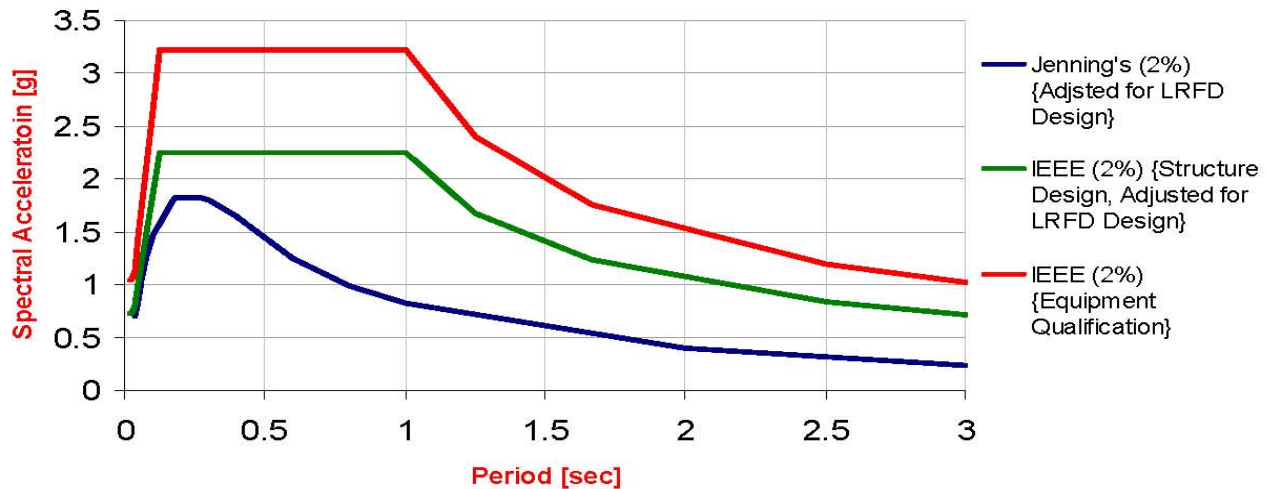
SCE Equipment Design Spectrum

- Focus to assure equipment performs to a high seismic level using more stringent qualification criteria (IEEE 693)
- Support Structures being designed to accommodate the high seismically-qualified equipment
- Site (fabrication and construction) inspections have been strictly implemented assuring the quality and workmanship of the material and equipment
