FEMA P-50 Project
Simplified Seismic Assessment
Procedures for Detached, Single-Family,
Light-Frame Dwellings for Nationwide
Use

Northridge 20 Symposium

FEMA P-50 Project and P-50-1
Simplified Seismic Assessment and
Seismic Retrofit Guidelines for
Detached, Single-Family, Wood-Frame
Dwellings

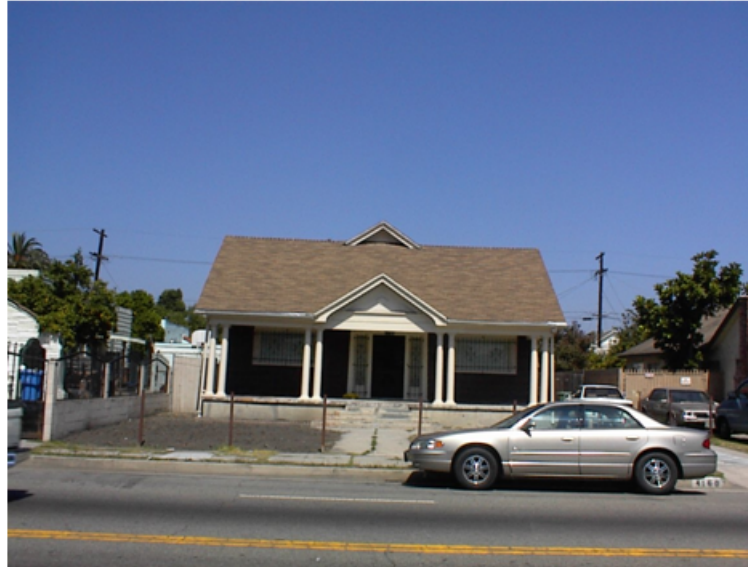
Street Address/ City /State: Los Angeles 90008

This single-story home has a raised floor supported by an unbraced cripple wall. Additionally, the cripple wall is not bolted to the foundation.
