Northridge Earthquake 1994-2014

Nabih Youssef – Nabih Youssef Structural Engineers

January 16-17, 2014 - University of California, Los Angeles

Northridge Earthquake 1994 – 2014 Symposium

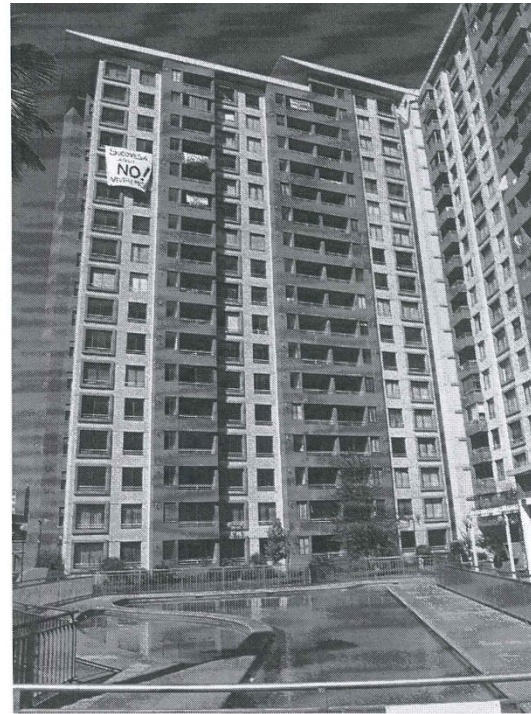
Figure 2 - Building in San Miguel in damaged state
(wall damage in basement on opposite side of building, left side of photo)

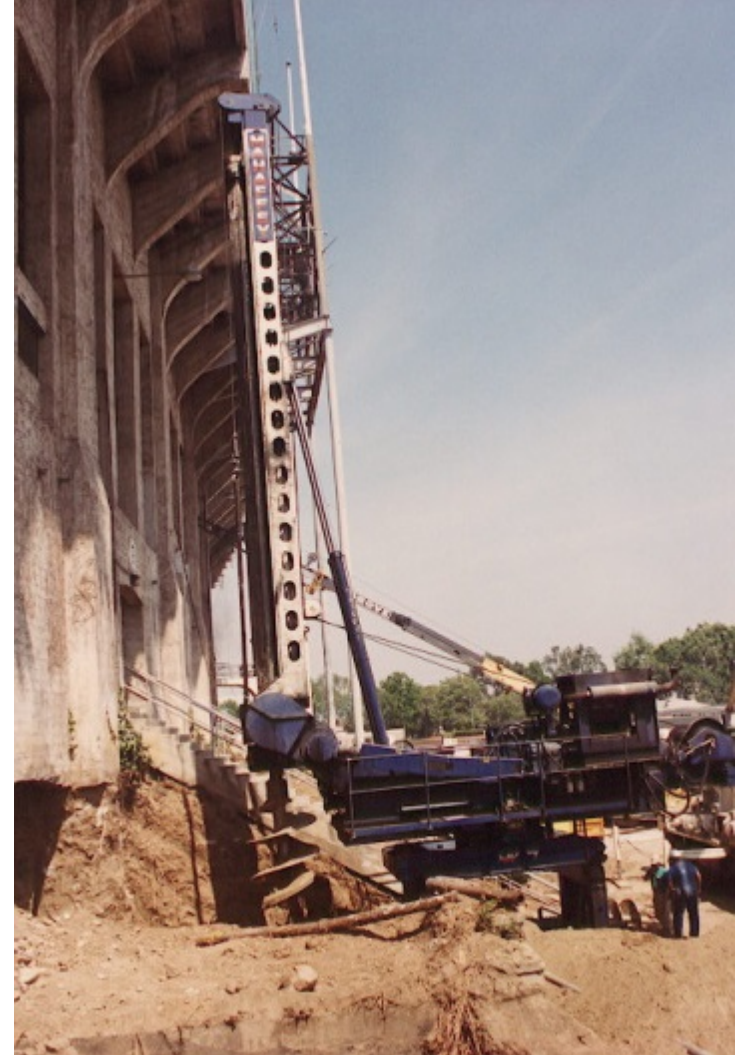
Los Angeles Memorial Coliseum

- New Frames + Foundation

- Peristyle Repair – Center Coring

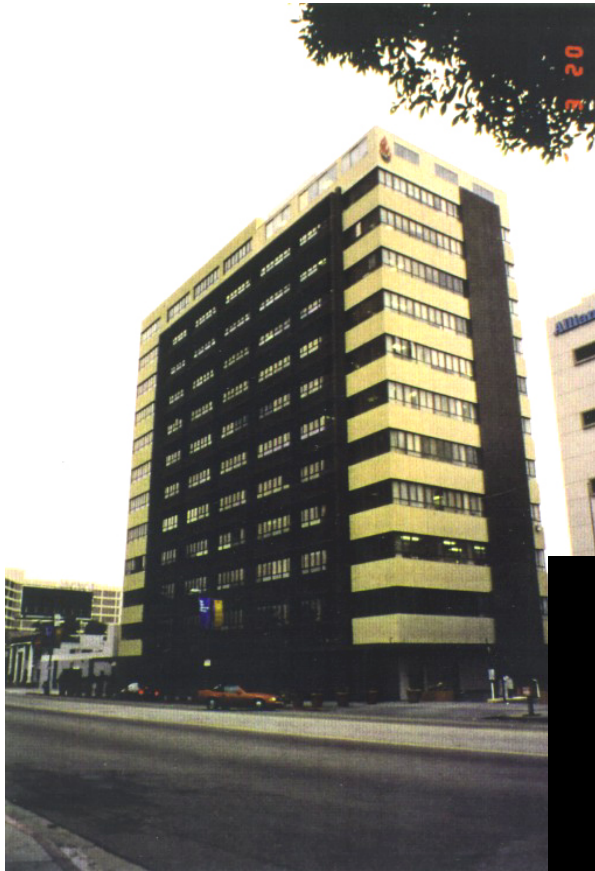
Before

- 1953
- Suffered significant structural damage to concrete walls.
- New exterior concrete frame.

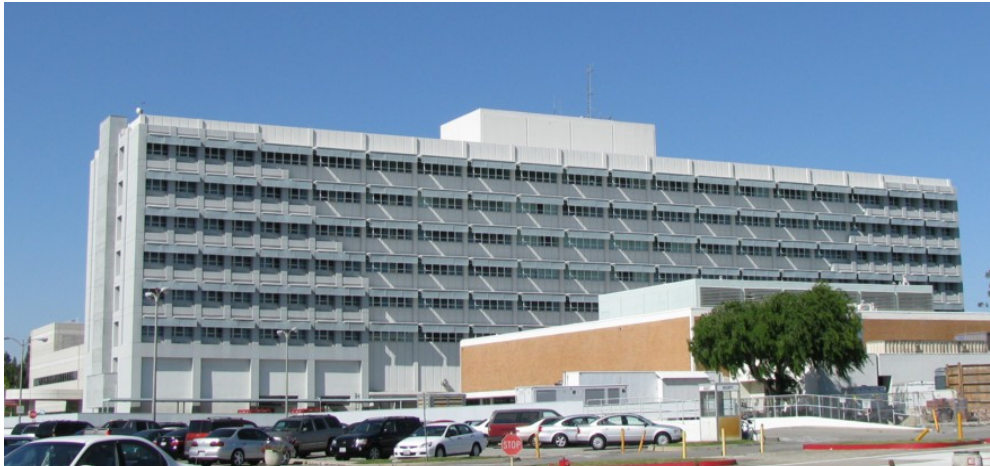
UCLA Harbor Medical Center

- 1946 Non-ductile concrete deep spandrel short columns.
- Deficient non-ductile shear walls.
- New exterior ductile concrete frames and shear walls along with composite fiber-wrapping of existing concrete piers.
- **reviewed under pending SB 1953 engineering criterion.**
- The hospital remained fully operational.

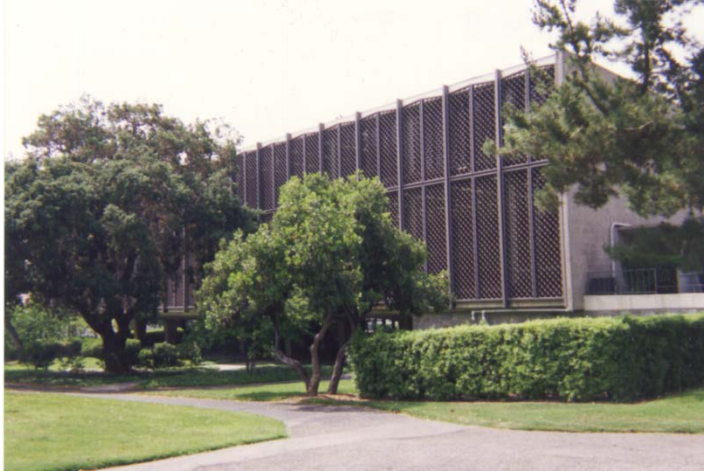
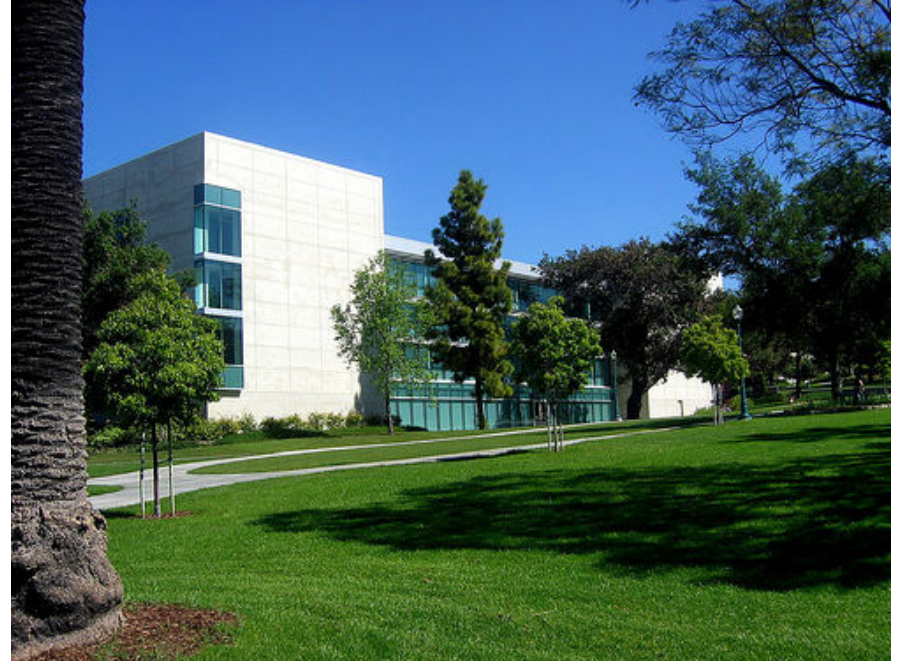
Whittier Library

- Discontinuous shear walls / frame over the ground floor circulation space that connects the campus.
- Strengthened with two new bookend structures.
- Additional space for expansion, preserving existing ground floor circulation.
- Allowed full occupancy during construction.

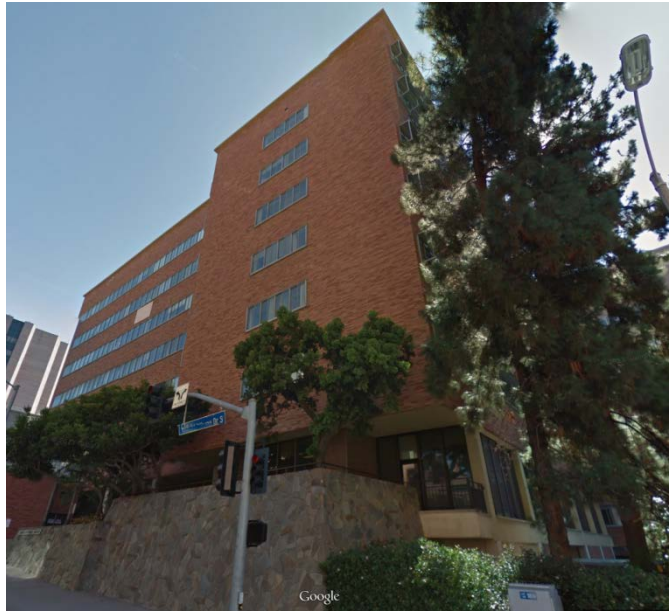
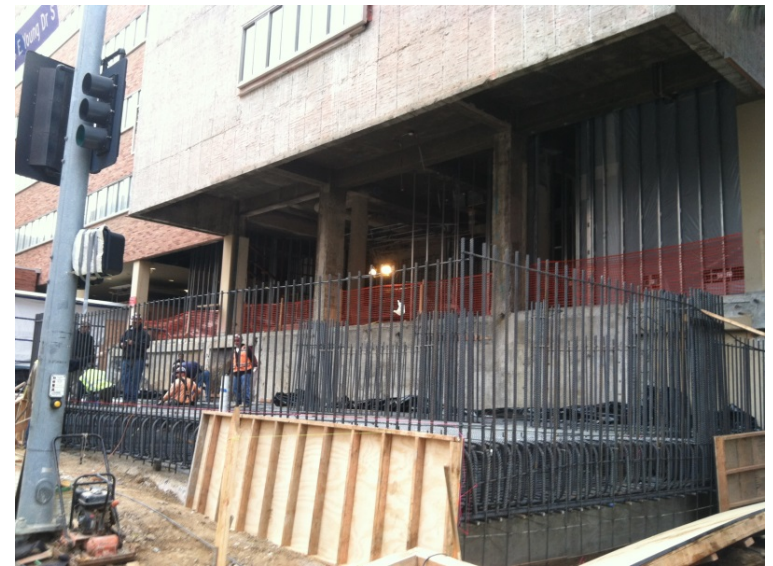
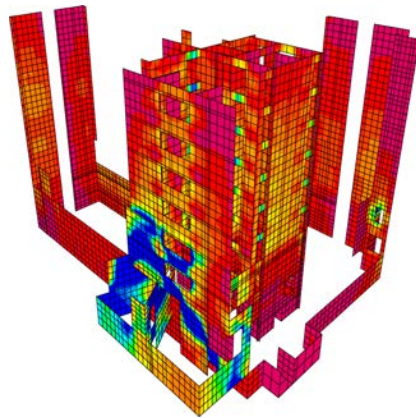
UCLA SOPH

- 7 story (1965) Inadequate concrete shear strength
 - Discontinuous shear walls
 - Deep spandrel short column non-ductile frames.
- New “buttress” walls to address main wall discontinuous walls
- **Confirmed with nonlinear pushover to ensure adequacy of existing perimeter short columns**

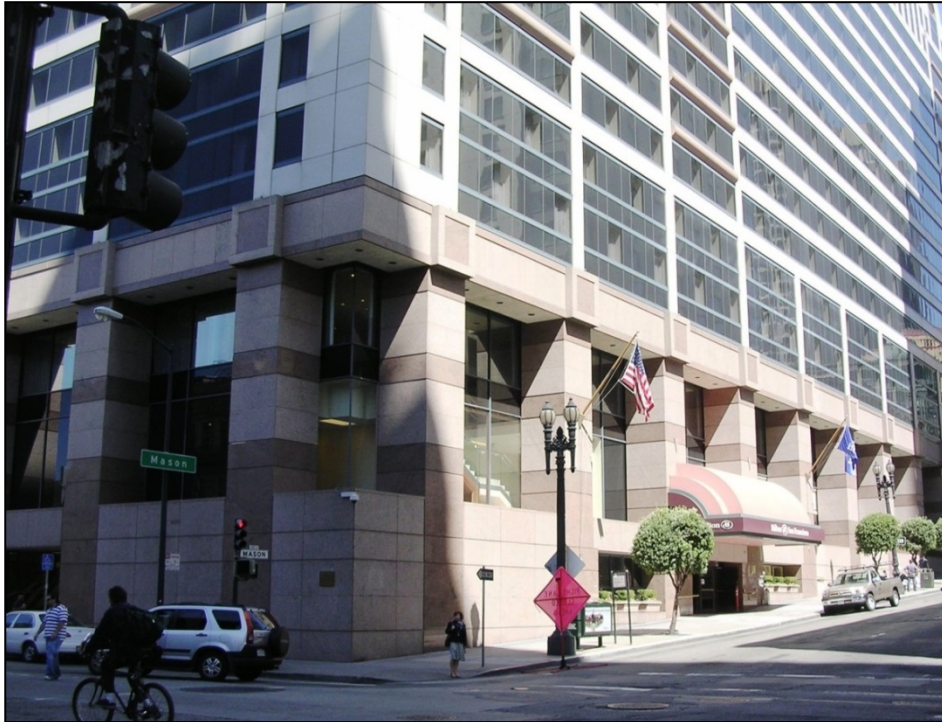
San Francisco Hilton

- 1964, 19-story with interior steel framing from 4th to 14th floor.
- Perimeter perforated light weight concrete walls above 4th floor.
- Two small interior concrete cores.
- Perimeter non-ductile concrete frames, lobby to 3rd floor.
- **“Brute Force” strengthening approach results in failure mechanisms developing in upper floors.**
- **Retrofit approach uses nonlinear analysis to “tune” strengthening of lower floors to utilize available strength of existing perforated walls in upper floors.**
- Added limited shear walls below 4th floor.

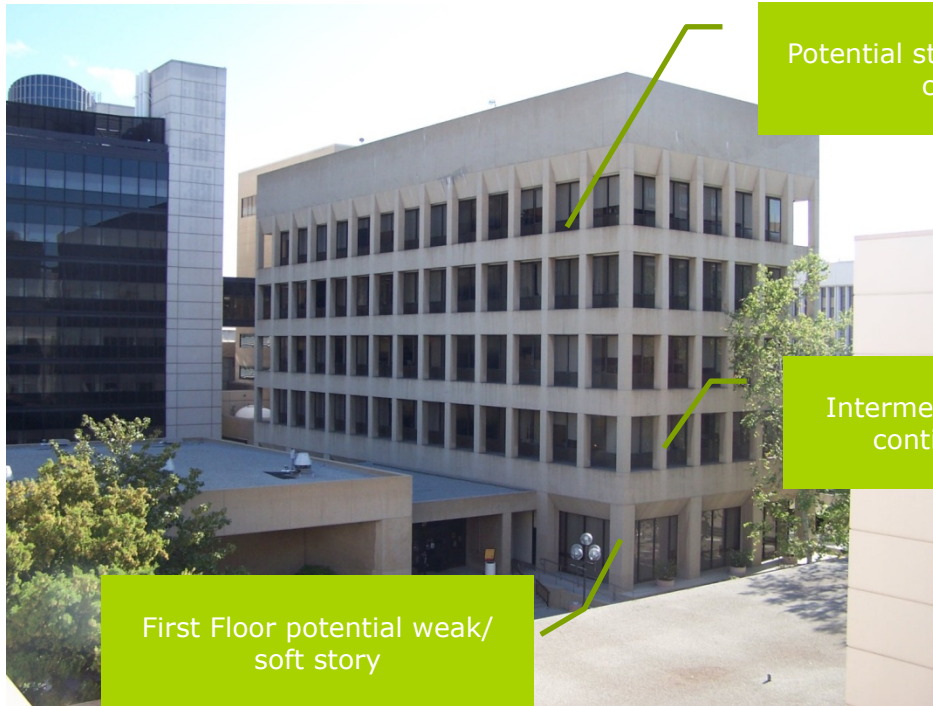
Original Building

Potential strong beam/weak column.

Intermediate columns not continuous to base

First Floor potential weak/soft story

- 5 story (1968)
- Lack of adequate shear capacity in existing beams and columns
- Potential weak/soft 1st story
- 3D nonlinear time history response analysis
- “Brute” force strengthening approach results in failure mechanisms developing in upper floors

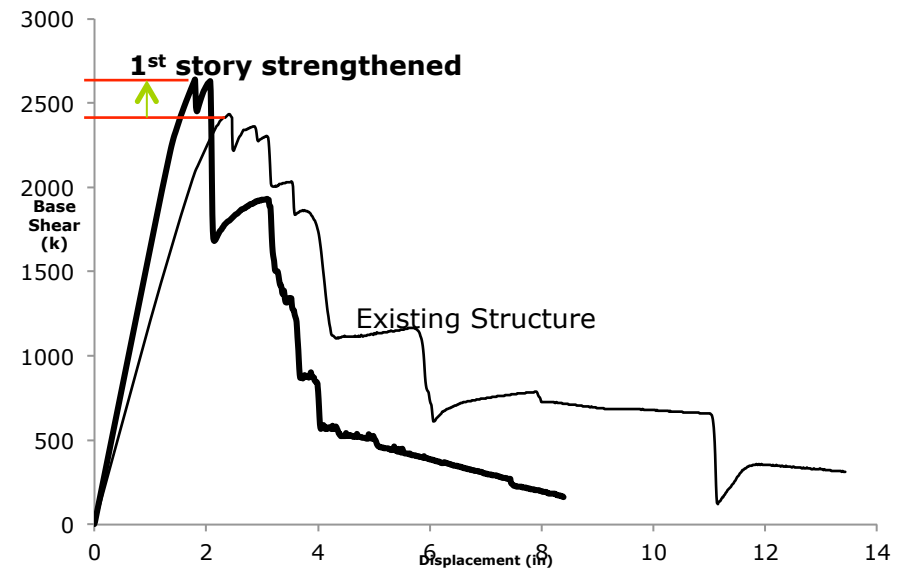
- Retrofit approach: Make building more flexural/ ductile
- FRP selected beams and columns on first 3 floors for shear strength to promote flexural yielding
- "Pin" select existing columns by coring vertical bars to promote more distributed yielding along height of structure

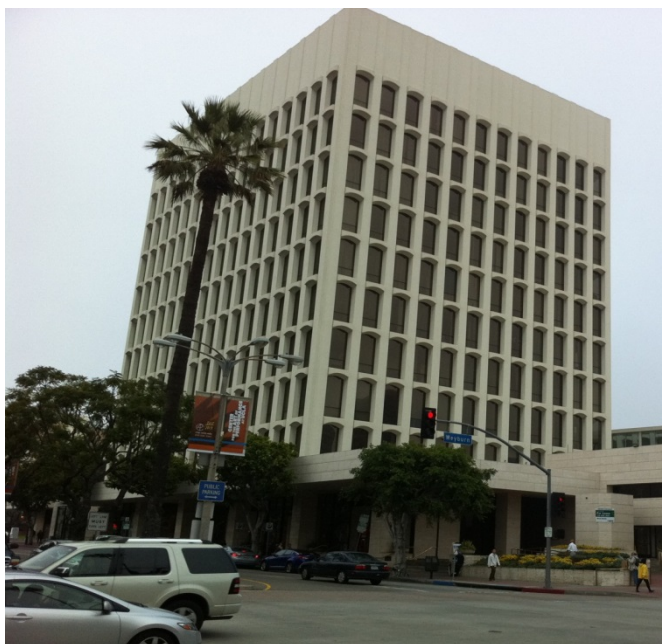
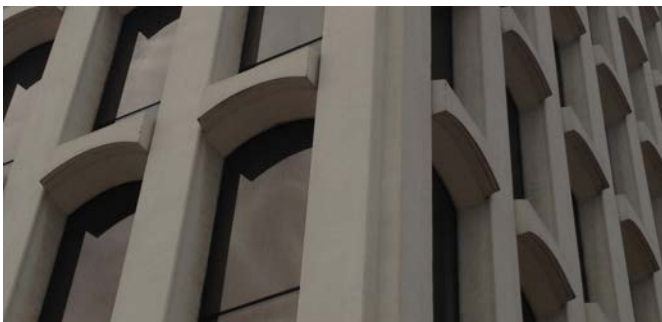
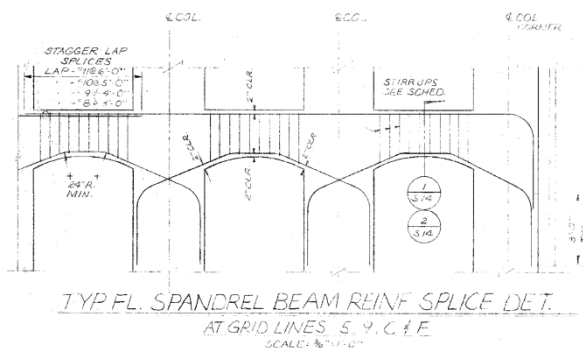
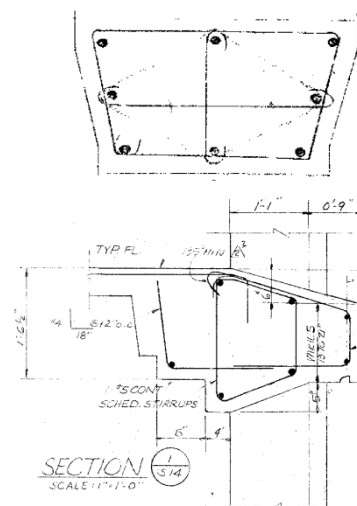
UCLA 924 Westwood

- 1970's 10 story tower – 3 below grade.
- Frame columns lack confinement in upper floors.
- Frame beams lack shear reinforcing.
- Lightweight concrete.
- 1990 retrofit to remove existing soft / weak story at base, however new walls did not extend to foundation.
- Linear analysis reports majority of existing moment frames are overstressed.

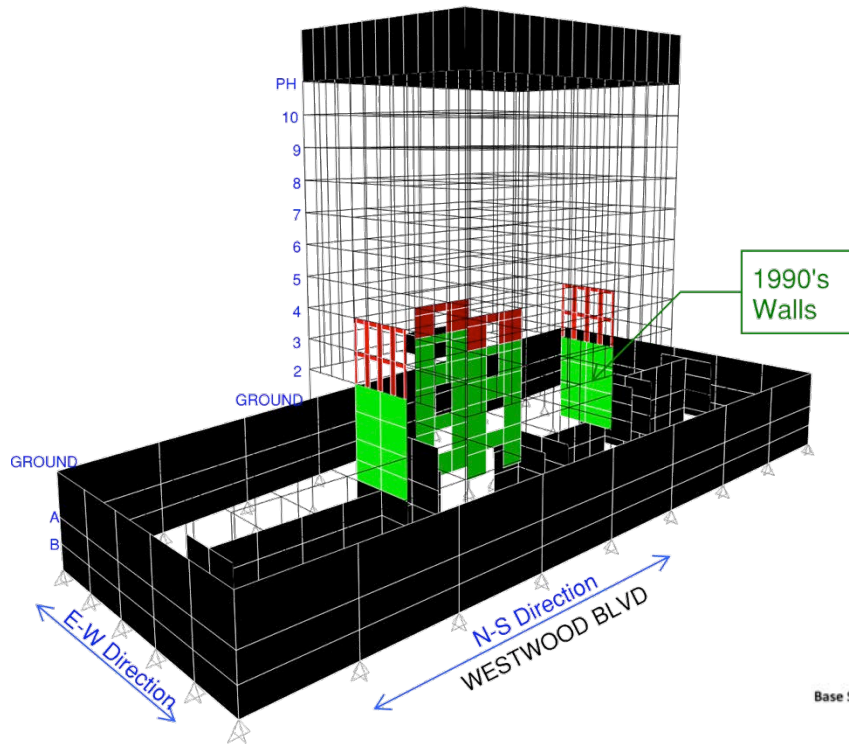
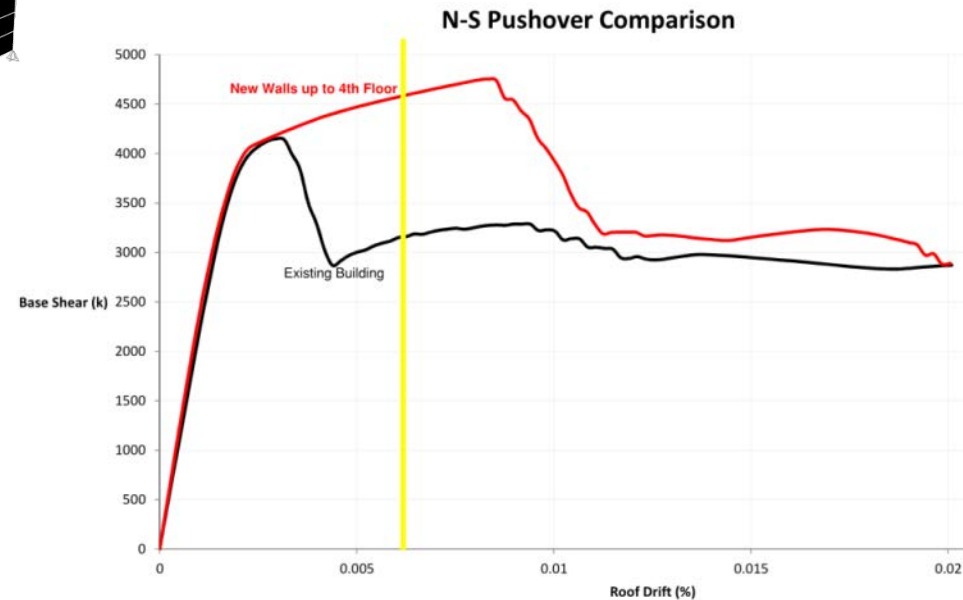
UCLA 924 Westwood

- Additional Walls
- “Pushes” demand up the tower frame

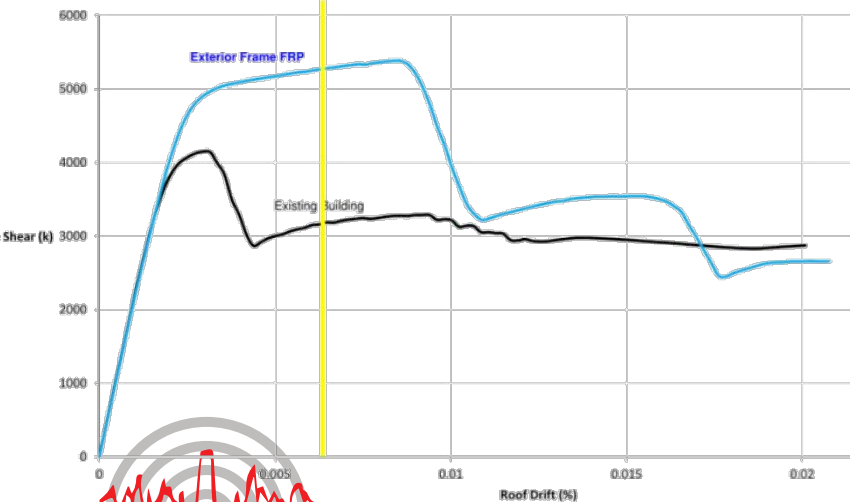
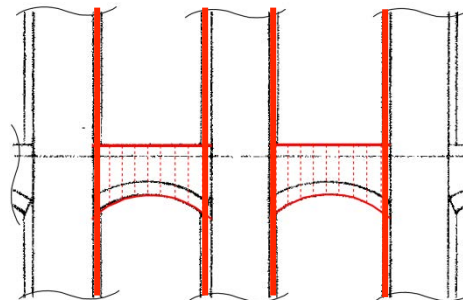
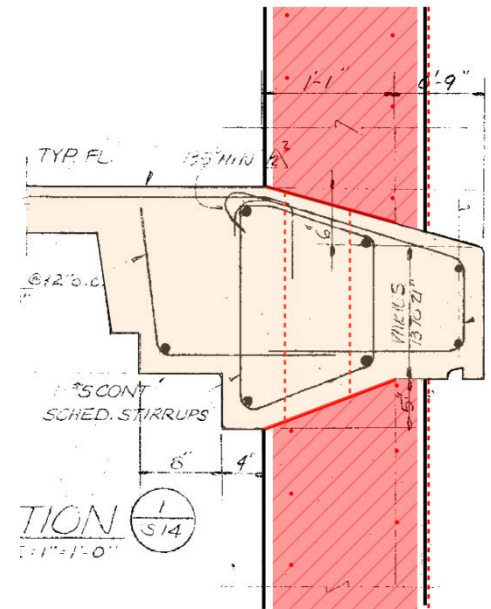
- Frame FRP Strengthening
- Aesthetics issues

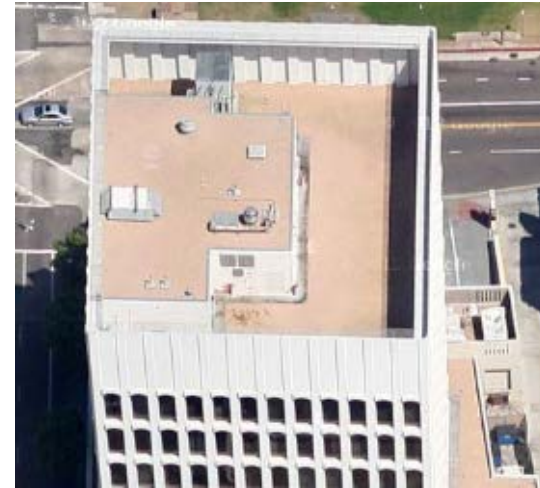
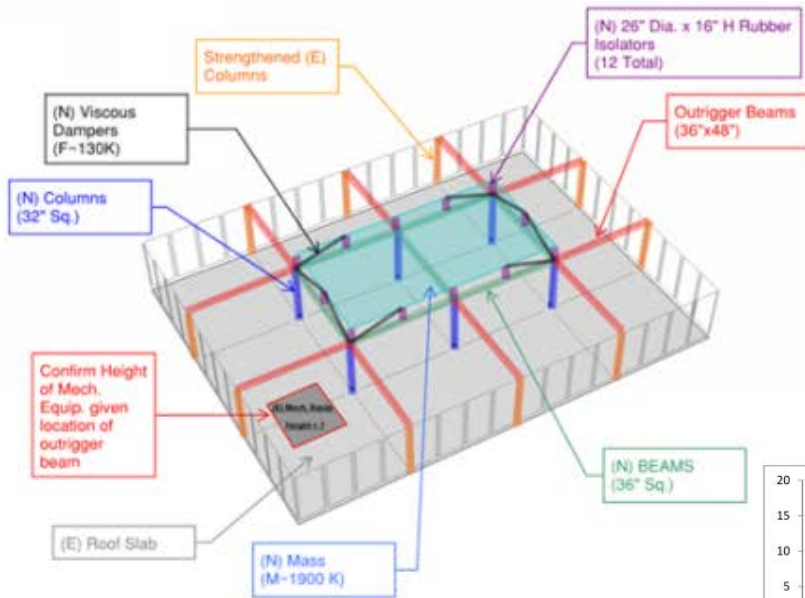
Scheme 3

- Tuned Mass Damper at roof to counteract seismic movement.

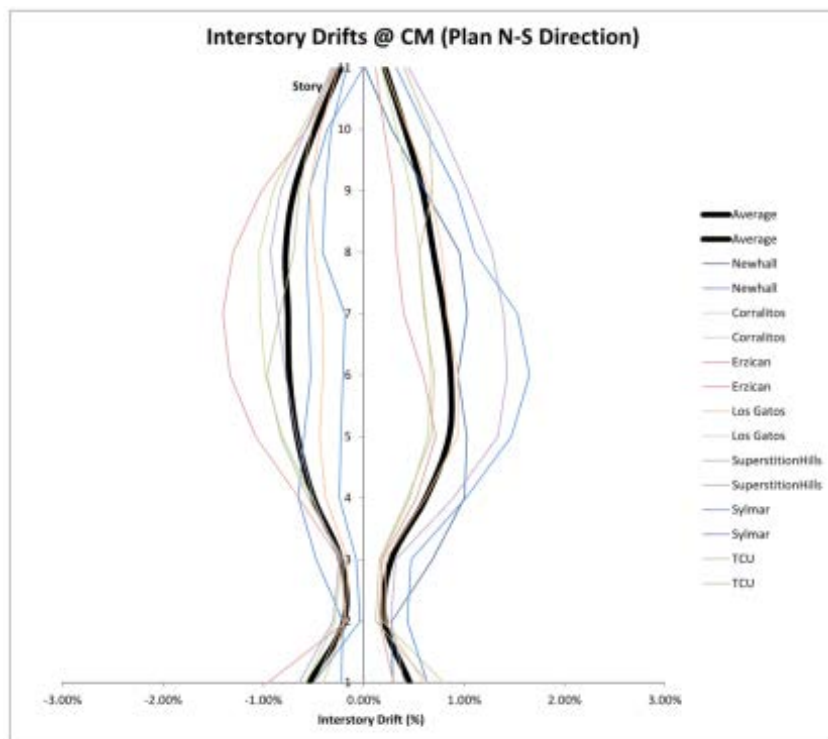
Figure 13 – BSE-2 Interstory Drifts

- Nonlinear Time History Analysis.
- In depth independent peer review adds confidence and reliability to the analysis.
- A good example of being able to take advantage of slightly better-than-typical detailing of the era (1970).
- Extra ductility and energy dissipation captured in the nonlinear analysis, not represented in the linear analysis.

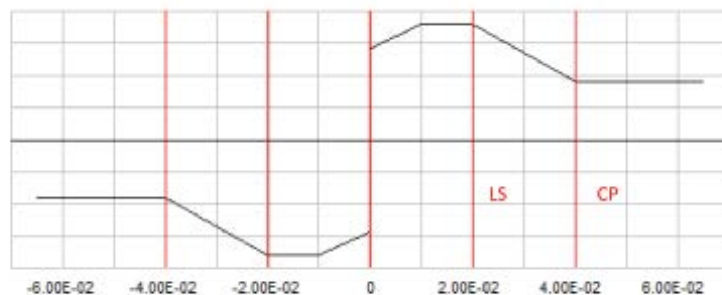
Figure 8 – Typical Moment Frame Beam Flexural Rotation Hinge

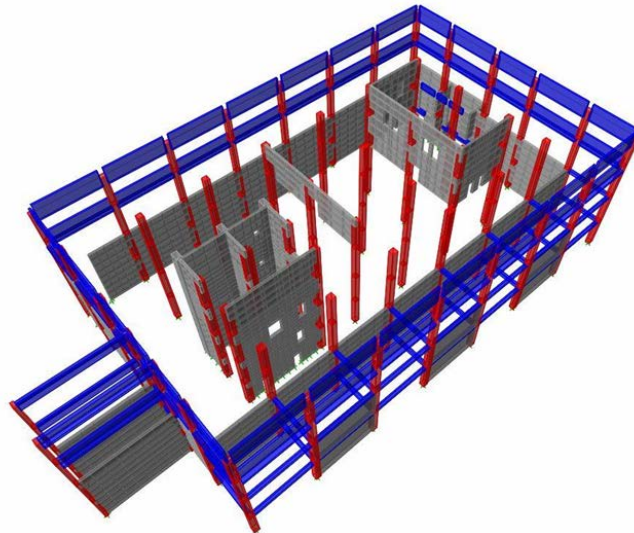
- 2 story above, 2 story below (1962)
- Discontinuous shear walls
- Thin walls with minimal reinforcing
- Shear dominated global behavior
- Nonductile exterior concrete frame

Existing Shear Walls Above Ground

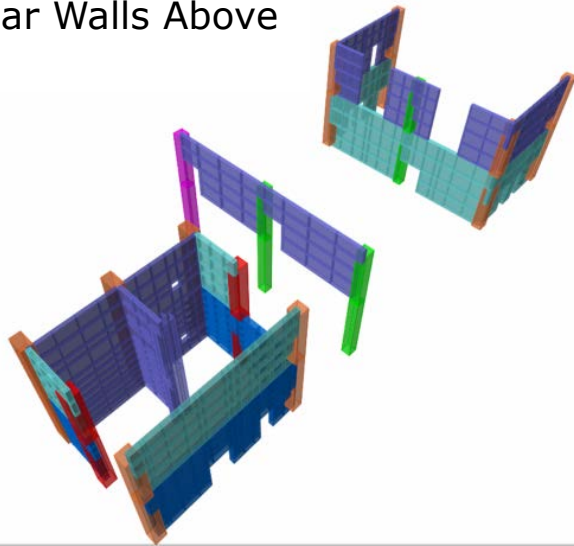
Slotted Wall w/FRP Concept

- Reduce Stiffness
- Flexure Control

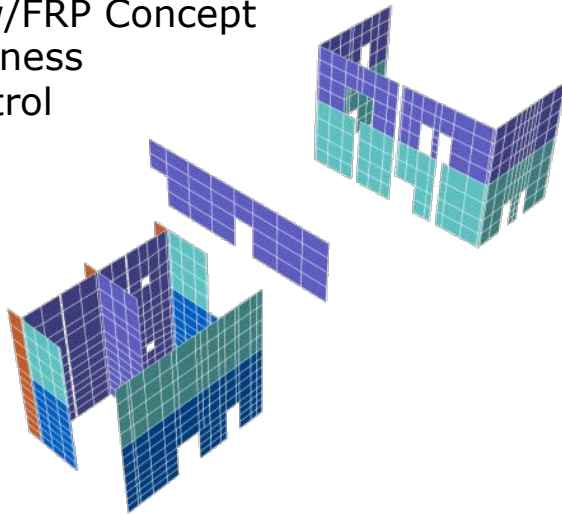
- Remove discontinuous walls above 2nd floor
- Slit walls to ensure flexural behavior
- FRP existing walls to enhance shear strength and boundary elements
- Philosophy:
 - Attract less seismic demand with better energy dissipation for remaining walls
 - Enhance existing walls rather than add new structure – difficult to compete with stiffness of existing walls
